ENGINE – ELECTRICAL POWER – IDG OIL COOLING TUBES – MODIFIED SUPPORT BRACKET FOR CLIP
POINT 1072 – CATEGORY CODE 6 – MOD.ENG-24-0004

V2500-ENG-24-0004

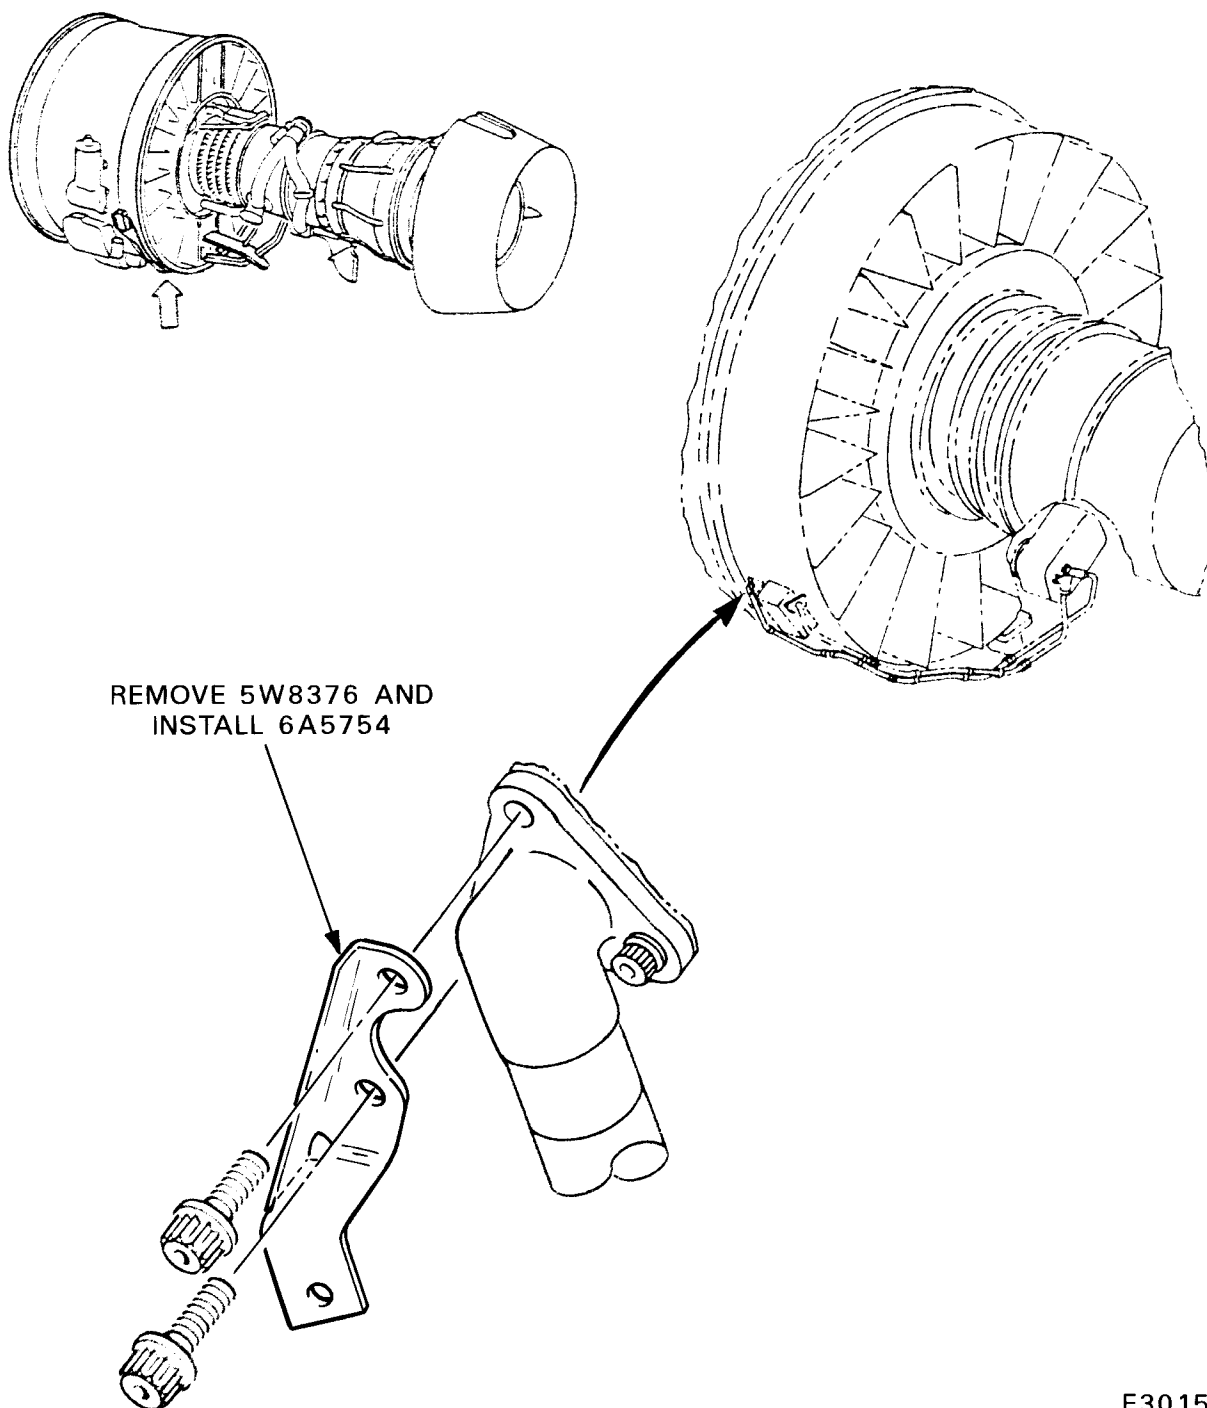
Location of support bracket for clip point 1072
Fig.1

It has been found on build that a foul may occur between the support bracket for Clip Point 1072 and the IDG oil cooler oil outlet tube adaptor.

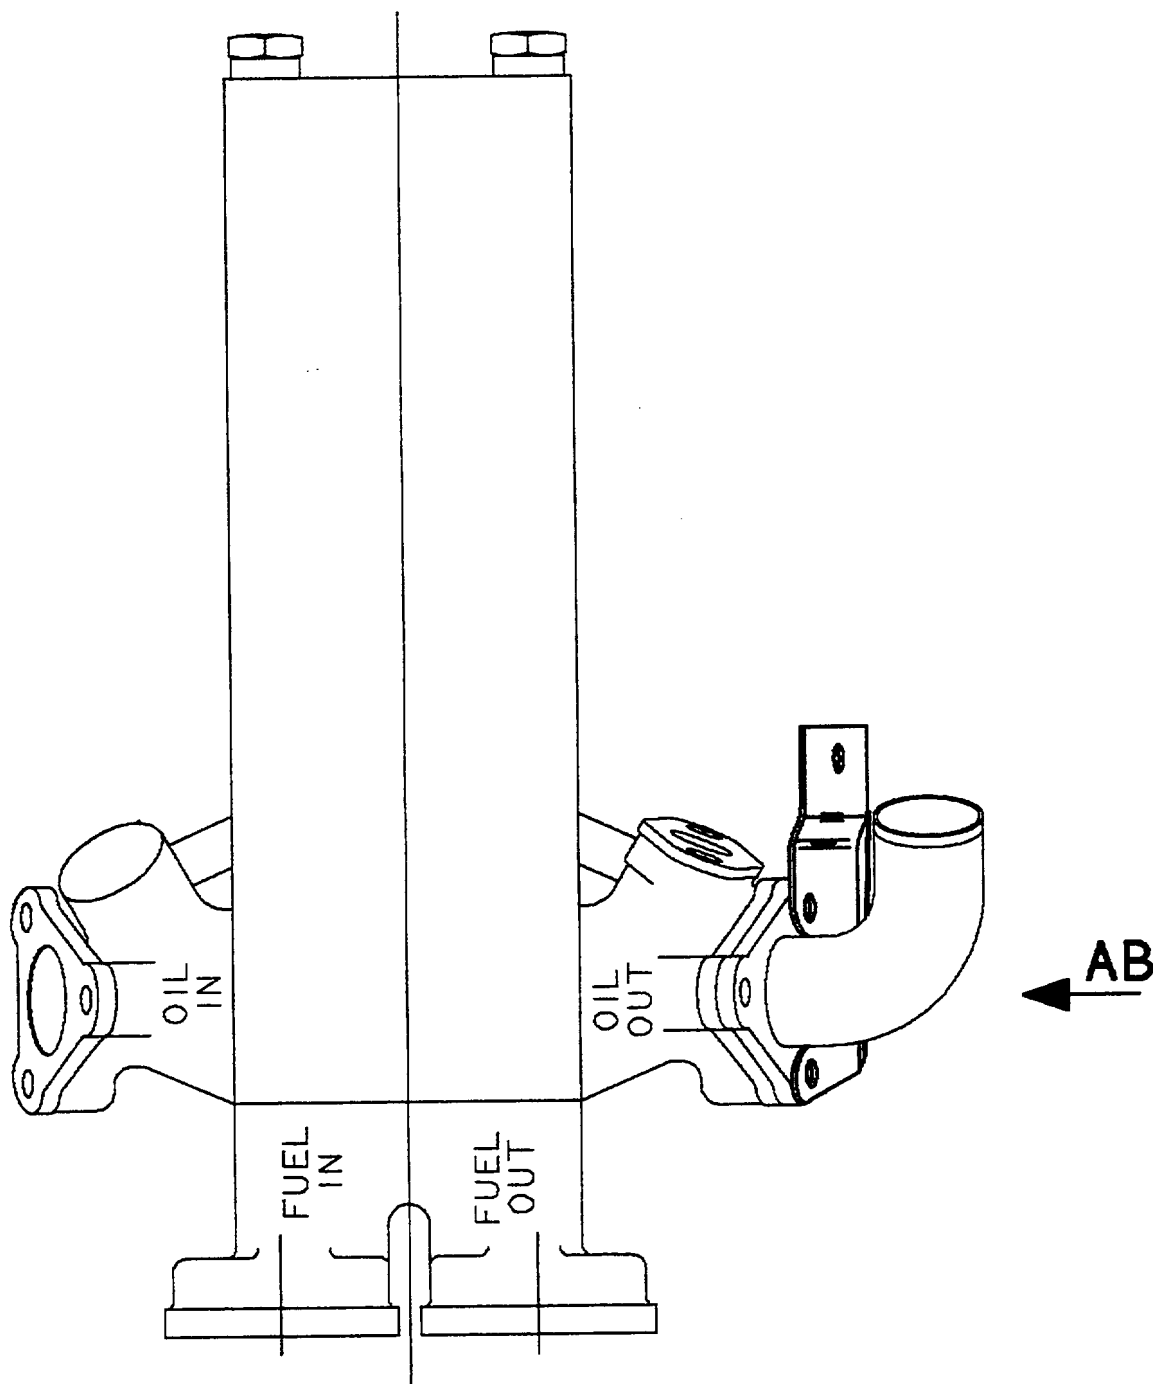
View on fuel cooled IDG oil cooler - Before and after alteration
Fig.2

The support bracket was designed to suit the forged adaptor but a foul may occur with the machined adaptor due to the different profile.

This Service Bulletin introduces a support bracket which is identical to the existing bracket but for a revised profile between the fixing holes.

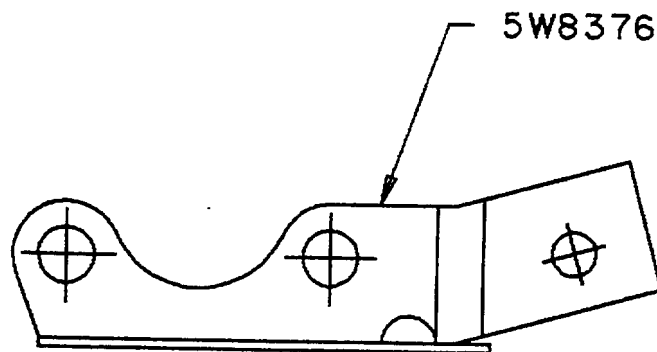
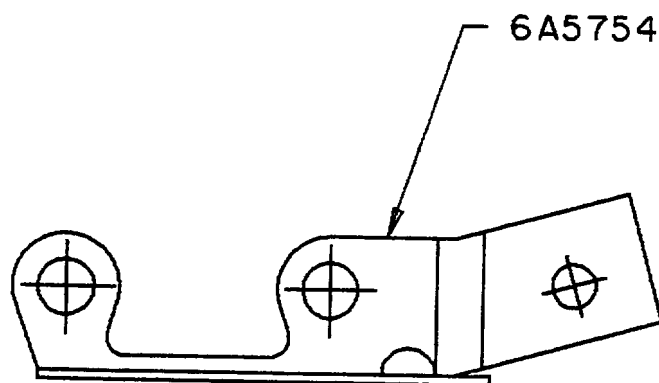
View on arrow AB showing bracket - Before and after alteration
Fig.3

VIEW ON ARROW **AB** SHOWING BRACKET
BEFORE ALTERATION
SHOWN THUS FOR CONVENIENCE

VIEW ON ARROW **AB** SHOWING BRACKET
AFTER ALTERATION
SHOWN THUS FOR CONVENIENCE
