V2500-D5 SERIES PROPULSION SYSTEM SERVICE BULLETIN

V2500-ENG-24-0019

ELECTRICAL POWER – VARIABLE SPEED CONSTANT FREQUENCY GENERATOR OIL COOLER –
INTRODUCTION OF REVISED VARIABLE SPEED CONSTANT FREQUENCY (VSCF) GENERATOR COOLING
TUBES

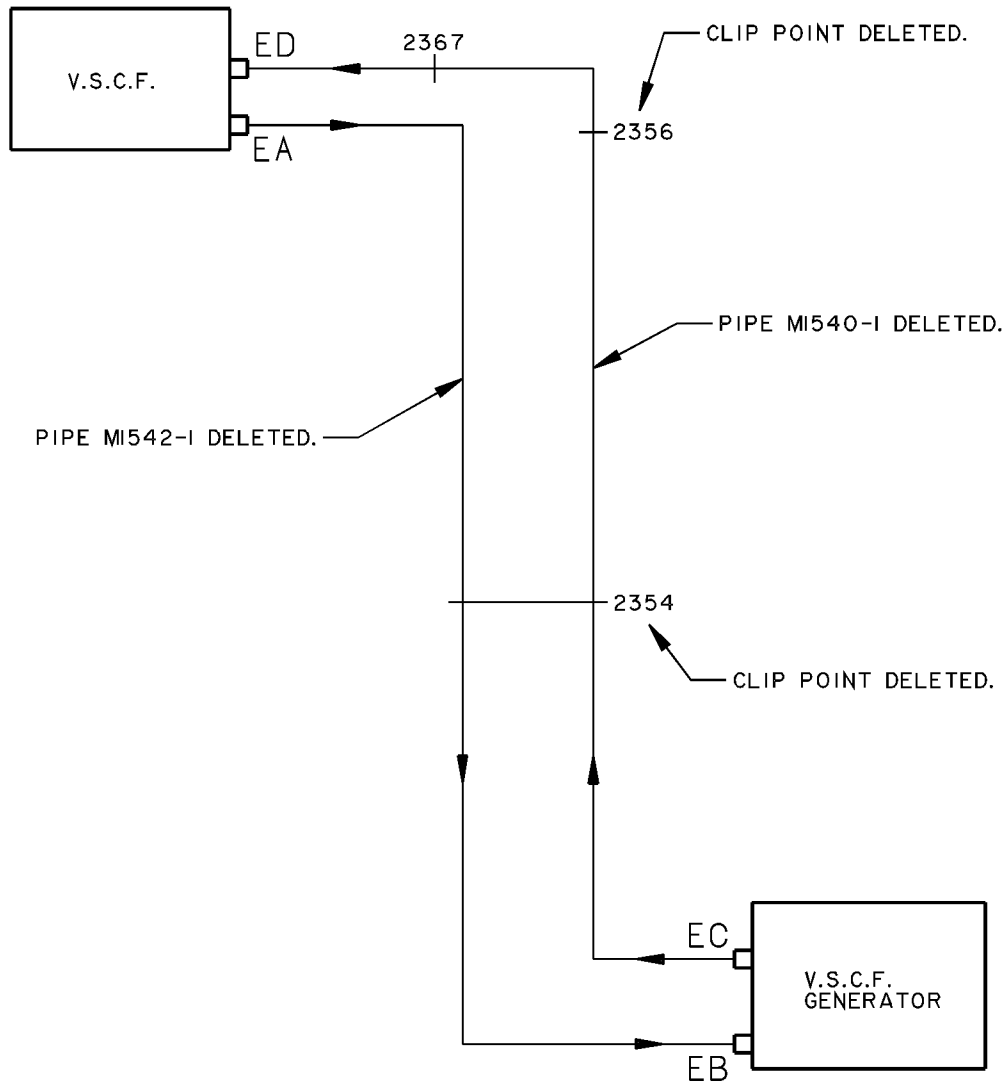
Schematic View VSCF Cooling Oil System (Before Alteration)
Figure 3

SCHEMATIC VIEW OF V.S.C.F. COOLING OIL SYSTEM BEFORE ALTERATION.

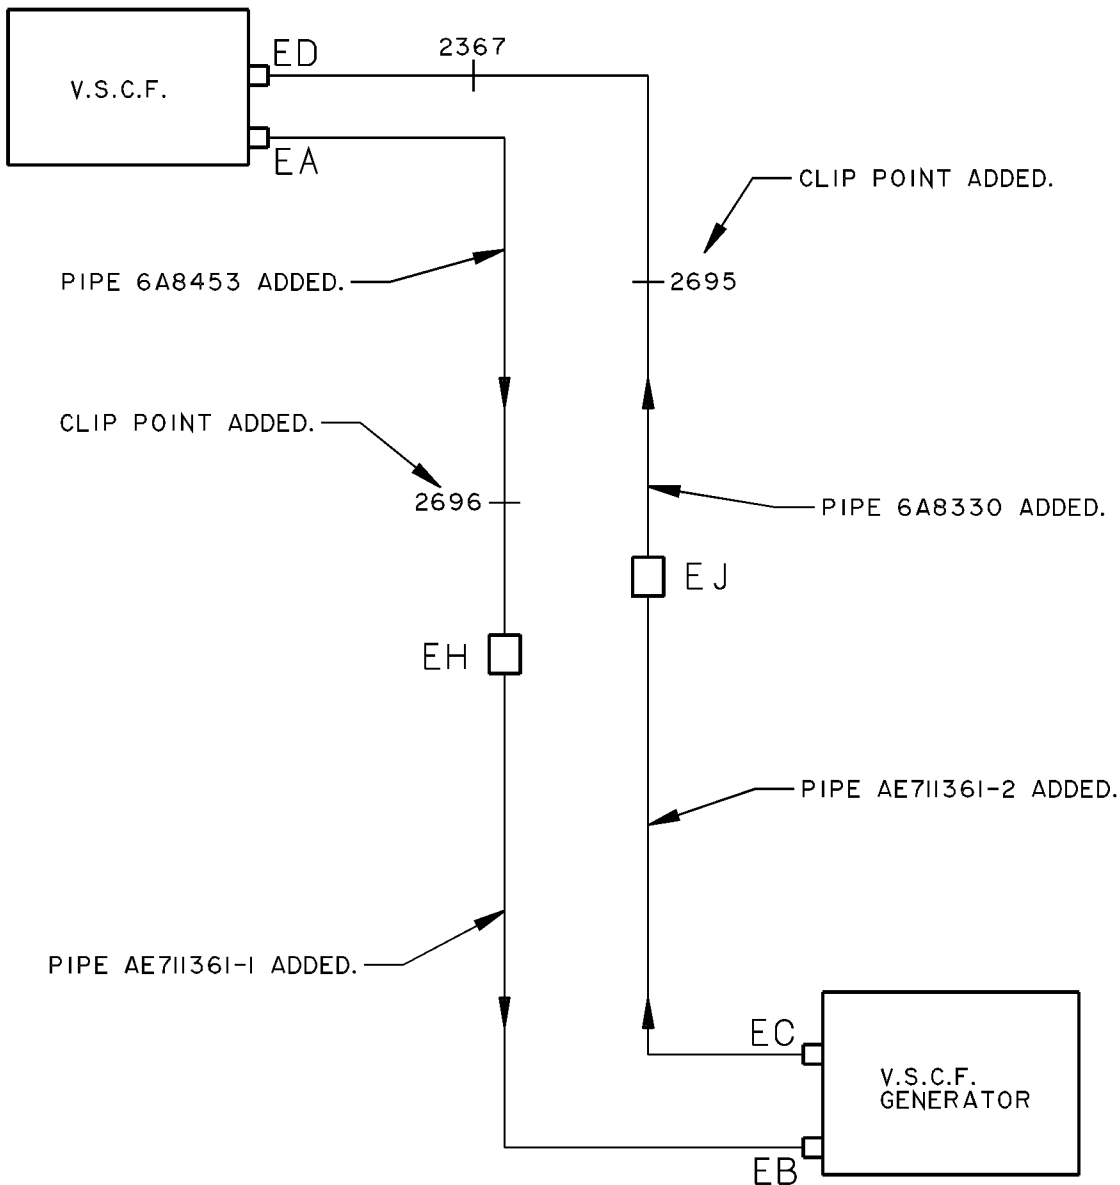
Schematic View VSCF Cooling Oil System (After Alteration)
Figure 4

SCHEMATIC VIEW OF V.S.C.F. COOLING OIL SYSTEM AFTER ALTERATION.

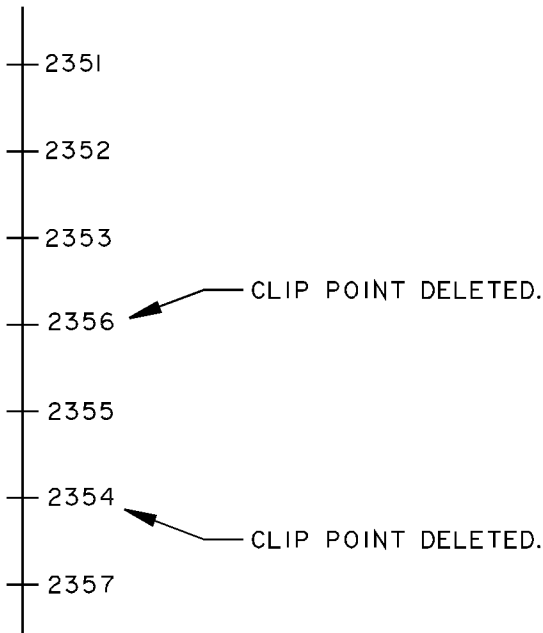
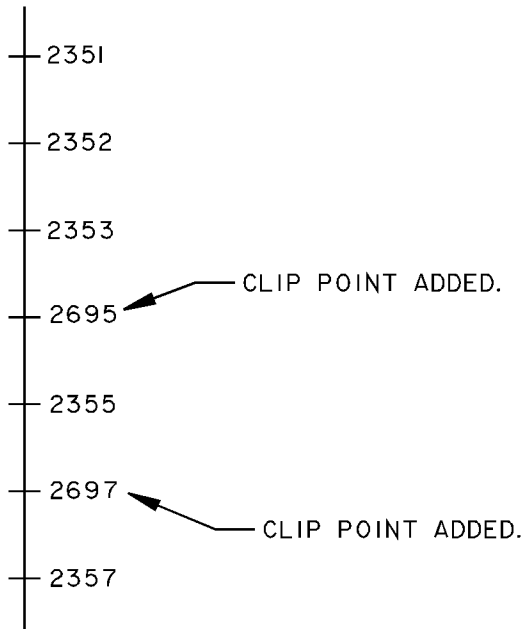
Schematic View of Raceway (Before and After Alteration)
Figure 5

SCHEMATIC VIEW OF RACEWAY
BEFORE ALTERATION.

SCHEMATIC VIEW OF RACEWAY
AFTER ALTERATION.

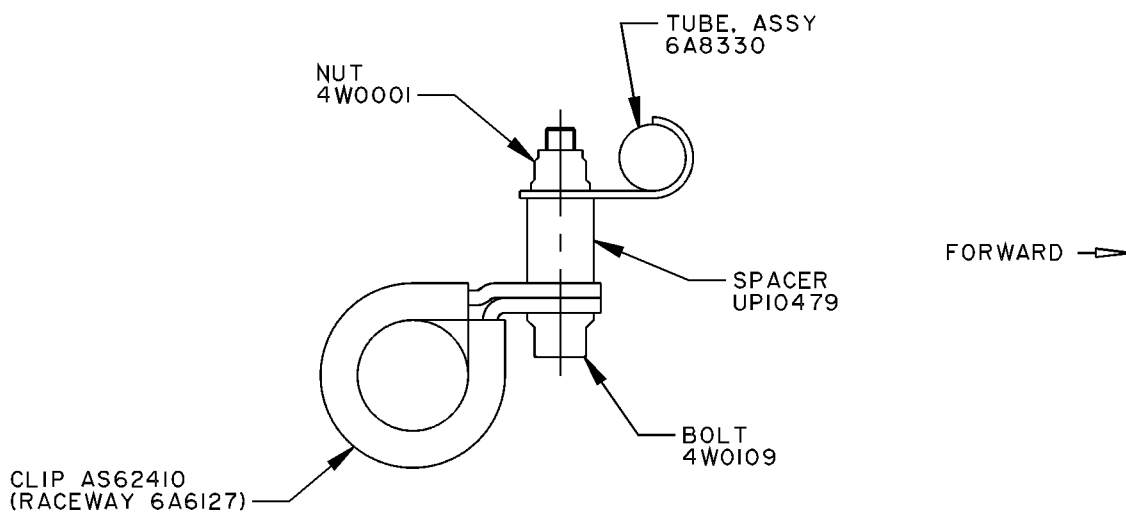
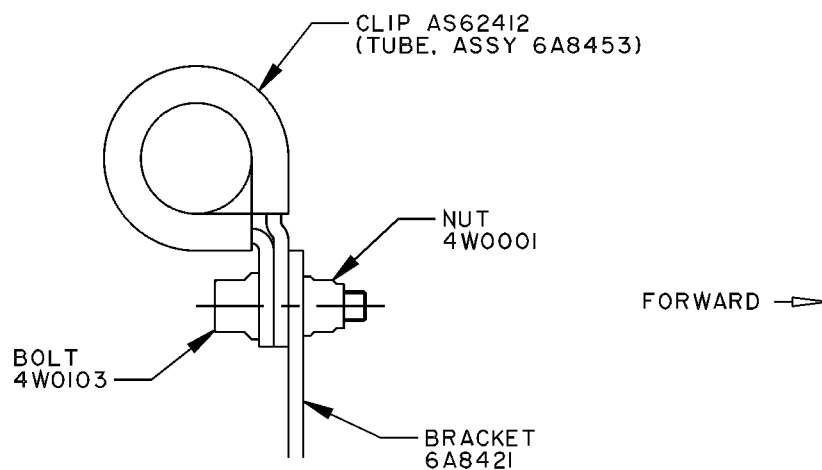
Clip Points 2695 and 2696
Figure 6

CLIP POINT 2695 ADDED.

CLIP POINT 2696 ADDED.

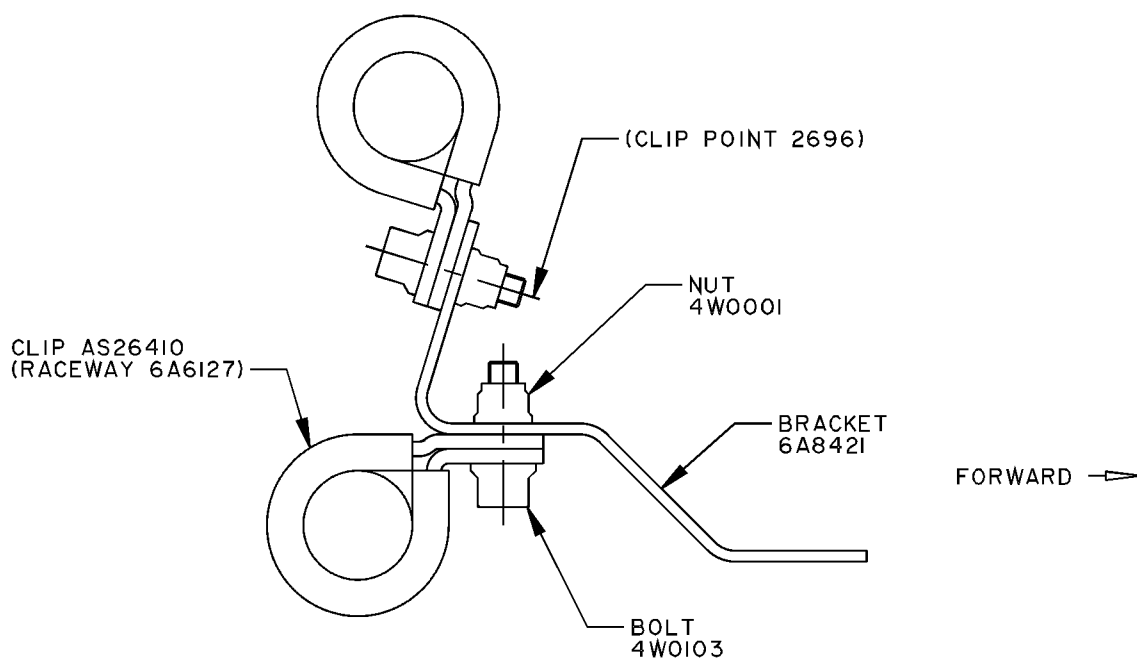
Clip Point 2697
Figure 7

CLIP POINT 2697 ADDED.
