## V2500-A5/D5 SERIES PROPULSION SYSTEMS SERVICE BULLETIN

# V2500-ENG-70-0830

INFORMATION – ENGINE – REMOVE ONE OF THE SOURCES FOR THE NO. 3 BEARING

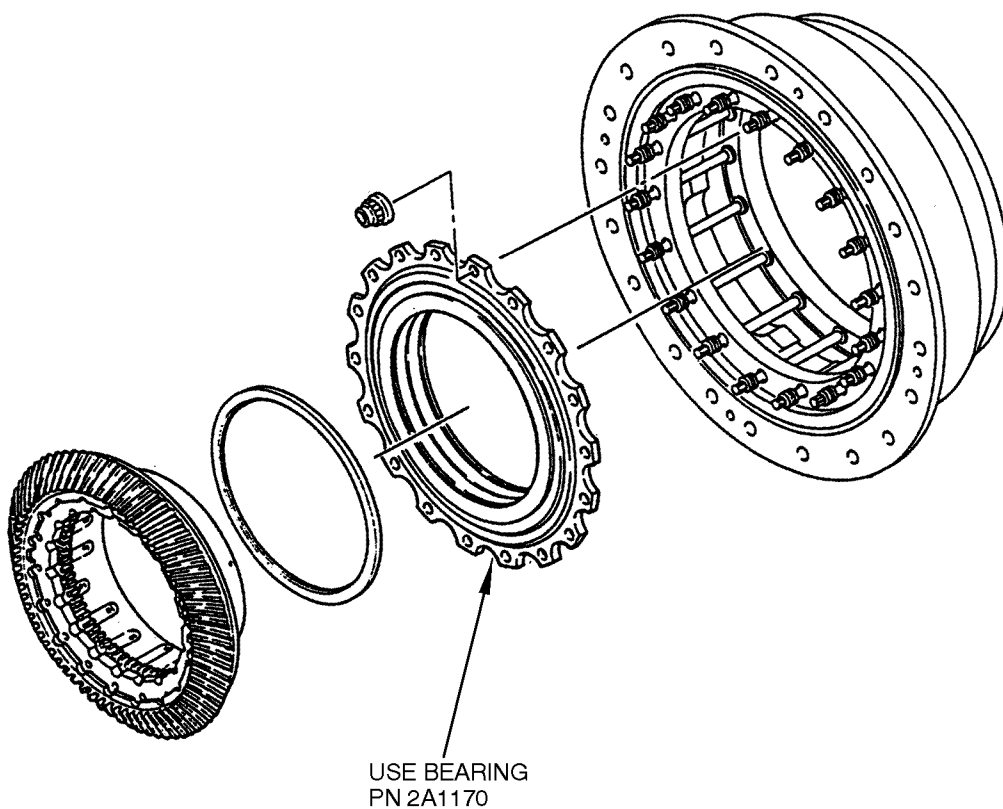
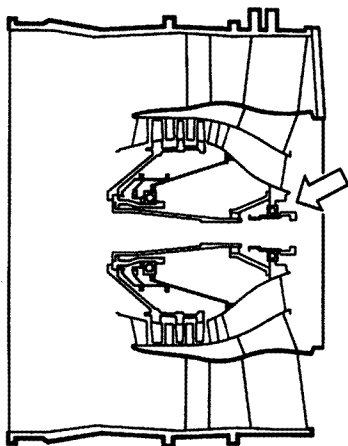
ENGINE - NO.3 BEARING  
Figure 1

(1) Problem: Multiple Number 3 Bearing service events have occurred.

(2) Background: There are presently 2 sources for the Number 3 Bearing. All of the events have occurred from one source.

Replace Bearing Option with Detail Bearing.
