SERVICE BULLETIN

IGNITION — SHROUD, LEAD PLUG END — INTRODUCTION OF A LONGER
SHROUD TO IMPROVE COOLING

V2500 Series 70-1005

74-21-43

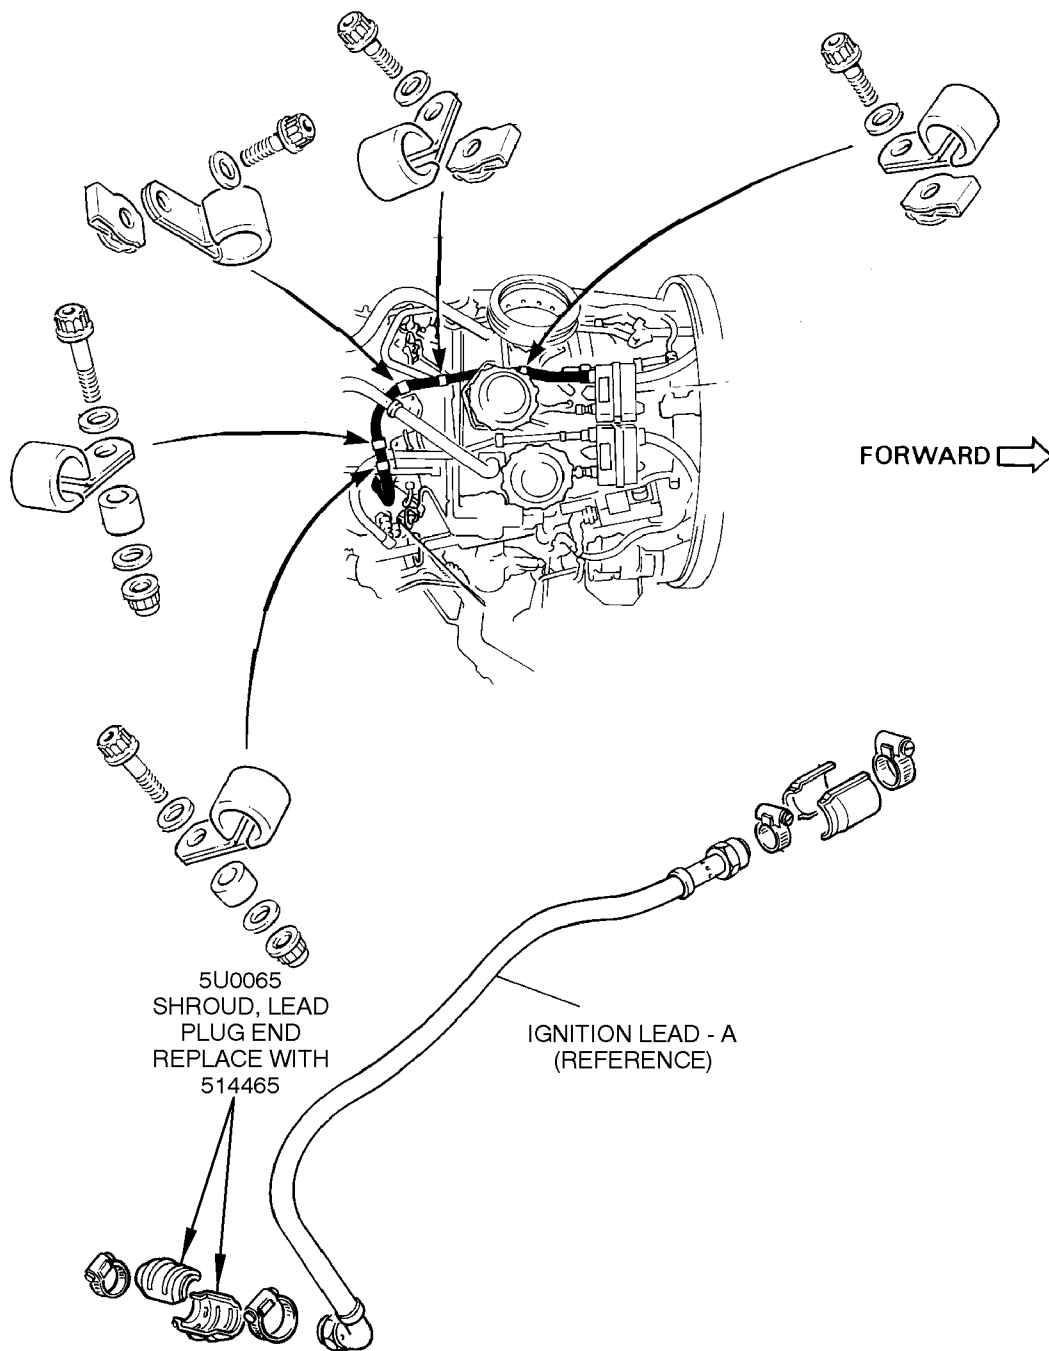
LOCATION OF SHROUD, LEAD PLUG END ON IGNITION LEAD — A
74-21-43-01
FIGURE 1

1. Condition: The Ignition Lead, PN 512090-1, with increased elbow length was introduced by Reference 6, Service Bulletin No. V2500-ENG-70-1004.
2. Background: Incorrect assembly of this ignition lead and the existing cooling shroud PN 9048444, which guides the cooling air exiting the lead over the ignition plug can lead to one of the following two conditions:

- A. Blocking the ignition lead cooling holes, hence both the ignition lead and plug are not cooled.
 - B. Ignition lead cooling holes remain outside the cooling shroud, and hence the plug is not cooled.

3. Objective: The lack of ignition lead and plug cooling results in reduced reliability and durability. A detailed review of the ignition lead and cooling shroud assembly indicated that 0.177 in (4.50 mm) needed to be added to the stainless steel cooling shroud length to ensure correct alignment with the lead vent holes to ensure sufficient flow of cooling air through the lead and the plug.

1. For engines installed on aircraft (on wing) do the following procedure. See Figures 1 and 2 for location of parts.
 - A. Replace the Lead Plug End Shroud, PN 5U0065, with a new Shroud, PN 514465, on both leads using the following references based on engine configuration:
 - (1) For V2500-A1 engines, see Reference 9, Aircraft Maintenance Manual, TASK 74-21-43-000-010-A REMOVAL and TASK 74-21-43-400-010-A INSTALLATION.
 - (2) For V2500-A5 engines, see Reference 9, Aircraft Maintenance Manual, TASK 74-21-43-000-010-B REMOVAL and TASK 74-21-43-400-010-B INSTALLATION.
2. For engines removed from aircraft (off wing) do the following procedure. See Figures 1 and 2 for location of parts
 - A. Replace the Lead Plug End Shroud, PN 5U0065, with a new Shroud, PN 514465, on both leads using the following references based on engine configuration:
