International  
Aero Engines

ENGINE - POWERPLANT - - MODIFICATION OF OIL PRESSURE SWITCH PIPING  
SUPPORT CLIPS

November 12, 1997

V2500-ENG-71-0004

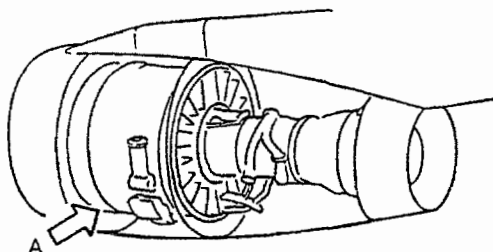
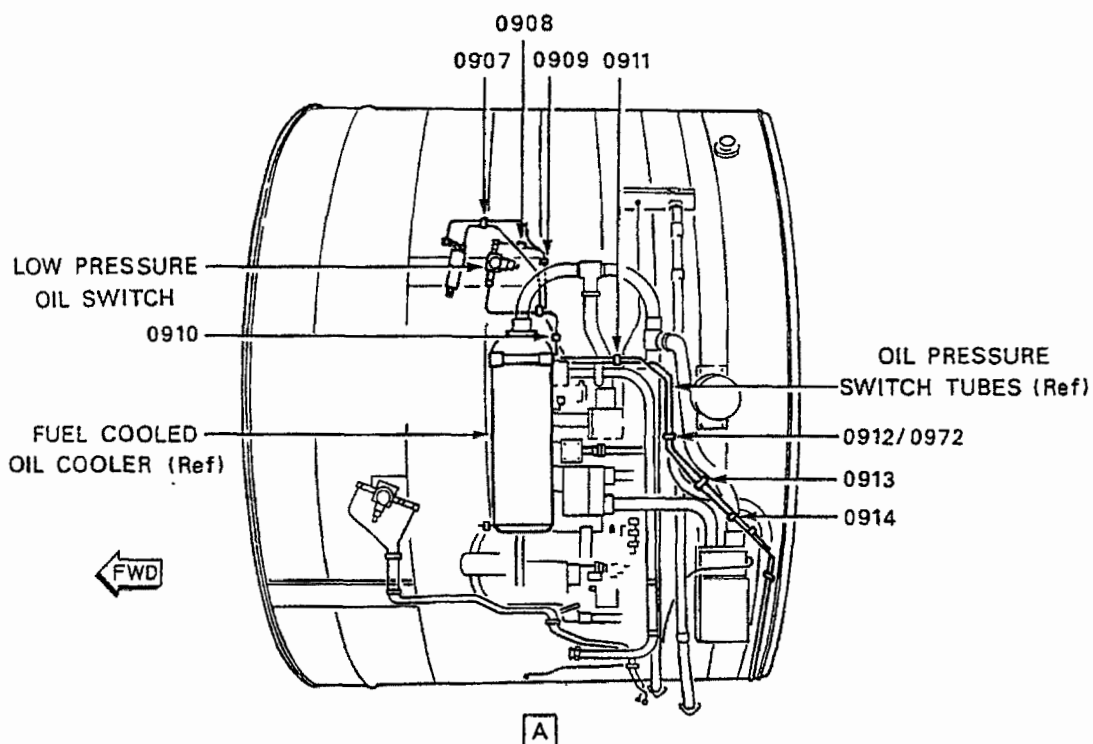
FIGURE 1

NOTES: 1.CP0972 REPLACES CP0912  
(REFER TO FIGURE 3)

LOCATION OF CP0912/0972 ON THE ENGINE FAN CASE

- (2) Remove two 400WSS-4 'P' clips, an AS21408 bolt, an AS20624 nut, and a SP154-D washer from clipping point CP0912. (Refer to Figures 1 and 3.) Keep clips for CP0972. Keep the remaining hardware for clipping point CP0973.

- (4) Put a 400WSS-14 'P' clip on the 5A8767 pipe, a 400WSS-4 'P' clip on the 740-5769 pipe, and a 400WSS-4 'P' clip on the 740-5757 pipe (local to clipping point CP0912) as shown to make clipping point CP0972. Attach the 'P' clips together with an AS21409 bolt, an AS20624 nut, and a SP154-D washer. Torque the bolt to 20-25 lbin (2.26-2.83 Nm).

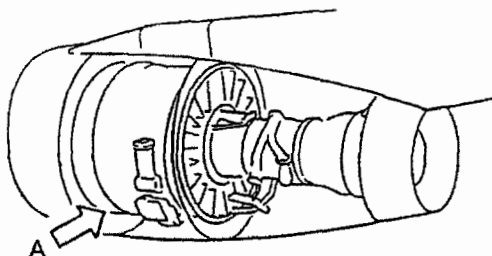
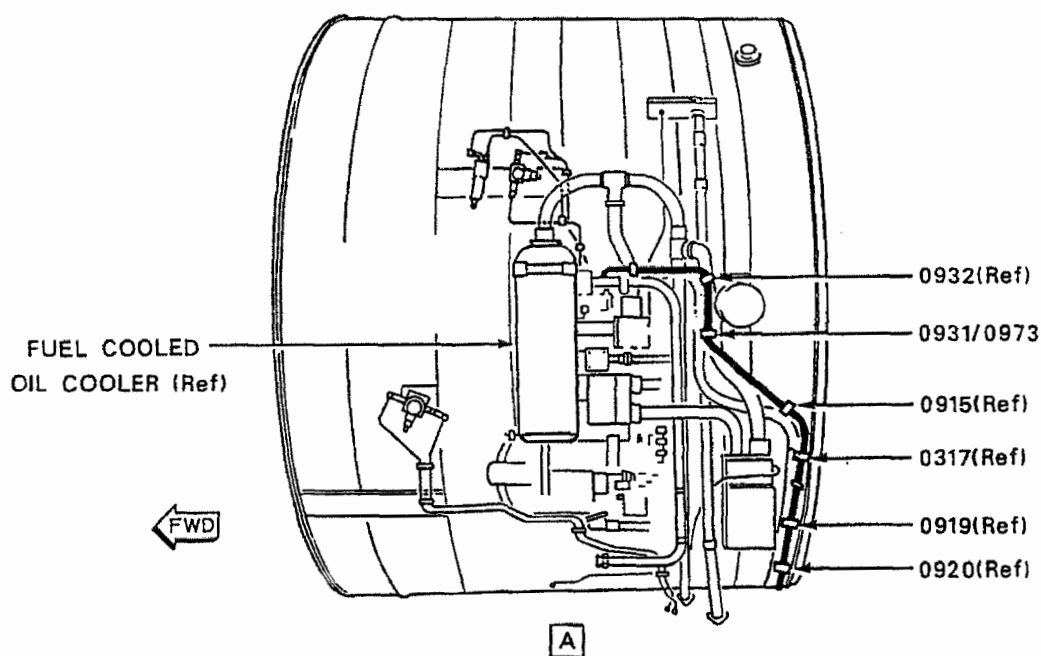
FIGURE 2

NOTE: CP0973 REPLACES CP0931  
(REFER TO FIGURE 3)

LOCATION OF CP0931/0973 ON THE ENGINE FAN CASE

- (1) Remove an AS20624 nut, a SP154-D washer, and a 400WSS-4 'P' clip from clipping point CPO9331. (Refer to Figures 2 and 3.) Install the nut and washer back on CPO931. Torque the nut to 20-25 lbin (2.26-2.83 Nm). Keep the 400WSS-4 'P' clip for installation on the 740-5790 pipe.

- (3) Put a 400WSS-16 'P' clip on the 2A0649 pipe and the 400WSS-4 'P' clip on the 740-5790 pipe as shown (local to clipping point CPO931) to make clipping point CP0973. Attach the two clips together with an AS21408 bolt, an AS20624 nut, and a SP154-D washer kept from paragraph 2.B.(2). Torque the bolt to 20-25 lbin (2.26-2.83 Nm).

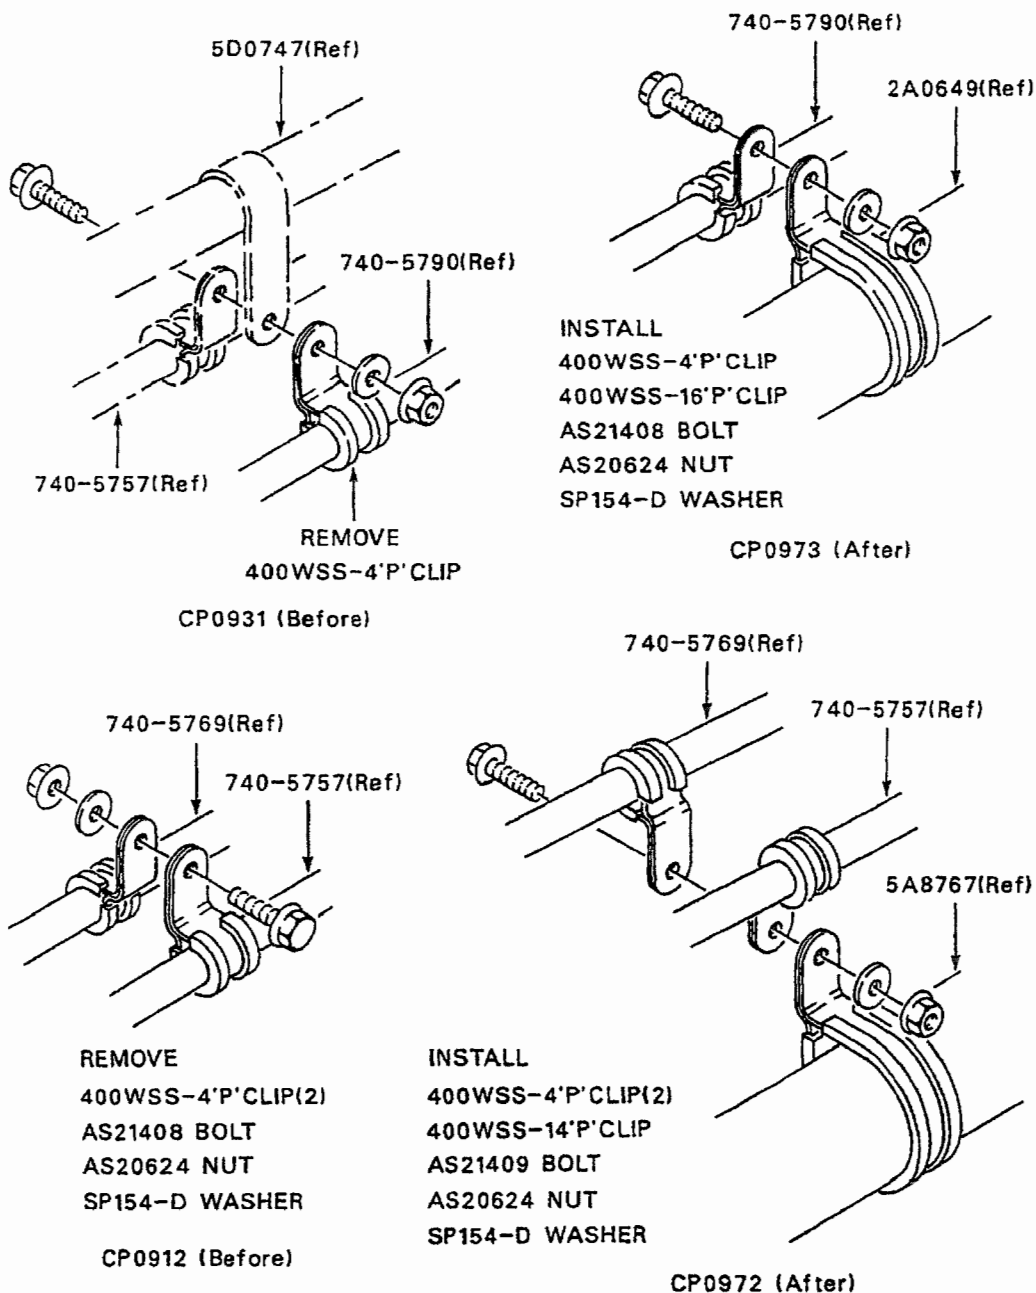
Minimum clearance condition exists between adjacent Oil Pressure Switch Piping.

- (a) Pipe clips at two clipping positions on the oil pressure switch piping are disconnected. Two new clipping positions are introduced. (Two new 'P' clips installed on larger pipes, local to the old clipping positions) to which the pipe clips are connected. (Refer to figure 3.)

MODIFICATION OF CLIPPING POINTS ON THE OIL PRESSURE SWITCH TUBES  
FIGURE 3
