POWER PLANT - ENGINE - CLIPPING POINT SUPPORT BRACKET - MODIFICATION OF - CATEGORY
CODE 6 - MOD.ENG-71-0006

V2500-ENG-71-0006

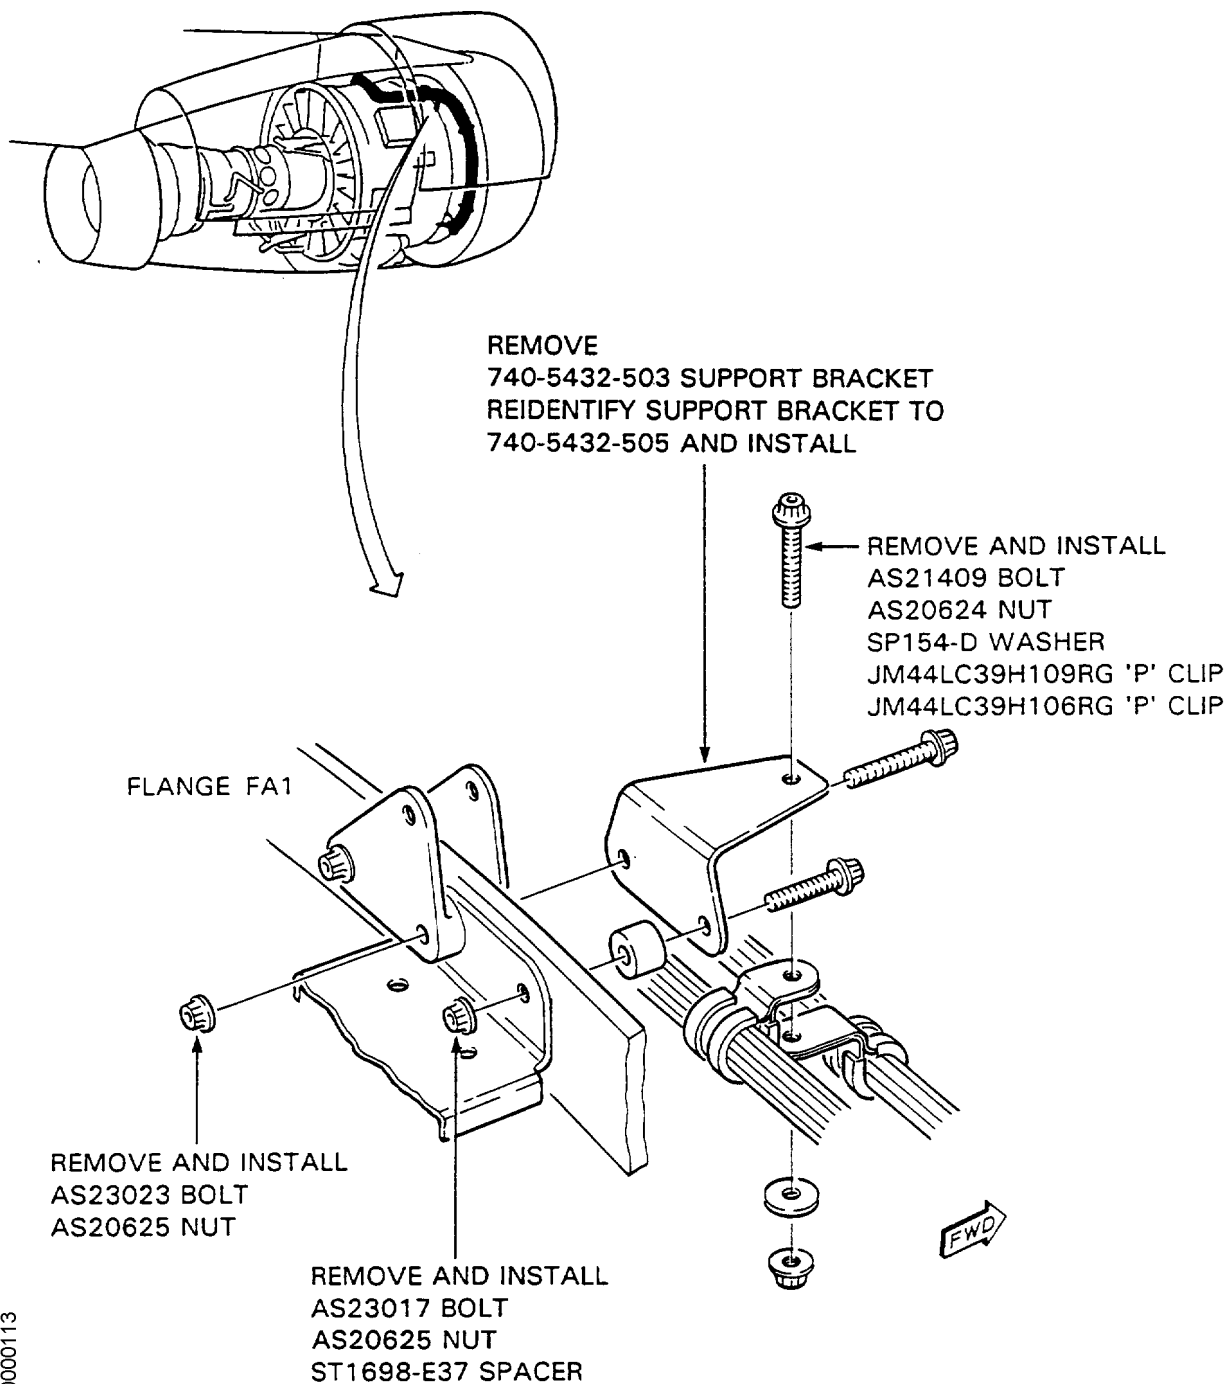
Fig. REMOVAL AND REPLACEMENT OF SUPPORT BRACKET

The mounting bolt for the air starter duct support link may touch the support bracket for the fan case clipping point CP0812.

The support brackets for the air starter duct were moved. Their new position compromised the clearance between the duct support link mounting bolt and an adjacent clipping point support bracket. In some instances the bolt and bracket touch.

- (1) Find clipping point CP0812 on the right side of the engine fancase (Refer to Figure 1).
- (2) Remove the AS21409 bolt, AS20624 nut and the SP154-D washer to release the JM44LC39H109RG and JM44LC39H106RG 'P' clips (at CP0812).
- (3) Remove the AS23017 bolt, AS20625 nut and an ST1698-E37 spacer as shown.
- (4) Remove the AS23023 bolt and AS20625 nut to release the 740-5432-503 support bracket.

- (1) Install the 740-5432-505 support bracket on the FA1 engine flange with:

Torque the nuts to 100lbf in (1.13 Nm). Refer to the A320 Aircraft Maintenance Manual Section 70-23-11 on torque tightening technique.

- (2) Assemble the clipping point CP0812 to the 740-5432-505 support bracket with:

Torque the nuts to 40lb in (4.52 Nm).
