SERVICE BULLETIN

POWER PLANT - ENGINE-AIR-FIRE DETECTION, MOUNTING BRACKET - REPLACEMENT OF - CATEGORY
CODE 4 - MOD.ENG-71-0021

V2500-ENG-71-0021

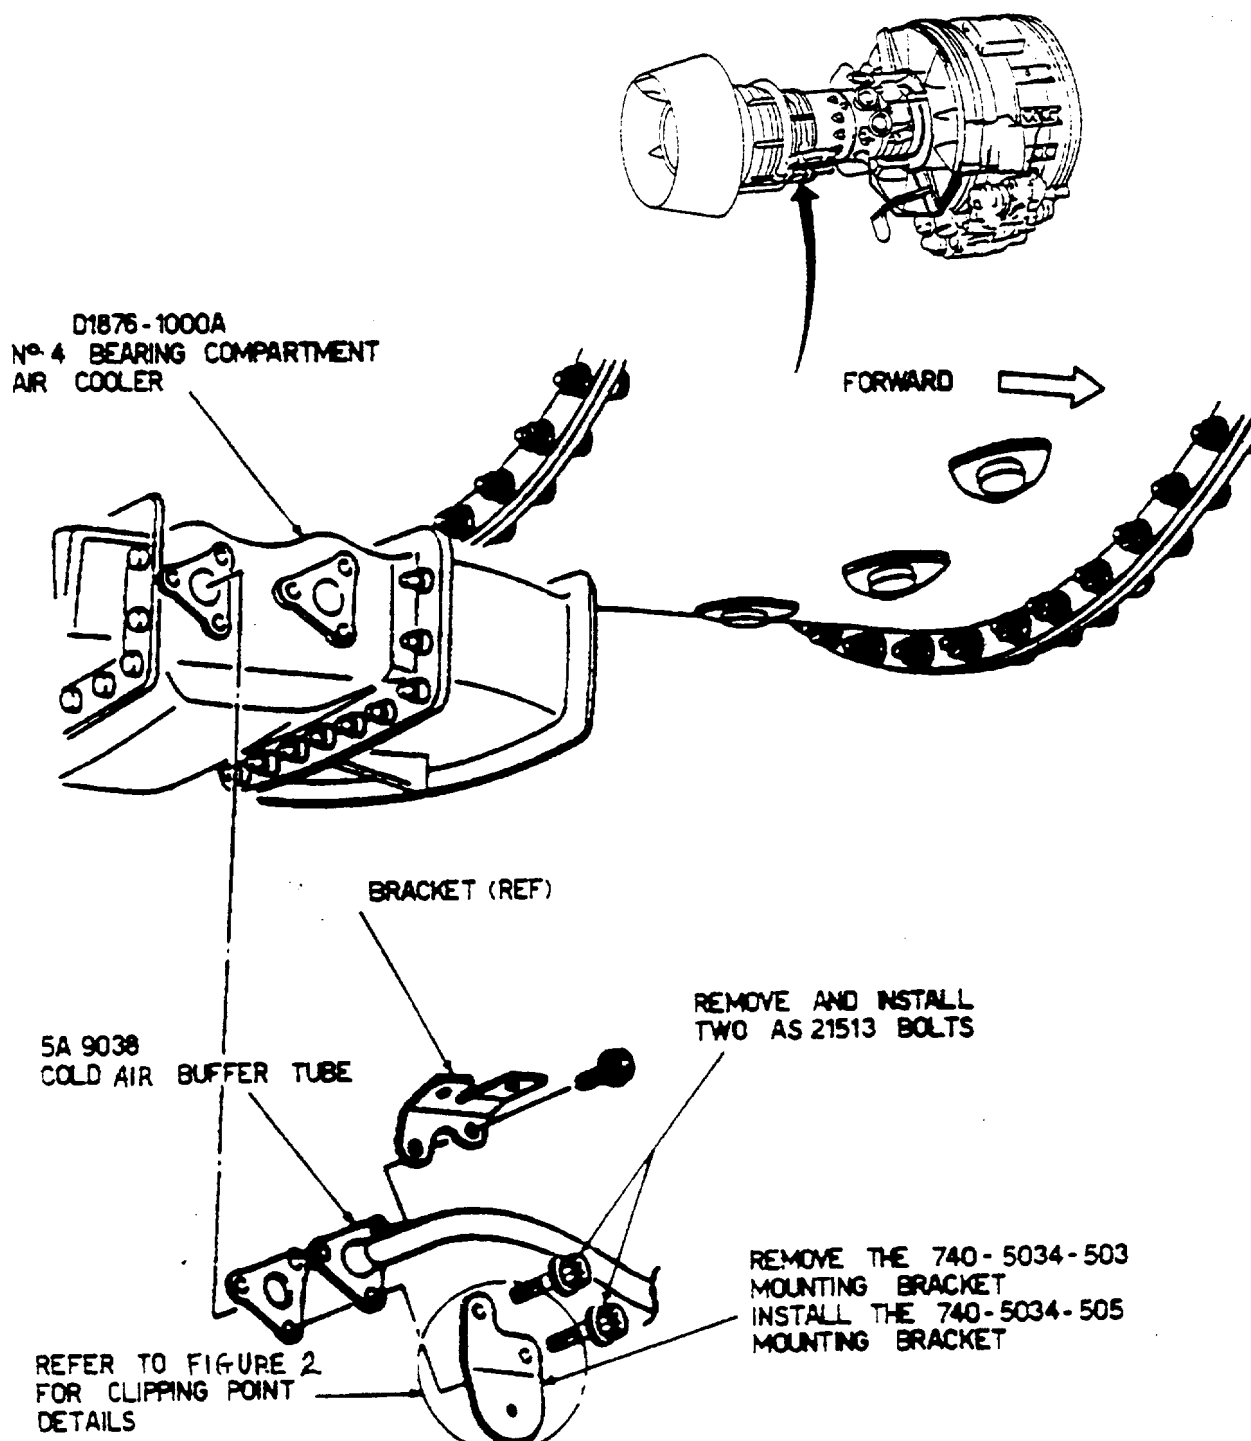
Removal/Installation of the Fire Detection Bracket
Fig.1

The 740-5034-503 fire detection mounting bracket touches the 5A0938 cold air buffer tube which uses the same installation holes.

When the 740-5034-503 mounting bracket was installed it was seen that it touched the 5A9038 cold air buffer tube. This could cause damage to these items. It is recommended to replace the 740-5034-503 mounting bracket with the new 740-5034-505 mounting bracket.

- (1) Open the thrust reverser halves as specified in the V2500 Aircraft Maintenance Manual, Task 78-32-00-010-010.
- (2) Find the D1876-1000A No. 4 bearing compartment air cooler on the bottom of the engine core. (Refer to Figure 1.)
- (3) Find the 740-5034-503 mounting bracket which is attached to the flange of the 5A9038 cold air buffer tube. This tube is installed to the No. 4 bearing compartment air cooler.

The 740-5034-503 is replaced by the 740-5034-505 fire detection mounting bracket. The new bracket has a changed contour which will give clearance between the bracket and the 5A9038 cold air buffer tube.
