# SERVICE BULLETIN

ENGINE - POWER PLANT - EEC AND IGNITION SUPPLY HARNESS, CLIPPING POINT - MODIFICATION  
OF - CATEGORY CODE 4 - MOD.ENG-71-0029

V2500-ENG-71-0029

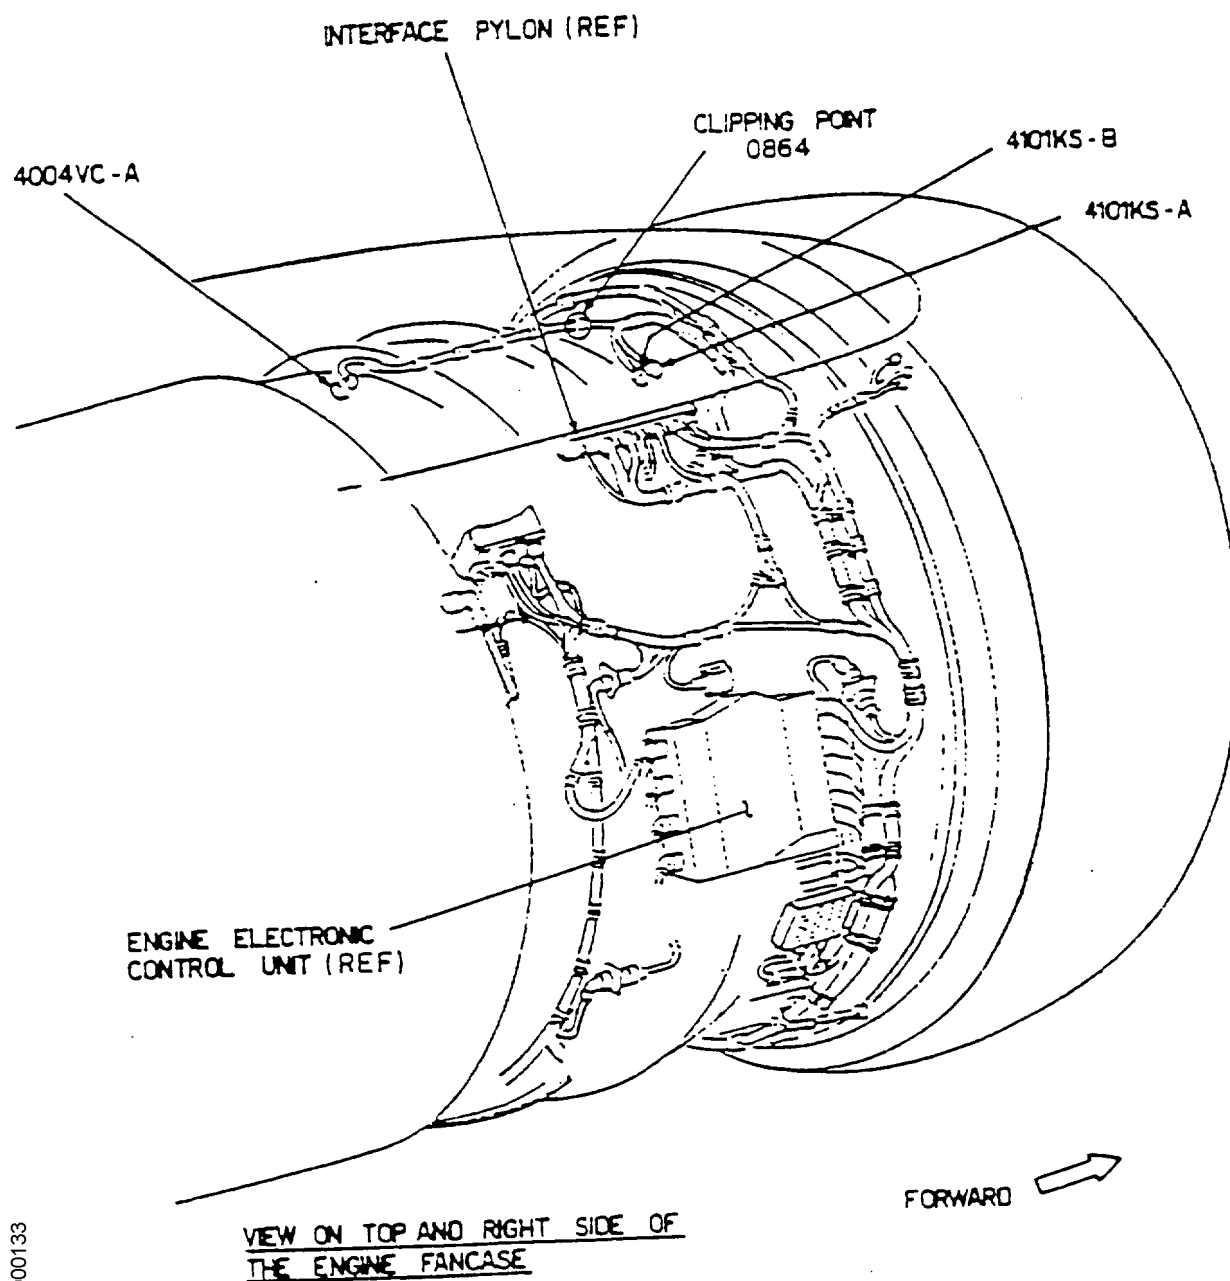
Location of Clipping Point 0864  
Fig.1

The EEC and ignition supply harness may have inadequate clearance with the engine flange near the clipping point 0864.

Some installed harnesses could have unsatisfactory clearance with the engine flange. Because of this condition, the harness could rub against the engine flange when the engine is in operation. It is recommended to increase the clearance between the harness and the flange.

- (1) Open right hand fan cowl door as specified in the V2500 Aircraft Maintenance Manual, Task 71-13-00-010-010.
- (2) Find the 0864 clipping point on the engine fancase. (Refer to Figure 1.)

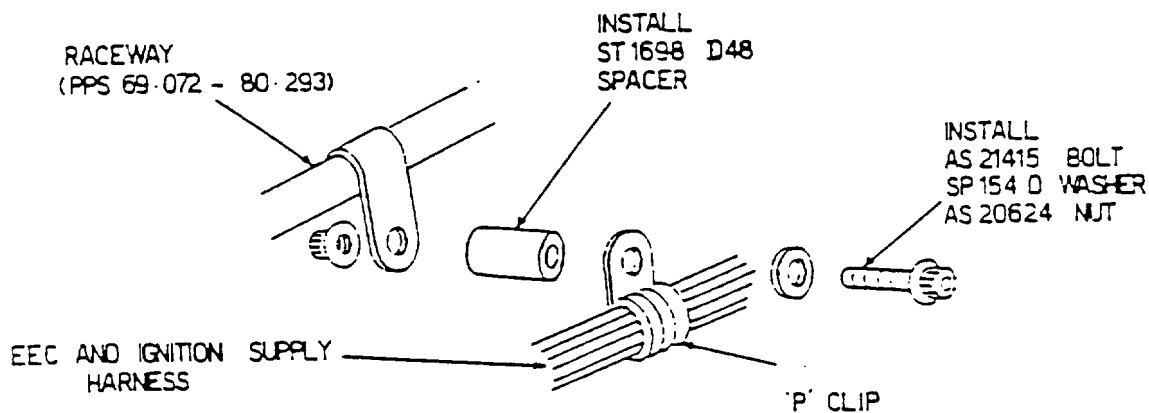
AFTER

A spacer and longer bolt are installed at clipping point 0864 on the engine fan case. This modification will increase the clearance between the EEC and ignition supply harness and the engine flange.

- (1) Remove the AS21408 bolt, the SP154-D washer, and the AS20624 nut which attach the 'P' clip to the raceway. Discard the bolt. (Refer to Figure 2.)
- (2) Assemble the clipping point to the raceway as shown in the after configuration of Figure 2. Install the ST1698D48 spacer and attach the 'P' clip to the raceway with an AS21415 bolt, a SP154-D washer, and an AS20624 nut.
- (3) Torque the AS20624 nut to 40 lb-in. (4.52 N.m) as specified in the V2500 Aircraft Maintenance Manual, Task 70-23-11-911-010.
