# SERVICE BULLETIN

## ENGINE - POWER PLANT - EEC AND IGNITION SUPPLY HARNESS, CLIPPING POINTS - CHANGES TO - CATEGORY CODE 4 - MOD.ENG-71-0035

# V2500-ENG-71-0035

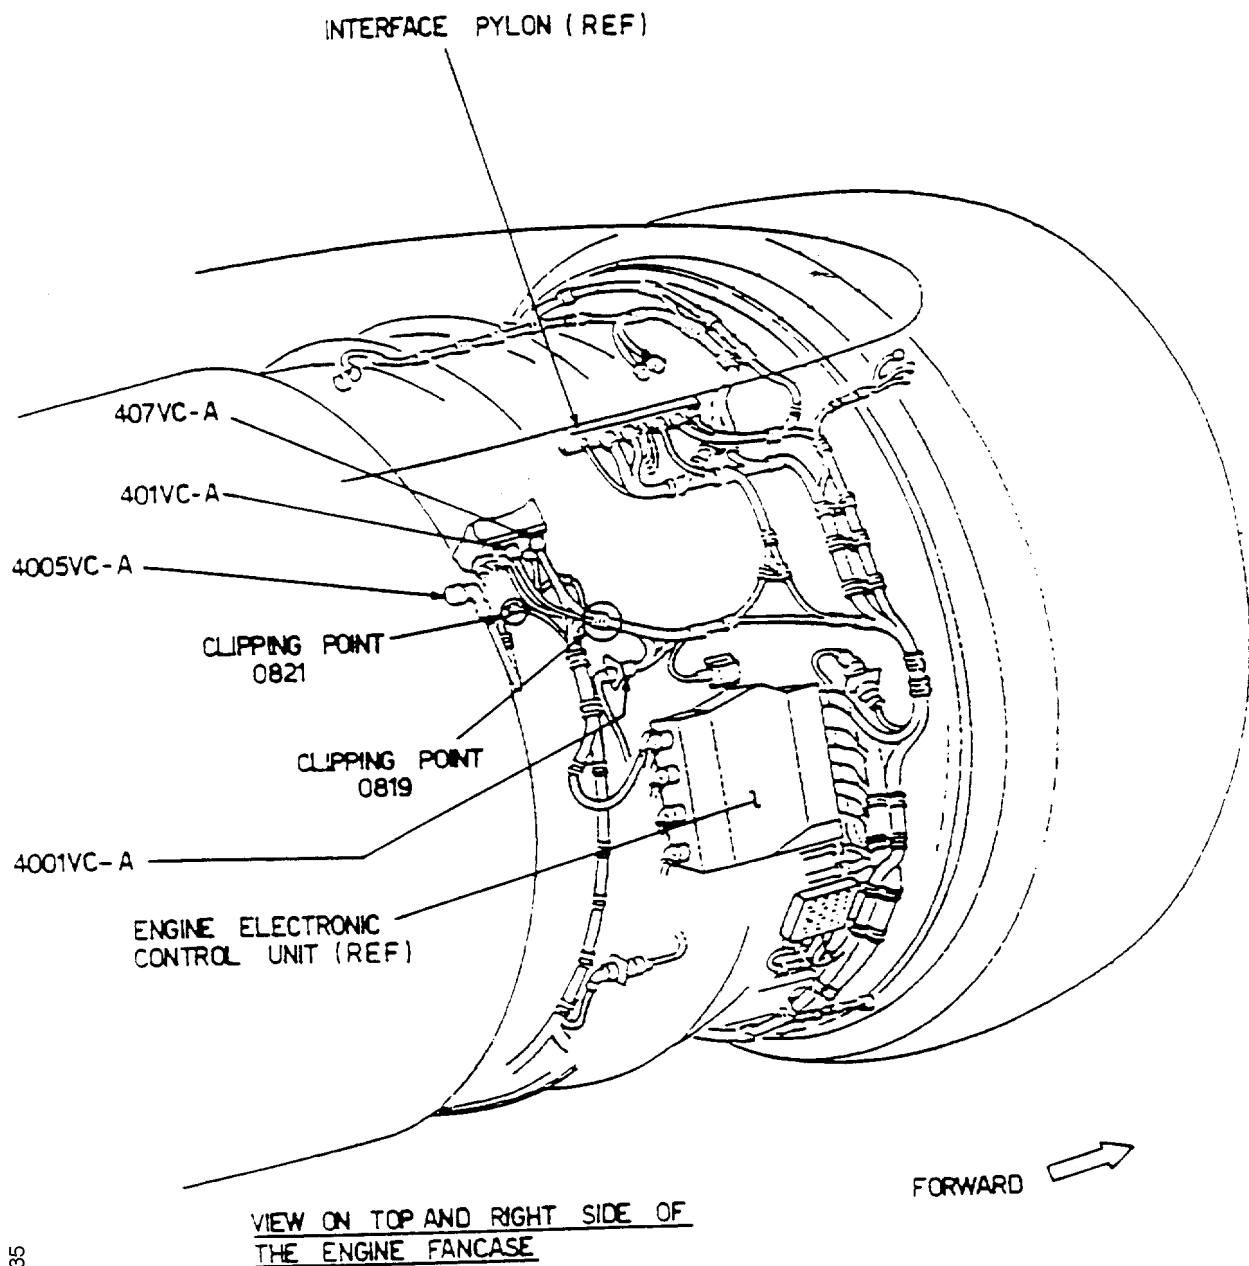
Location of Clipping Points 0819 and 0821  
Fig.1

The EEC and ignition supply harness may have inadequate clearance with the engine flange at clipping points 0819 and 0821.

- (1) Open the fan cowl doors as specified in the V2500 Aircraft Maintenance Manual, Task 71-13-00-010-010.
- (2) Find the 0819 and 0821 clipping points on the engine fancase. (Refer to Figure 1.)

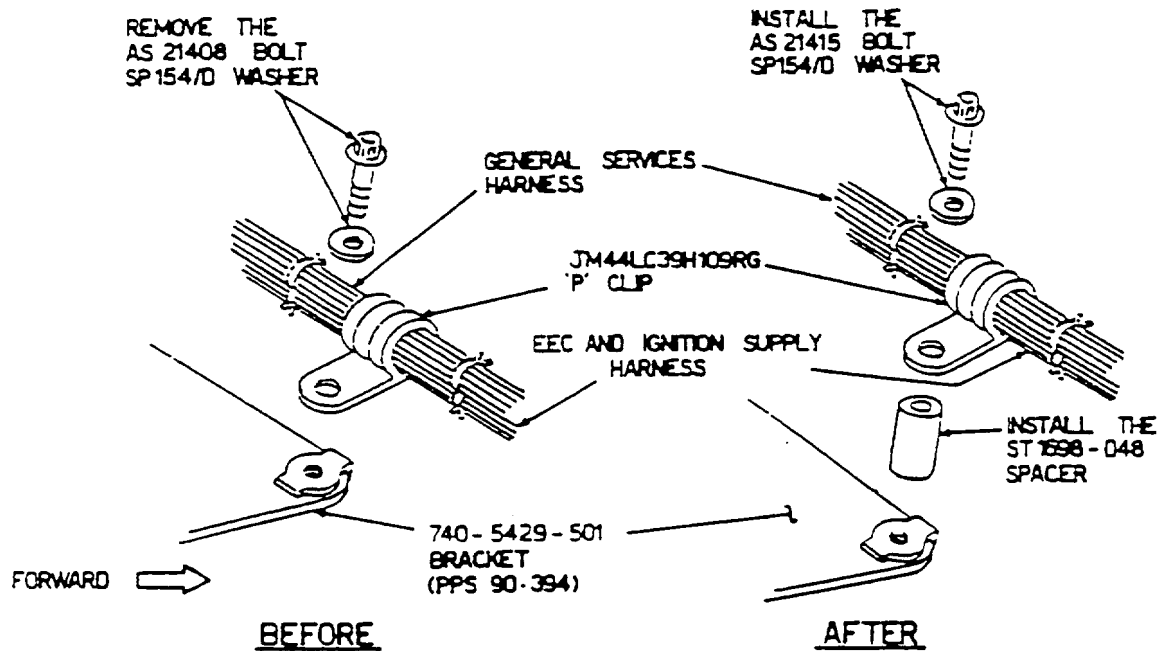
CLIPPING POINT 0819

Some installed harnesses could have unsatisfactory clearance with the engine flanges. Because of this the harness could possibly rub against the engine flange when the engine is in operation. It is recommended to increase the clearance between the harness and the flanges.

- (1) Change clipping point 0819 as follows: (Refer to Figure 2.)
  - (a) Remove the AS21408 bolt, the SP154/D washer which attach the JM44LC39H109RG 'P' clip to the 740-5429-501 mounting bracket. Discard the bolt.

- (b) Assemble the clipping point to the 740-5429-501 mounting bracket as shown in the after configuration of Figure 2. Install the ST1698-D48 spacer and attach the JM44LC39H109RG 'P' clip to the bracket with an AS21415 bolt and an SP154/D washer.

- (c) Torque the AS21415 bolt to 40 lb-in. (4.52 N.m) as specified in the V2500 Aircraft Maintenance Manual, Task 70-23-11-911-010.
- (2) Change clipping point 0821 as follows: (Refer to Figure 2.)
