SERVICE BULLETIN

ENGINE - POWER PLANT - FANCASE GENERAL SERVICES HARNESS - CONNECTOR BACKSHELLS - REPLACEMENT OF - CATEGORY CODE 4 - MOD.ENG-71-0038

V2500-ENG-71-0038

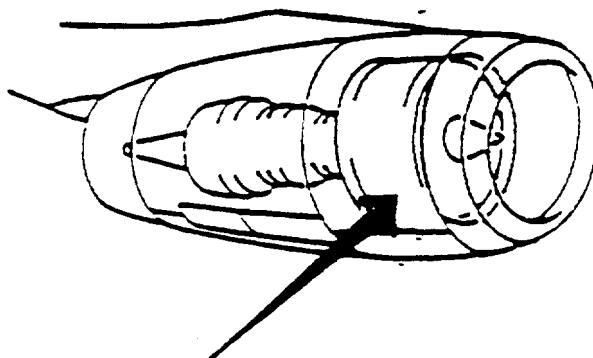
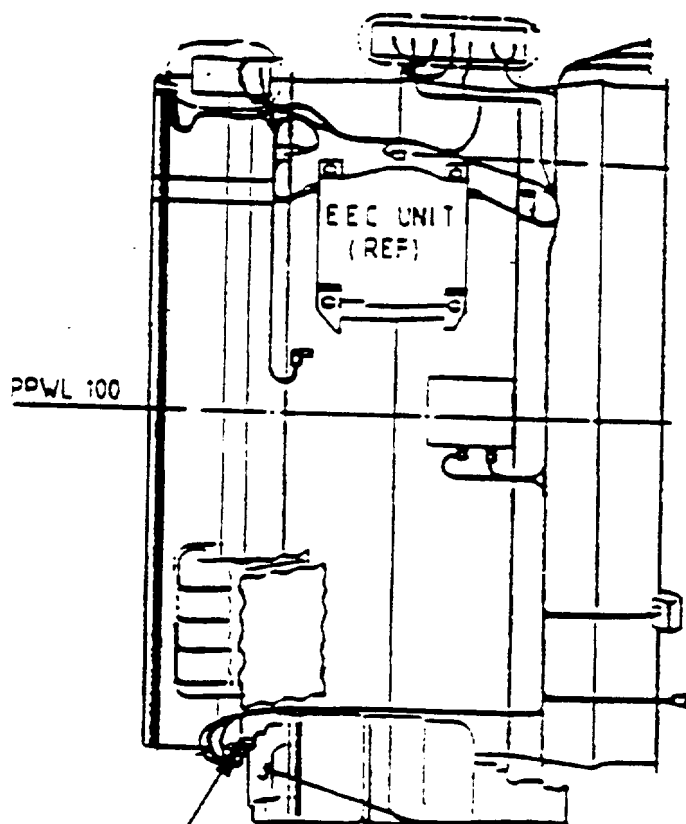
Location of the IDG Connectors on the Right Side of the Engine Fancase
Fig.1

DISCONNECT AND CONNECT
ELECTRICAL CONNECTORS
4000XU-A & 4000XU-B

INTEGRATED DRIVE
GENERATOR (REF)

- (1) Open the fan cowl doors as specified in the V2500 Aircraft Maintenance Manual, Task 71-13-00-010-010.
- (2) Find the 4000xu-A and 4000xu-B connectors on the right side of the engine fan case at the integrated drive generator. (Refer to Figure 1.) Disconnect the connectors.
