POWER PLANT - ENGINE - EEC FAN HARNESS - INCORPORATE ADDITIONAL SPACERS ONTO CLIPPING
POINTS CP1022 AND CP1017 - CATEGORY CODE 3 - MOD.ENG-71-0048

V2500-ENG-71-0048

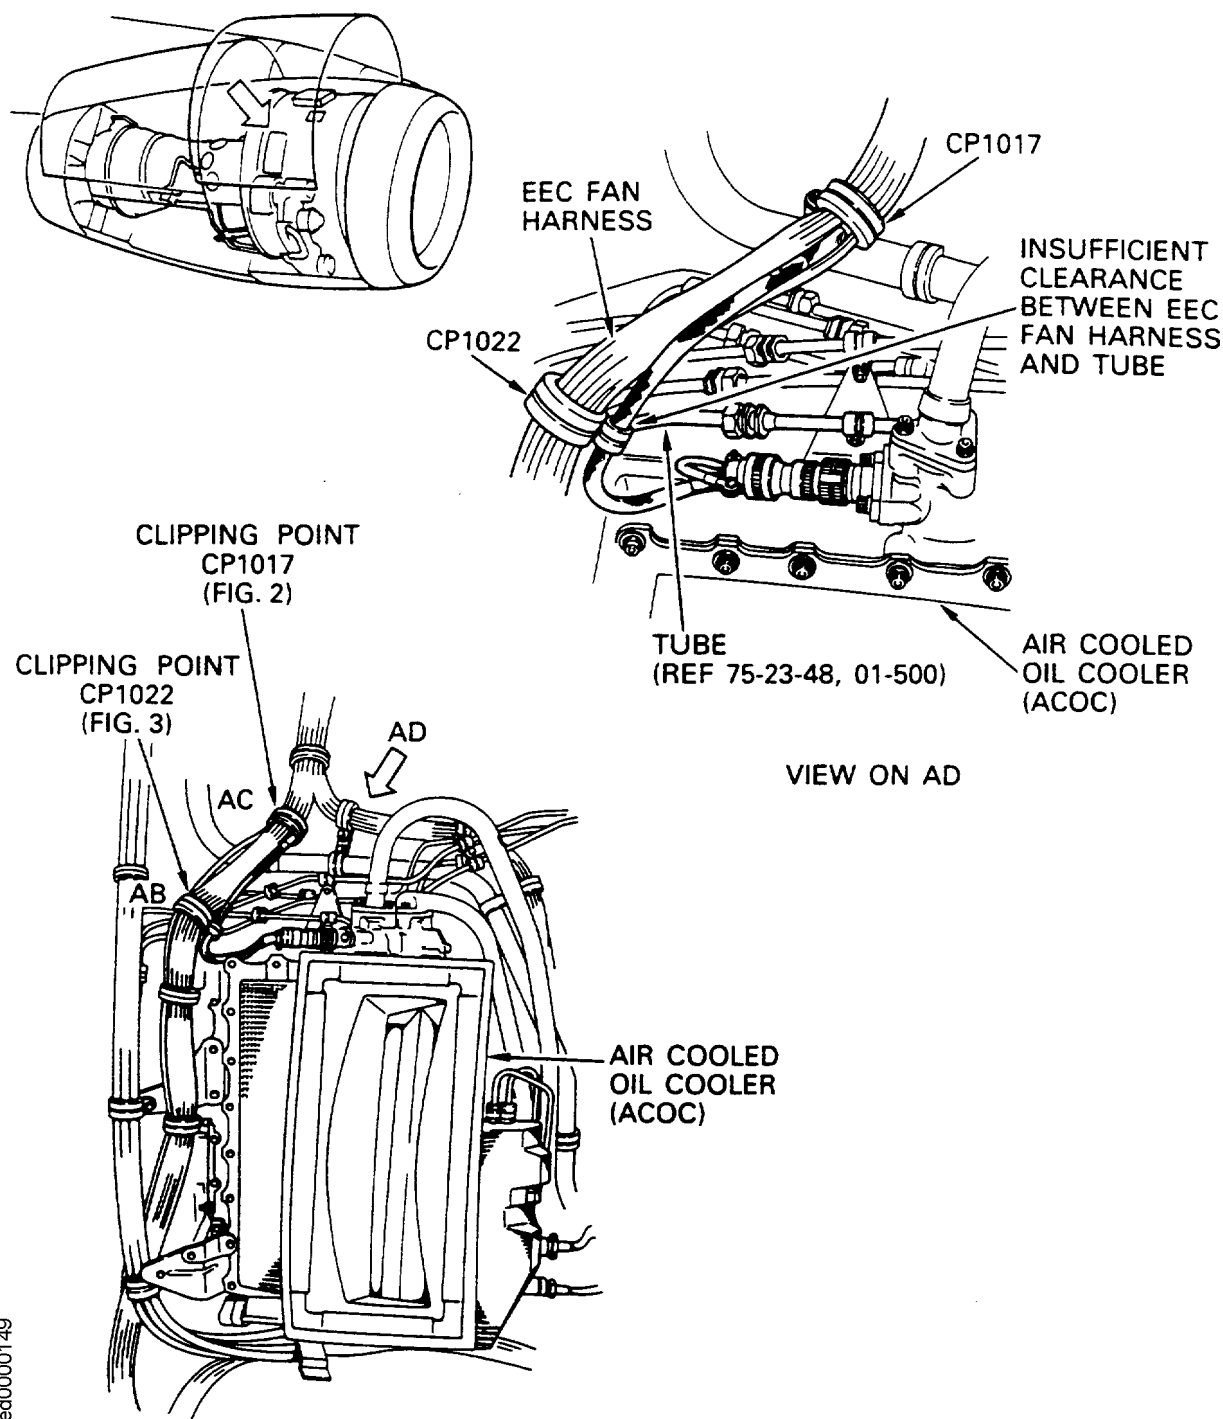
View on right-side of the fan case
Fig.1

There is little clearance between the EEC Fan Harness and the Turbine Cooling Controlled Air Tube (Ref. 75-23-48, 01-500) near the top corner of the ACOC. Chafing may occur between them. (Refer to Figure 1.)

Due to this revision, the clearance between the bolt end and the tube was improved, but the clearance between the Tube and the EEC Fan Harness near the top corner of the ACOC, was reduced. The possibility of chafing remains between them. (Refer to Figure 1.)

To give additional clearance between the EEC Fan Harness and Turbine Cooling Controlled Air Tube.

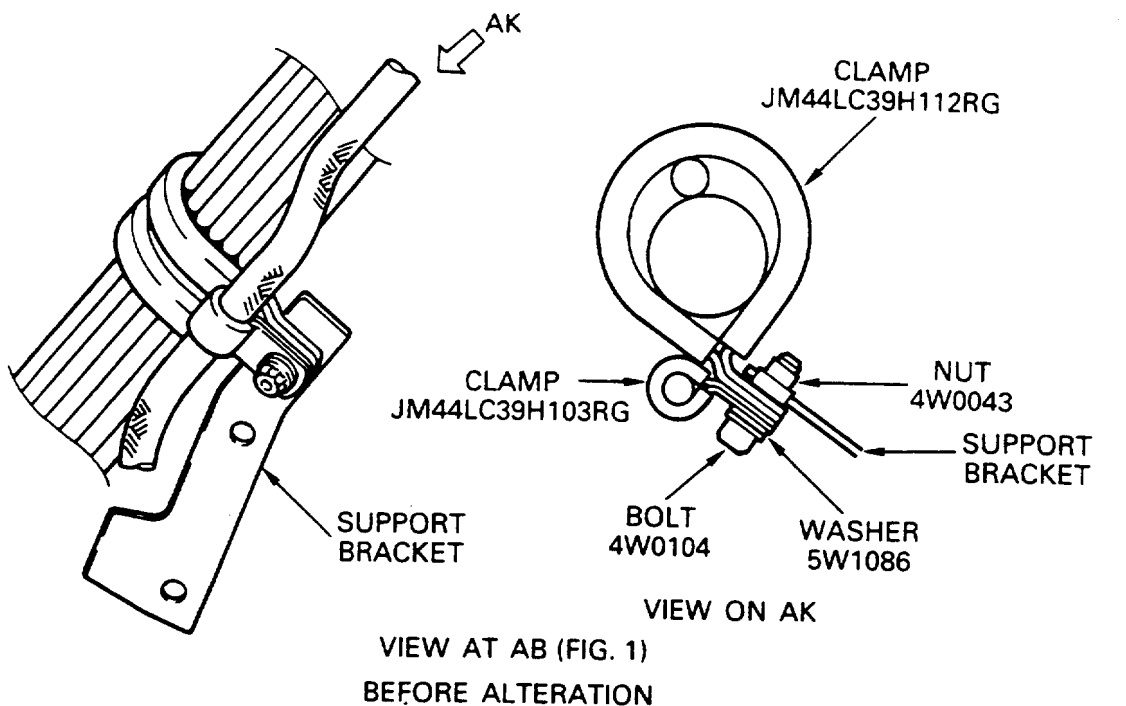
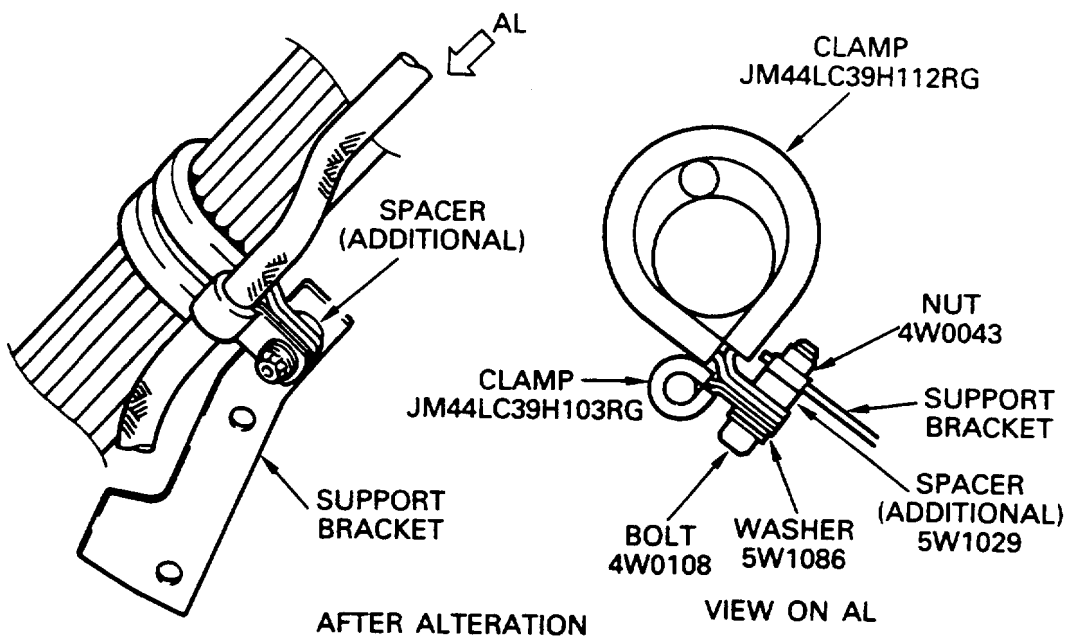
. Details of clipping point CP1022 – Before and after alteration
Fig 3

During development program, the support condition of clipping point CP1022 was changed to get sufficient clearance between the bolt end at the clipping point CP1022 and the Turbine Cooling Controlled Air Tube (Ref. 75-23-48, 01-500).

- (a) Additional spacers are introduced into EEC fan harness clipping points CP1022 and CP1017. The clipping point CP1022 are separated from the support bracket on the ACOC with a 0.1969in. (5,00 mm) long spacer. (Refer to Figure 3.) The clipping point CP1017 are separated from the lug on the tube with a 0.7480in. (20,00 mm) long spacer. (Refer to Figure 2.)
- (b) The resultant clearance between the EEC Fan Harness and the Turbine Cooling Controlled Air Tube (Ref. 75-23-48, 01-500) is approximately 0.3937in. (10,00 mm).

| (3) Remove the PN 4W0043 nut, the PN 5W1086 washer and the PN 4W0104 bolt from the clipping point CP1022. | Refer to Figure 3. |
| (4) Install the new PN 5W1029 spacer to the clipping point CP1022 with the PN 4W0043 nut, the PN 5W1086 washer and the PN 4W0108 bolt. Torque the bolt to 100 lbfin (1,13 mdaN). | Refer to Figure 3.
