POWER PLANT - ENGINE - INCORPORATE REVISED EEC FAN HARNESS CLIPPING REQUIREMENTS  
(REFERENCE CP1013) - CATEGORY CODE 3 - MOD.ENG-71-0049

V2500-ENG-71-0049

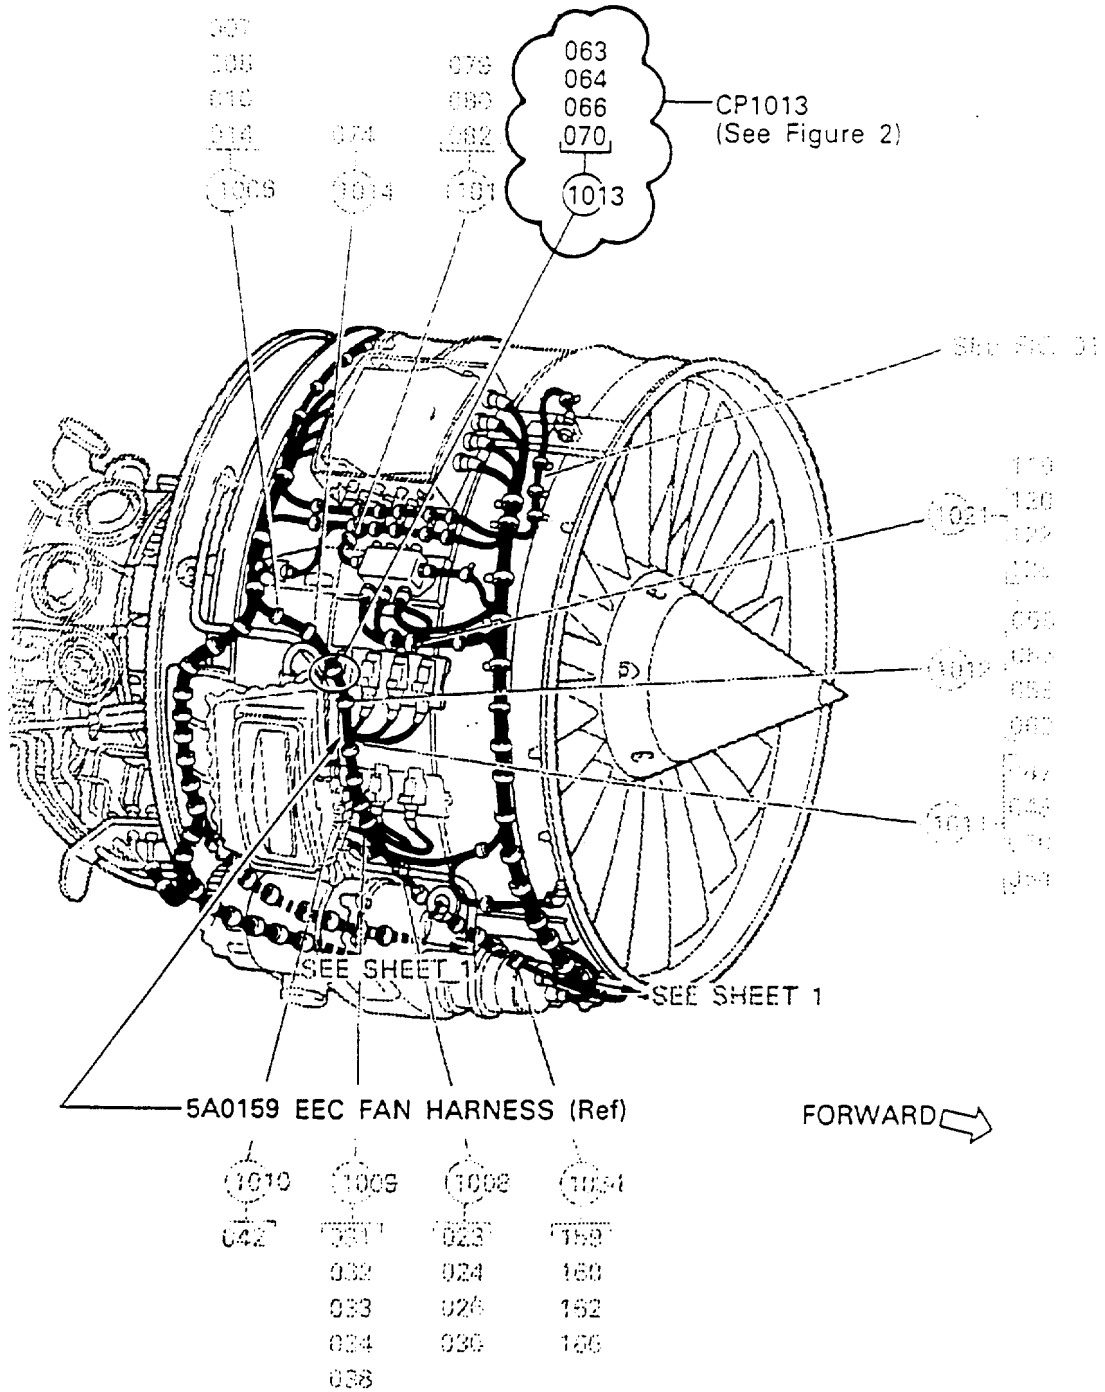
Location of the Clipping Point CP1013  
Fig.1

Insufficient clearance may occur between the EEC Fan Harness and the Stage 10 Bleed Solenoid Valve because of unsatisfactory clipping configuration at CP1013.

Procedure	Supplementary Information
(1) Find the CP1013 where is the left side of the Stage 10 Bleed Solenoid Valve	Refer to Fig.1 and 2
(2) At CP1013, remove 4W0001, Nut, 4W0103, Bolt, 5W1086, Washer and JM44LC39H109RG, Clip, from 5A0159, EEC Fan Harness, and 5A9088, Scavenge Oil Tube	Refer to Fig.2

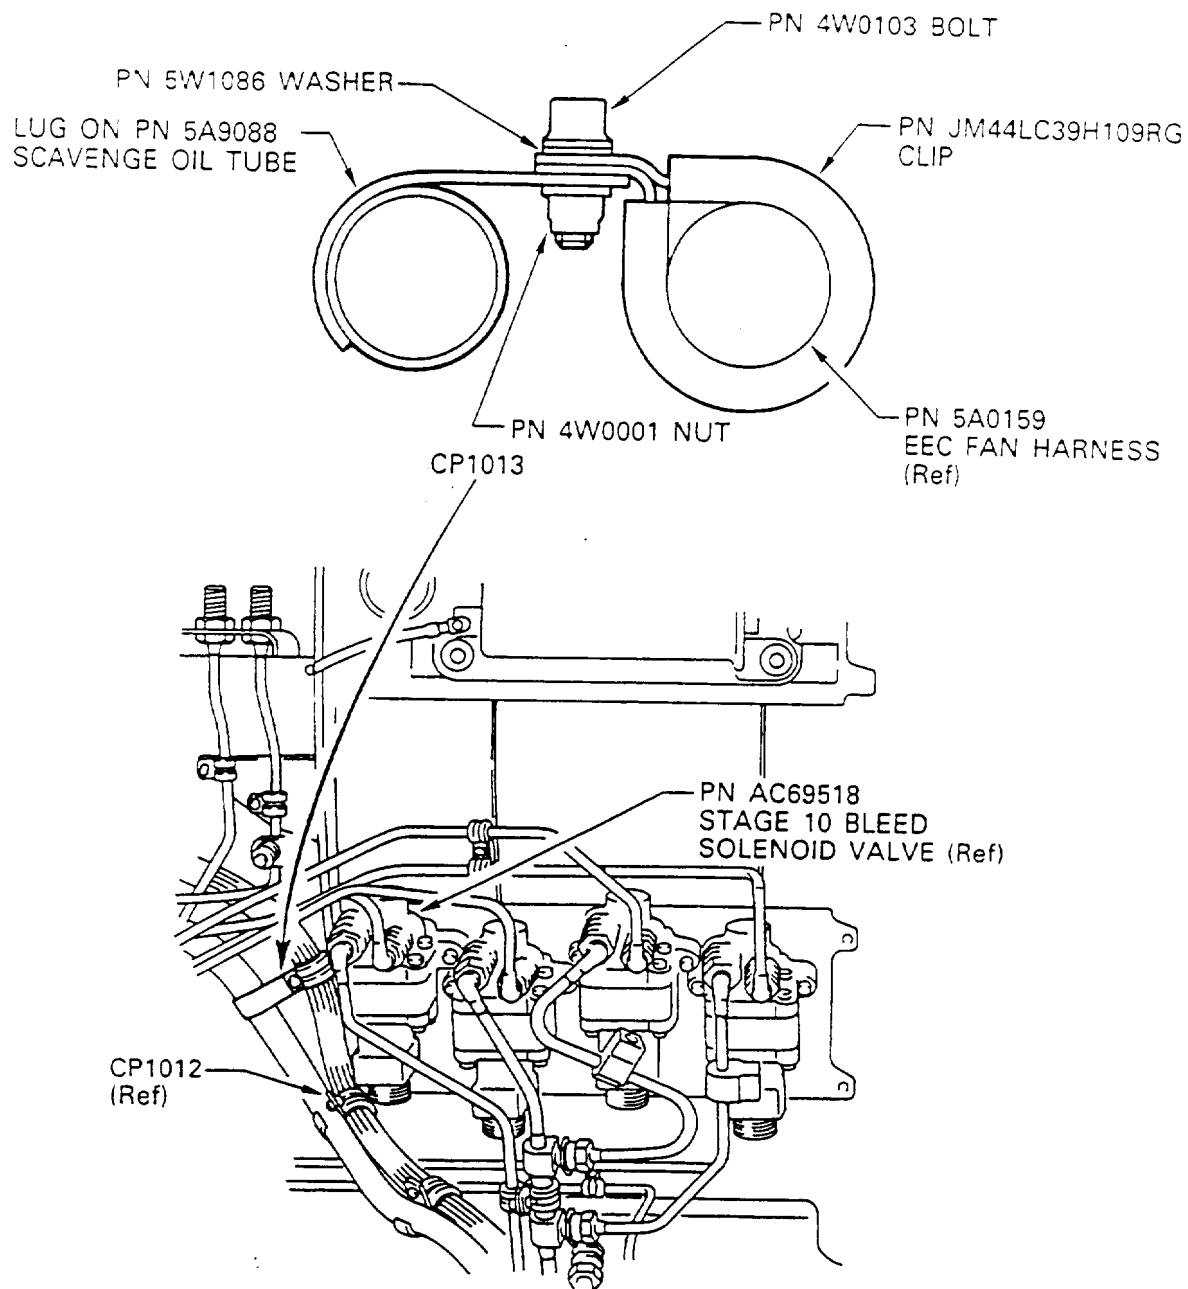
View of the Clipping Point CP1013 - Before Alteration  
Fig.2

- (1) The changes introduced by this Bulletin are as follows:
- (a) The existing CP1013 which safeties the EEC Fan Harness and the Scavenge Oil Tube has been deleted to replace with CP1092, see Fig.1 and 2.
  - (b) A new CP1092 is introduced adjacent to the existing CP1013 to reroute the EEC Fan Harness, see Fig.3.
  - (c) One of the six lugs on the Scavenge Oil Tube which is used at CP1013 has been removed, see Fig.4.
- (2) The existing Scavenge Oil Tube can be reworked to a new configuration, see Fig.4.
- (3) New Scavenge Oil Tube will be available for replacement purpose.
