POWER PLANT - ENGINE - INCORPORATION OF REROUTING AND MODIFICATION REQUIREMENTS FOR THE
EEC FAN HARNESS - CATEGORY CODE 5 - MOD.ENG-71-0050

V2500-ENG-71-0050

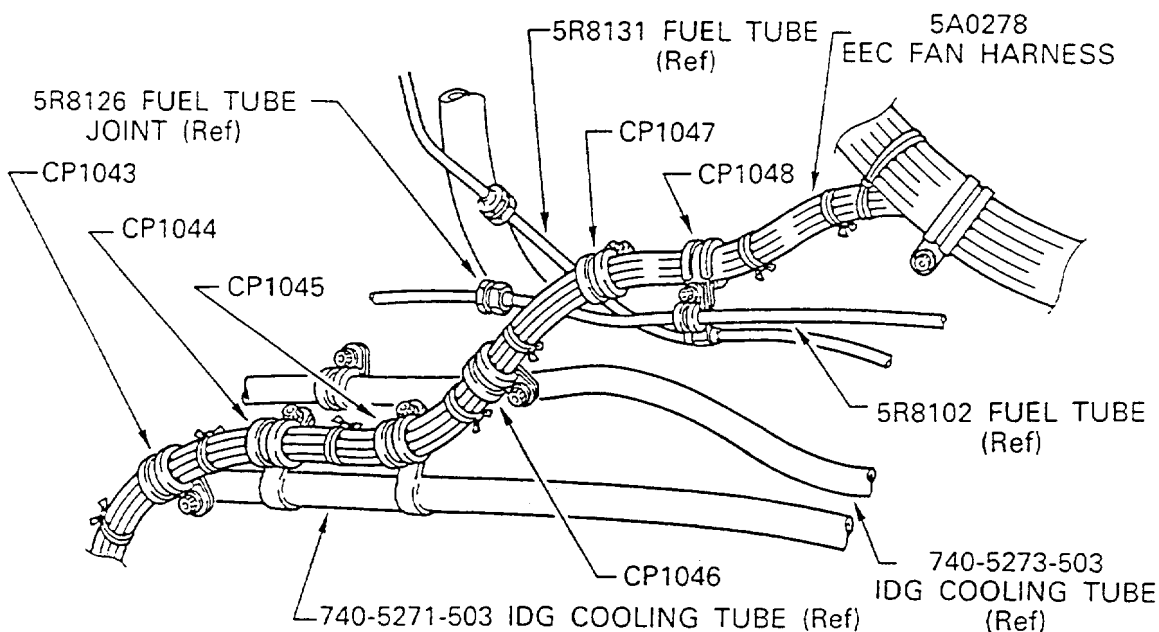
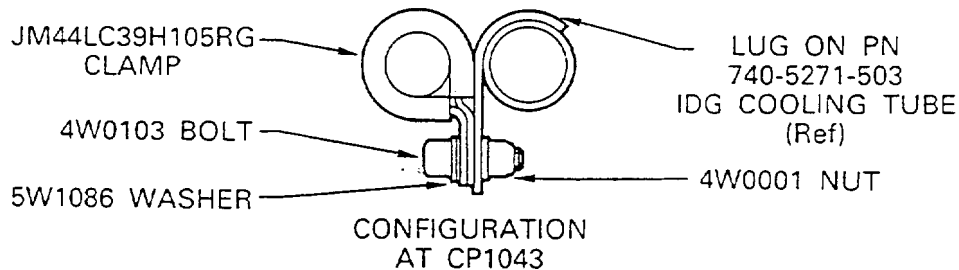
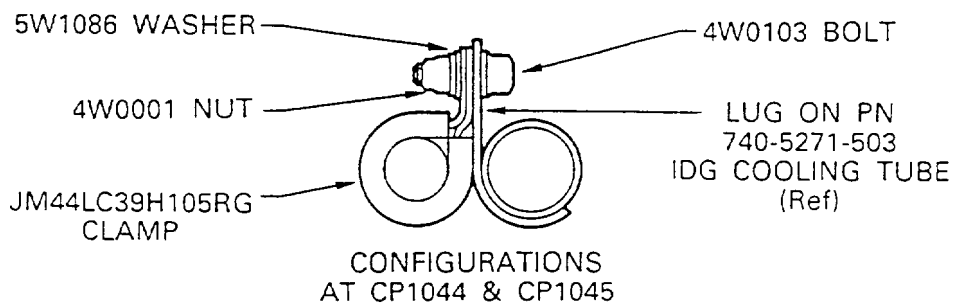
EEC Fan Harness clipping detail - Before alteration
Fig.2 (Sheet 1 of 2)

Chafing to the FMU Harness (which breaks out of the EEC Fan Harness (A/O), may occur because of the close proximity to a wirelocked tube joint between CP1046 and CP1047. The FMU Harness may also contact the No.4 Fan Cowl Latch during the opening of the Fan Cowl Doors.

The cause of the condition results from current routing and clipping of the FMU Harness.

- (b) At each CP1043, CP1044 and CP1045, remove PN 4W0001 Nut, PN 5W1086, Washer, PN 4W0103, Bolt and PN JM44LC39H105RG, Clamp from PN 5A0278, EEC Fan Harness and each Lug on PN 740-5271-503, IDG Cooling Tube

- (c) At CP1046, remove PN 4W0001, Nut, PN 5W1086, Washer, PN JM44LC39H105RG, Clamp and PN 4W0103, Bolt from PN 5A0278 EEC Fan Harness and the Lug on PN 740-5273-503, IDG Cooling Tube

- (d) At CP1047, remove PN 4W0001, Nut, PN 5W1086, Washer, PN JM44LC39H105RG, Clamp and PN 4W0103, Bolt from PN 5A0278 EEC Fan Harness and the Lug on PN 5R8131 Fuel Tube
