Subject: Transmittal of Revision 2 to Service Bulletin No. V2500-ENG-71-0051

V2500 Propulsion System — Engine

ENGINE - INTRODUCTION OF CHANGES TO ENGINE DRESSING CLEARANCES

V2500-A1

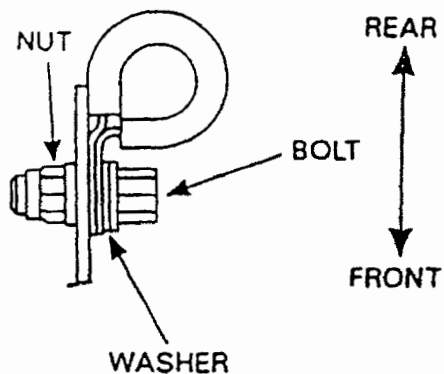
CLIP POSITION 0831

(b) Incorrect orientation of clips at clipping positions CP1088, CP0831 and CP1073.

- (i) The minimum clearance between the electrical harness, tubes and other hardware should be 0.100 inches (2,54 mm).
- R (ii) Clip CP0831 is transferred from the outboard to the inboard side of the bracket.
- R (iii) Clip CP5690 is rotated through 180 degrees and is now facing inboard.

R (b) CP0831, (Refer to figure 1 and Engine Manual, TASK 72-00-32-420-004)

R (i) Reposition the clip from outboard to inboard side of the bracket.

R (ii) Torque the nut/bolt to 36 to 45 lbf.in. (4 to 5 Nm).

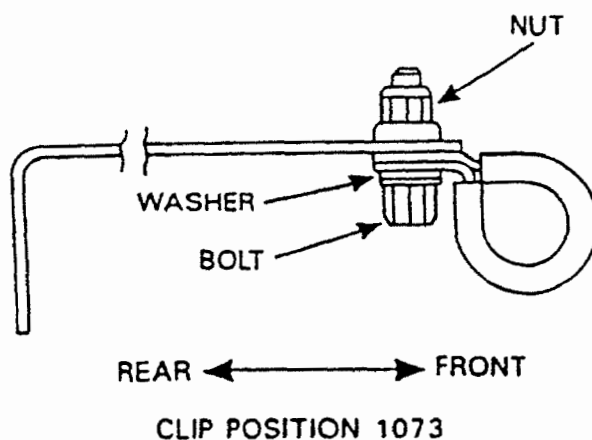
Figure 2

R (i) Clip CP1073 is transferred from the outboard to the inboard side of the bracket.

- R (iii) Torque the nut/bolt to 36 to 45 lbf./in. (4 to 5 Nm).
- R (3). Part 3
- R (a) CP1073, (Refer to figure 2 and Engine Manual, TASK 72-00-32-420-003)

- R (i) Reposition the clip on the tube.
- R (ii) Reposition the clip from outboard to inboard side of the bracket.
- R (iii) Torque the nut/bolt to 36 to 45 lbf./in. (4 to 5 Nm).

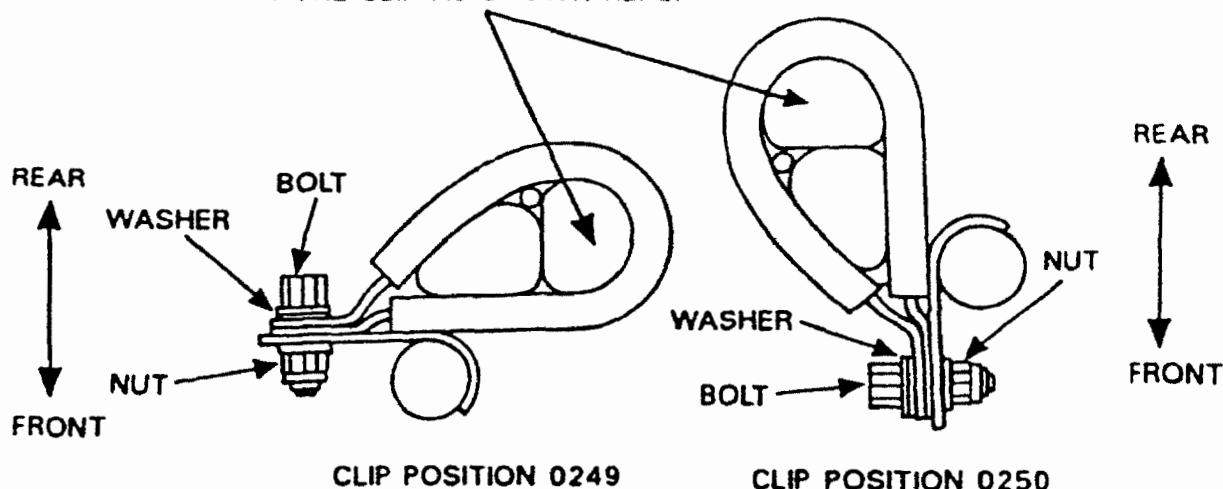
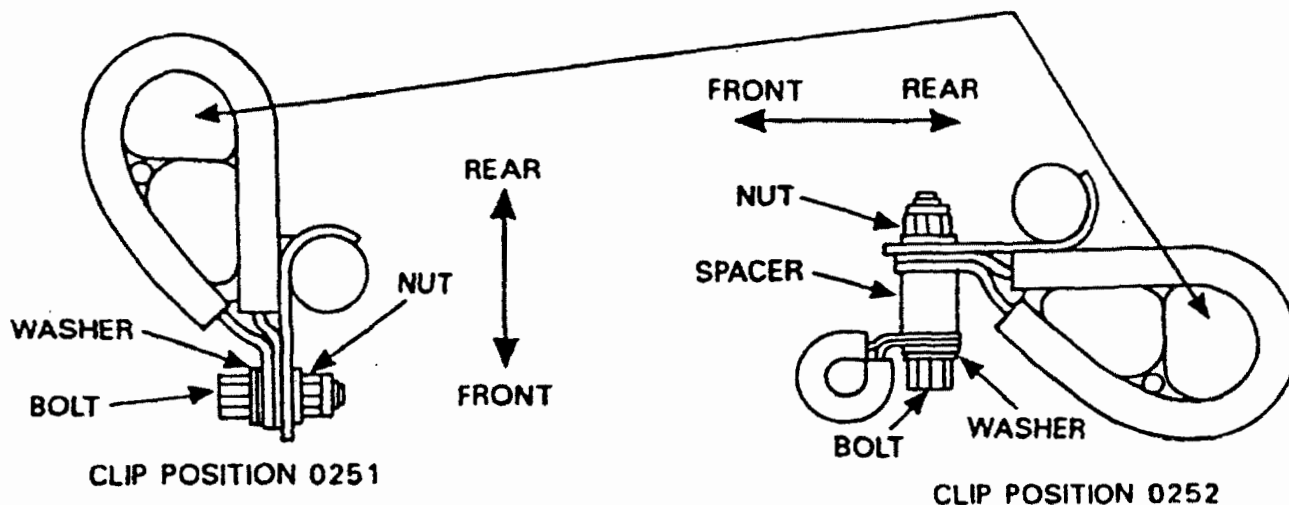
Clipping arrangements (Part 3)  
Figure 3

(c) Insufficient clearance between harness and adjacent hardware at clipping points CP0249, CP0250, CP0251, CP0252, CP0257, CP0862 and CP5690.

R (iii) The positions of the individual harness within the clips are specified and the clips CP0249, CP0250, CP0251 and CP0252 are slightly reshaped.

THIS BUNDLE GOES TO PLUG  
4008VC - A ON THE BIFURCATION  
PANEL AND MUST BE POSITIONED  
IN THE CLIP AS SHOWN HERE.

THIS BUNDLE GOES TO PLUG  
4008VC - A ON THE BIFURCATION  
PANEL AND MUST BE POSITIONED  
IN THE CLIP AS SHOWN HERE

- R (b) CP0249, CP0250 and CP0251, (Refer to figure 3 and Engine Manual TASK 72-00-32-420-004). CP0252, (Refer to figure 3 and Engine Manual TASK 72-00-60-420-003).

- R (i) Disconnect clips.
- R (ii) Re-shape the clips and position the harness bundles side by side, as shown in figure 3.
- R (iii) Refit the clips and torque the nuts/bolts to 36 to 45 lbf./in. (4 to 5 Nm).
