POWER PLANT - ENGINE - INCORPORATE A FUMESAL BRACKET TO PROVIDE ADDITIONAL STRENGTH -
4 - MOD.ENG-71-0052

V2500-ENG-71-0052

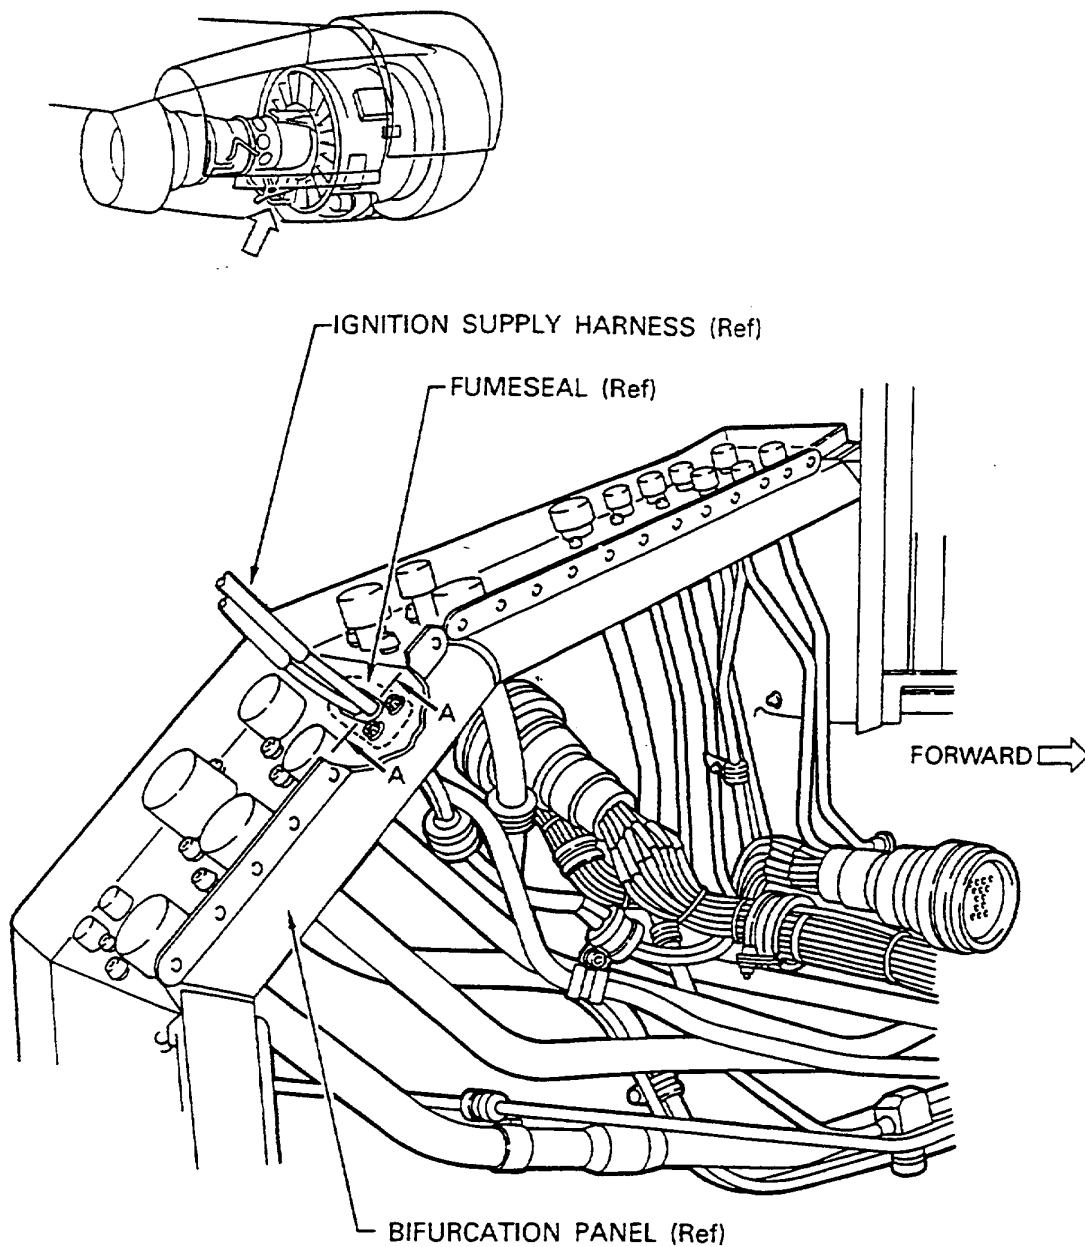
Fumeseal Installation on the Bifurcation Panel
Fig.1 Sheet 1 of 2

An invalid fire-proof may take place on the Fumeseal during a fire because of possible buckling of the Bifurcation Panel and the Fumeseal flange.

The cause of this condition is due to insufficient strength for the installation of Fumeseal on the Bifurcation Panel.

- (a) Additional Fumeseal Brackets are installed to the Bifurcation Panel to increase strength for the installation of Fumeseal in the Bifurcation Panel (See Figure 1).

- (1) Remove the four 4W0001, Nuts, and the four 4W0104, Bolts from the Fumeseal and the Bifurcation Panel. (Refer to Figure 1).
- (2) Install the two additional 5A0368, Fumeseal Brackets to the opposite side of the Fumeseal on the Bifurcation Panel. (Refer to Figure 1).
- (3) Install the four 4W0104, and the four 4W0001, Nuts, to the two 5A0368, Fumeseal Brackets, and the Fumeseal on the Bifurcation Panel. (Refer to Figure 1).
- (4) Tighten the four 4W0001, Nuts on the four 4W0104, Bolts with a torque of 36 - 40 lbfin (4,07 - 4,52 Nm). (Refer to Figure 1, and Aircraft Maintenance Manual, 70-23-11, Torque Tightening Technique).
