POWER PLANT - ENGINE - INCORPORATE REVISED CLIPPING REQUIREMENTS AT CP1001 - CATEGORY
CODE 5 - MOD.ENG-71-0053

V2500-ENG-71-0053

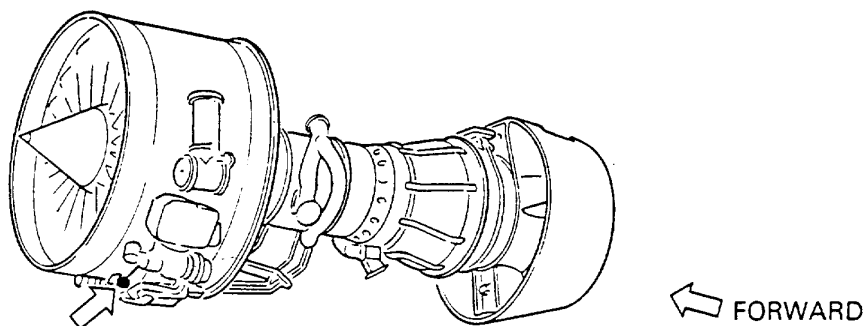
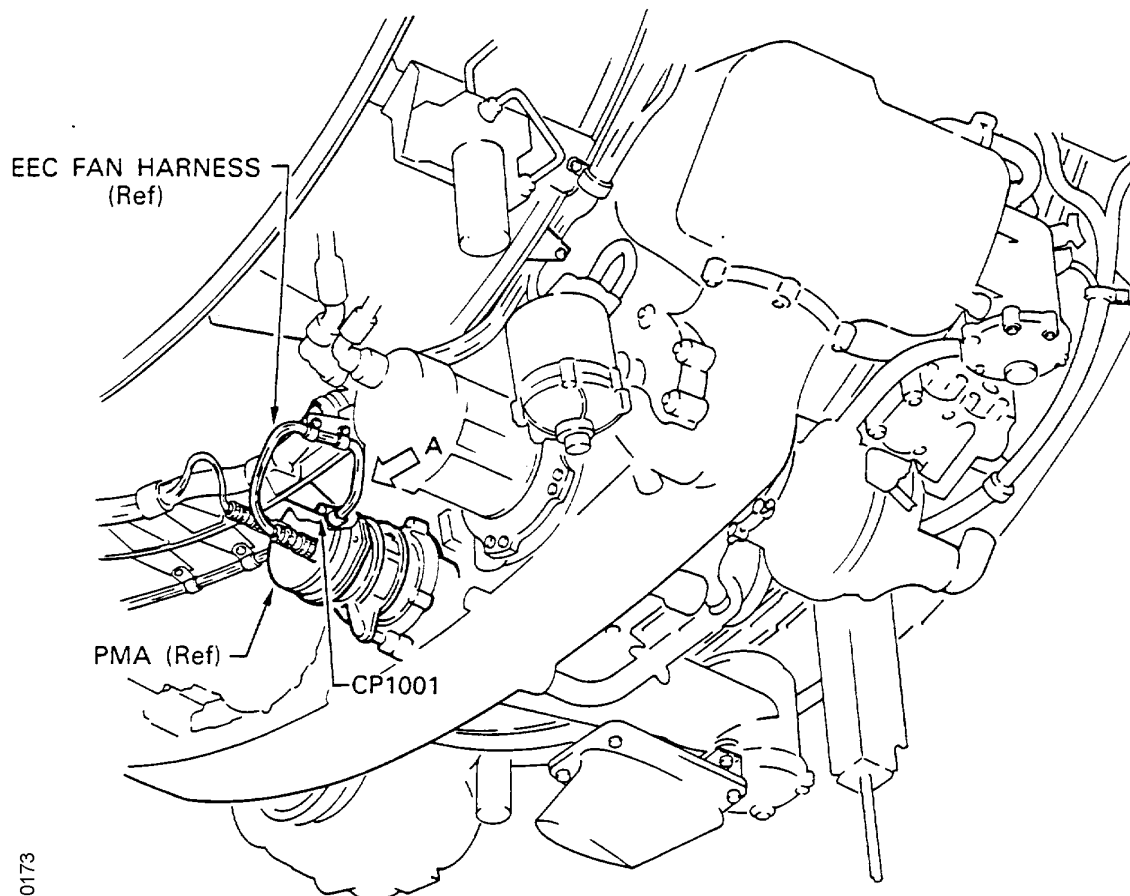
EEC Fan Harness Clipping Detail at CP1001 - Before and After Alteration
Fig.1 (Sheet 1)

Insufficient clearance may occur between the EEC Fan Harness and the Permanent Magnet Alternator (PMA) attaching bolt, and this could cause the EEC Fan Harness to contact to the bolt.

This condition has been found on some production engines. A review for the Harness clippings has shown that the clipping configuration at CP1001 is inadequate to give a sufficient clearance between the Harness and the PMA attaching bolt.

- (a) At clipping position CP1001, the existing Clamp is turned upside down to reroute the EEC Fan Harness. (See Figure 1).
- (b) At clipping position CP1001, the Nut is changed from the clip nut to the ordinary nut. (See Figure 1).

- (1) At CP1001, Install PN 4W0102, Bolt, PN JM44LC39H104RG, Clamp, PN 5W1086, Washer, and new PN 4W0001, Nut to the EEC Fan Harness and PN 5W8315, bracket, by the procedures given in the Engine Manual. (refer to Figure 1, and Engine Manual, 72-00-32, LP Compressor/Intermediate Case Module - Installation, TASK 72-00-32-420-004).
