# SERVICE BULLETIN

## POWER PLANT - ENGINE - INCORPORATION OF MODIFICATION REQUIREMENTS FOR THE EEC FAN HARNESS - CATEGORY CODE 5 - MOD.ENG-71-0055

V2500-ENG-71-0055

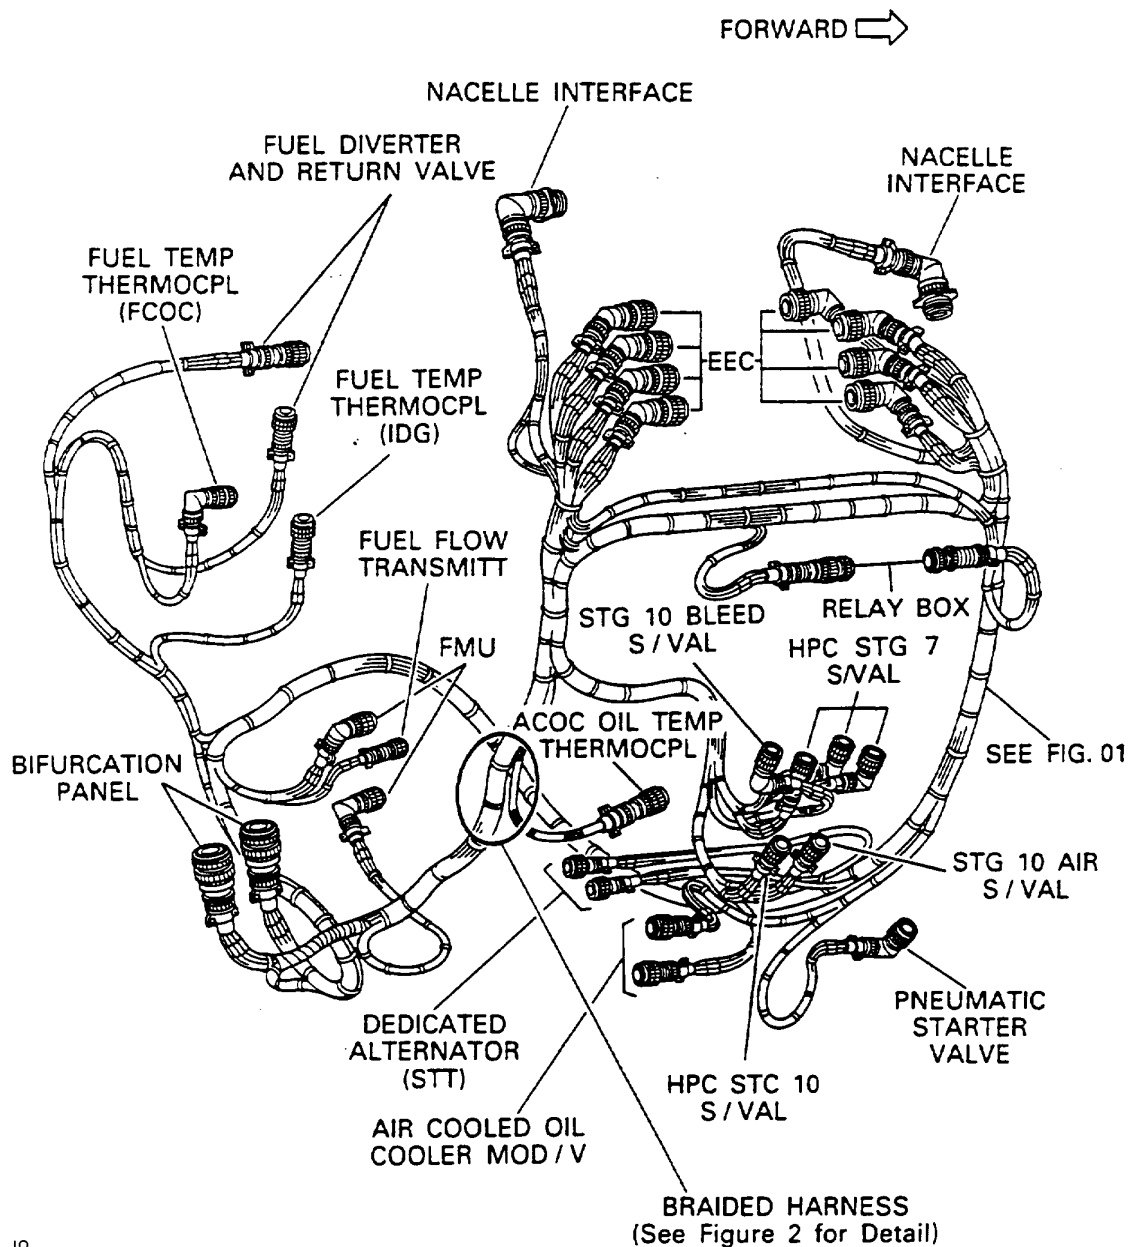
Location of the Braided Harness on EEC Fan Harness  
Fig.1

Chafing to the EEC Fan Harness may occur at the bunched area with the oil temperature thermocouple harness for the Air Cooled Oil Cooler.

(a) An additional Spiral Wrapping is installed to the braided harness on 5A0356, EEC Fan Harness to prevent chafing to the EEC Fan Harness (See Figures 1 and 2).

Procedure	Supplementary Information	
(1) Find the braided harness on 5A0356, EEC Fan Harness	Refer to Figure 1	
(2) Cut and discard the four Lacing Tapes which safety the braided harness and the main EEC Fan Harness	Refer to Figure 3, Sheet 1
