POWER PLANT - ENGINE - INCORPORATE REVISED CLIPPING REQUIREMENTS AT CP0789 - CATEGORY
CODE 4 - MOD.ENG-71-0056

V2500-ENG-71-0056

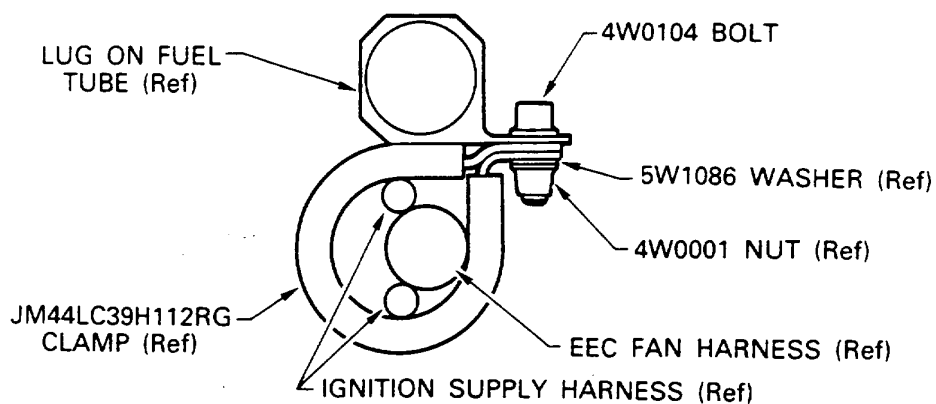
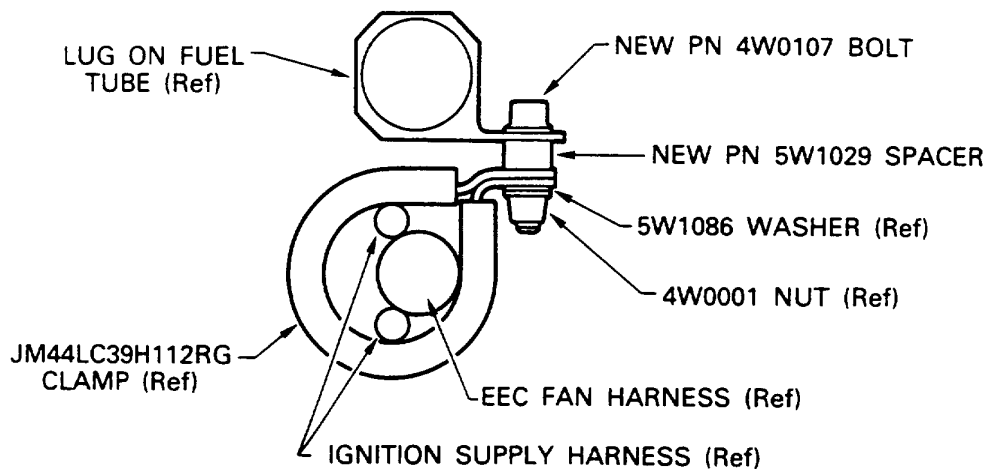
Location of the clipping point VP0789
Fig.1

The EEC Fan Harness and the Ignition Supply Harness may not have sufficient clearance with the Fuel Tube as they approach clipping point CP0789. This may cause the Harnesses to contact to the Fuel Tube.

- (a) At clipping point CP0789, an additional spacer has been introduced to give the sufficient clearance between the Harnesses and the Fuel Tube. (See Figure 1).
- (b) At clipping point CP0789, the Bolt has been lengthened in line with the additional spacer. (See Figure 1).

- (1) Find the clipping point CP0789 where is located near the Oil Tank. (refer to Figure 1).
- (2) At CP0789, remove 4W0001, Nut, 5W1086, Washer, JM44LC39H112RG, Clamp. and 4W0104, Bolt, from the Harnesses and the Lug on Fuel Tube. (refer to Figure 2).
- (3) At CP0789, install JM44LC39H112RG, Clamp, new 5W1029, Spacer, 5W1086, Washer, new 4W0107, Bolt, and 4W0001, Nut, to the Harnesses and the Lug on Fuel Tube. (Refer to Figure 2).
- (4) At CP0789, torque the Nut to 36 - 40 lbfin (4,07 - 4,52 Nm). (Refer to Figure 2, and Aircraft Maintenance Manual, 70-23-11, Torque Tightening Technique).

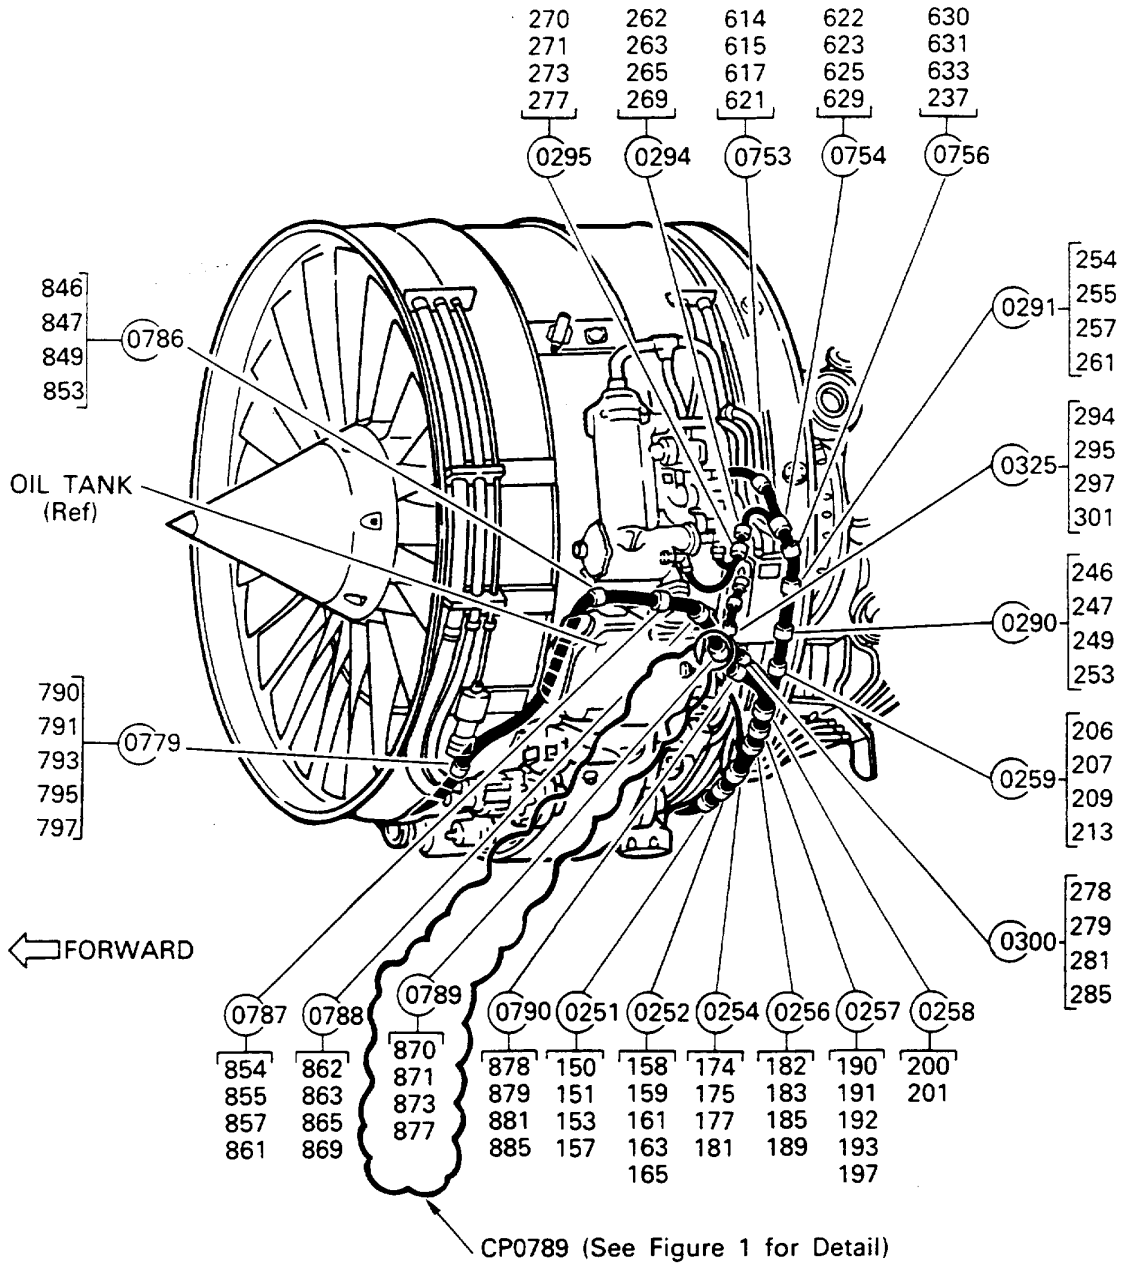
Clipping Detail at CP0789 – Before and After alteration
Fig.2

A review of the Harnesses clipping has shown that an additional spacer is necessary at clipping point CP0789 to ensure the adequate clearance between the Harnesses and the Fuel Tube.
