POWER PLANT - ENGINE - INCORPORATE REVISED BRACKET ATTACHING BOLTS AT THE FLANGE FA1 -  
CATEGORY CODE 3 - MOD.ENG-71-0057

- (1) Aircraft: Airbus A320
- (2) Engine: V2500-A1 Engines, Serial Number V0014

V2500-ENG-71-0057

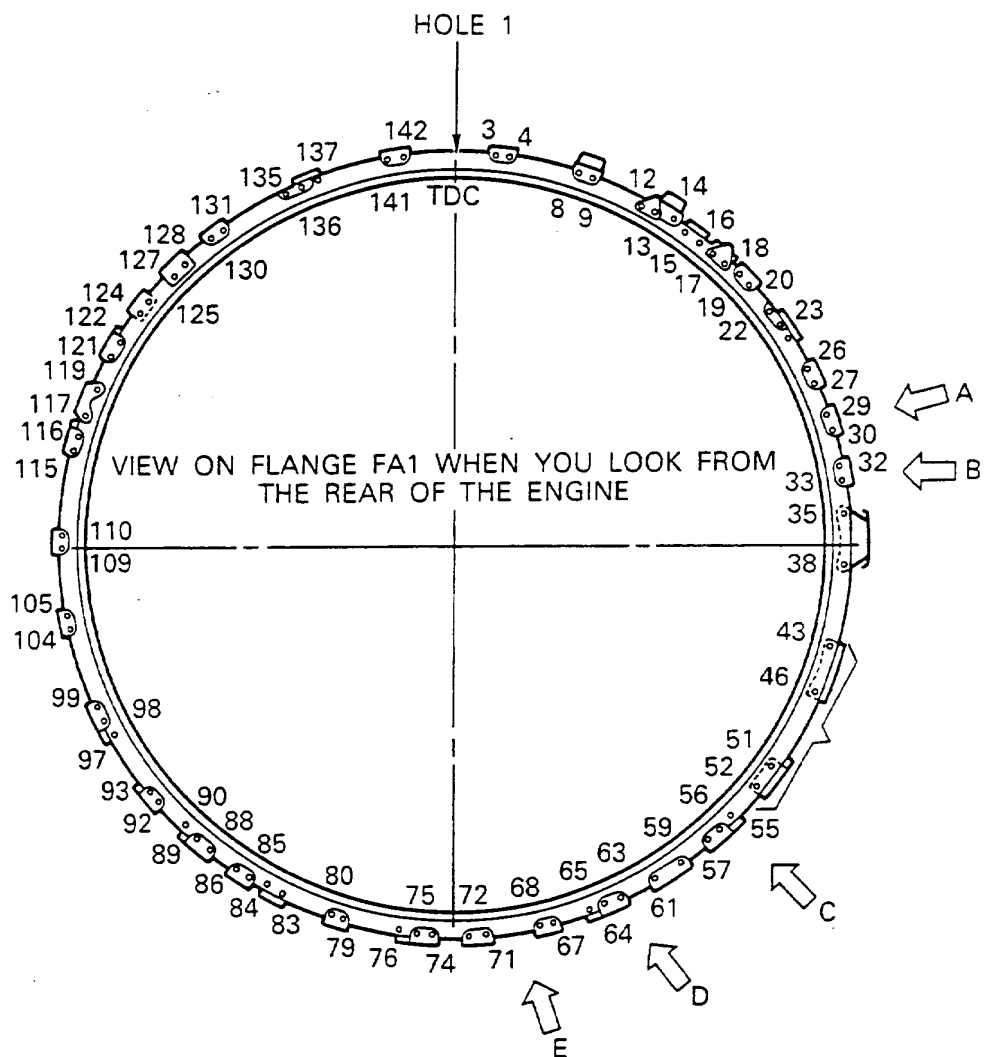
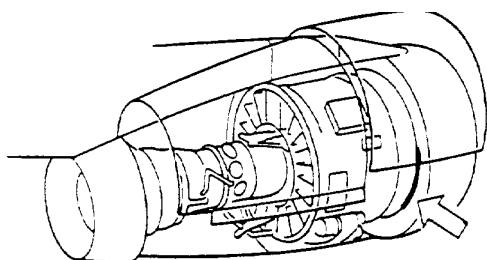
Location of the flange holes at the flange FA1  
Fig.1

The bolts which install the two brackets including the bracket part number 5W8317 to the flange FA1, may have an insufficient length to tighten the two brackets together with the flange FA1.

This could cause a looseness of the bolts, nuts and the brackets because of possible unsatisfactory self locking of the nuts at the bolt ends.

- (1) Find the flange holes 29, 30, 32, 33, 57, 63, 64, 67 and 68 on the flange FA1 where the brackets including bracket PN 5W8317 are installed (Refer to Figures 1 and 2.)
- (2) At each flange hole 29, 30, 32, 33, 57, 63, 64, 67 and 68, remove PN 4W0002, nut, and PN 4W0164, bolt from the flange FA1 and the brackets. (Refer to Figures 1 and 2.)
- (3) At each flange hole 29, 30, 32, 33, 57, 63, 67 and 68, install PN 4W0165, bolt, and PN 4W0002, nut to the brackets and the flange FA1. (Refer to Figures 1 and 2.)
- (4) At each flange hole 29, 30, 32, 33, 57, 63, 64, 67 and 68, tighten PN 4W0002, nut on PN 4W0165, bolt with a torque of 85-95 lbfin (9,6 - 10,7 Nm). (Refer to Figures 1 and 2, and the Aircraft Maintenance manual, 70-23-11, Torque Tightening Technique).

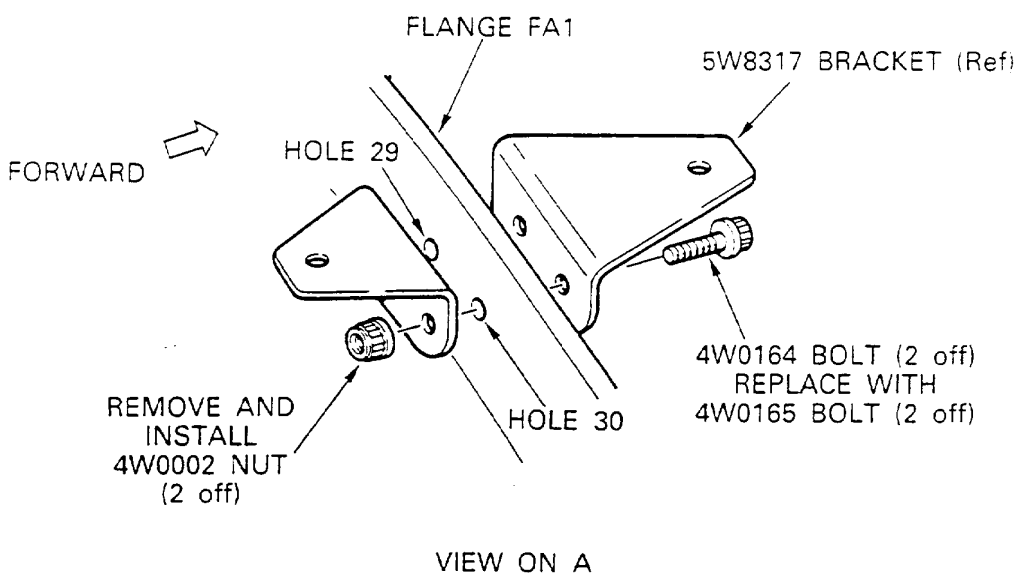
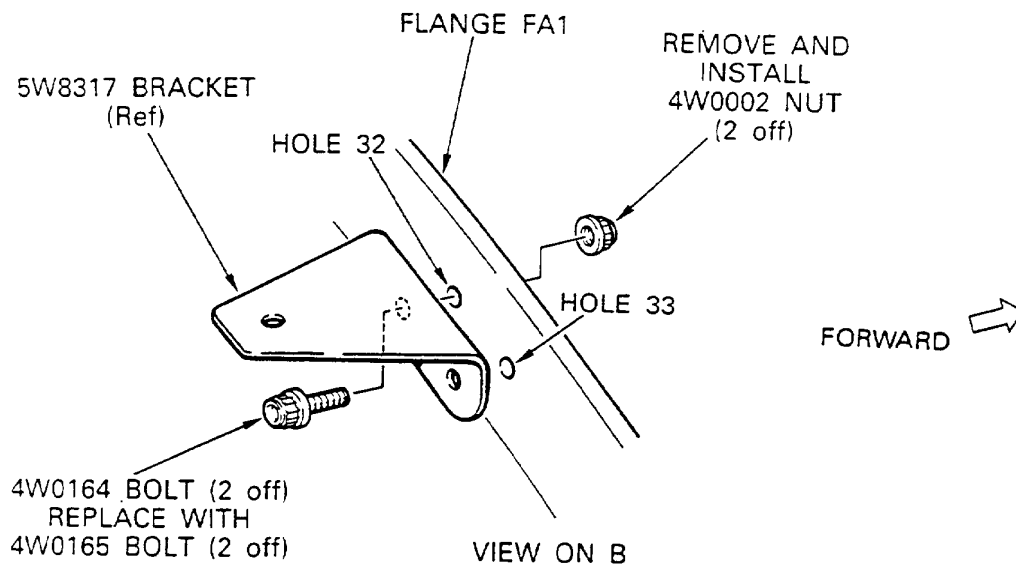
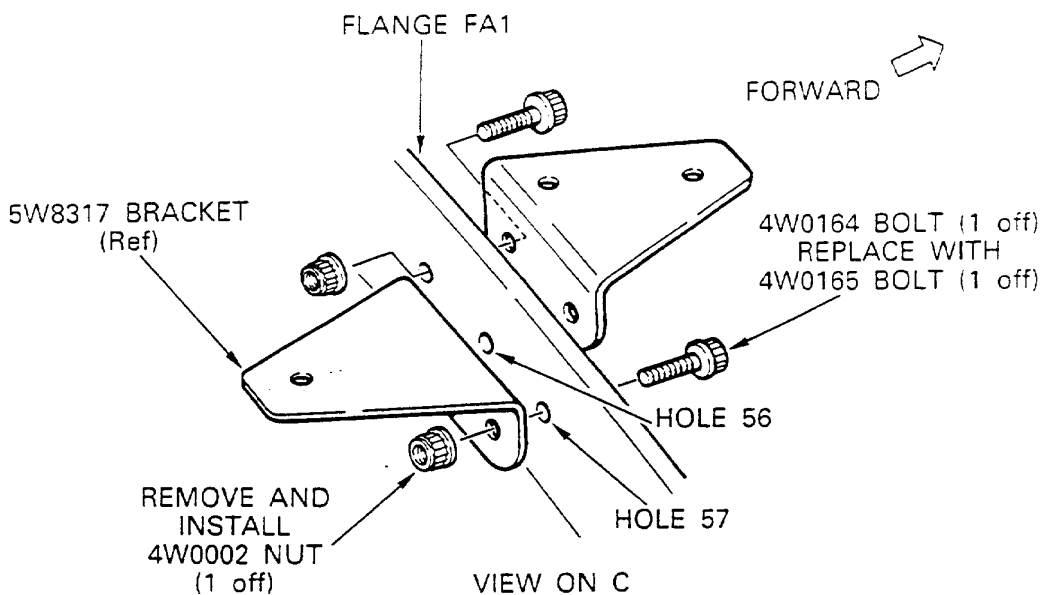
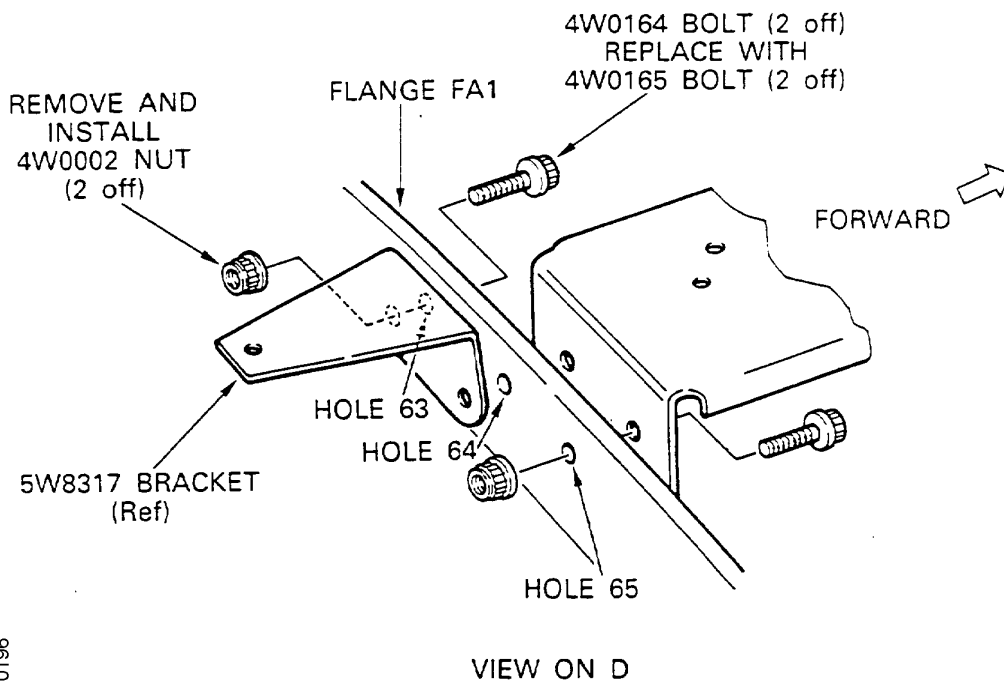
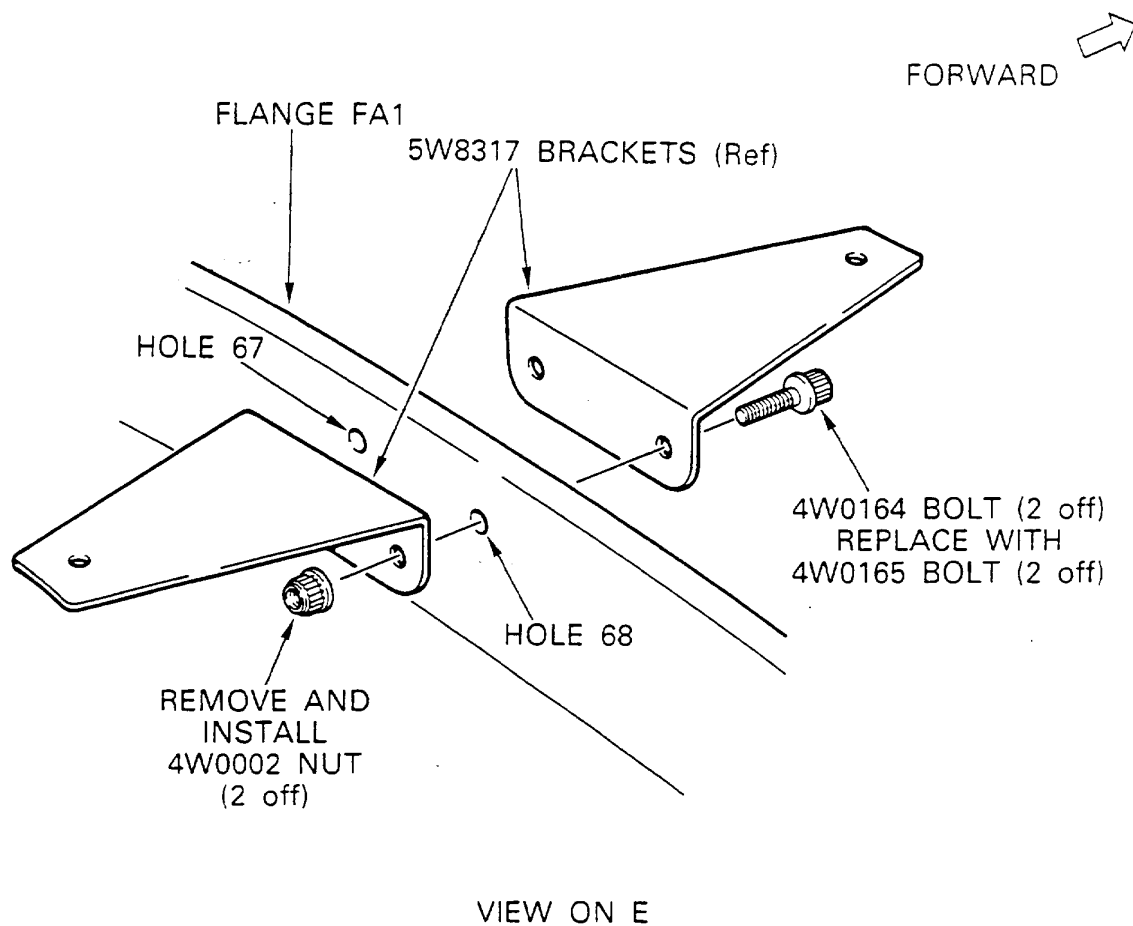
Replacement of the bracket attaching bolts on flange FA1  
Fig.2

(a) The existing bolts which install the brackets including the bracket PN 5W8317 to the flange FA1, have been changed from PN 4W0164 to PN 4W0165 to increase the bolt length.
