SERVICE BULLETIN

POWER PLANT - ENGINE - INCORPORATE A REVISED RELAY BOX MOUNTING BRACKET HAVING AN
ADDITIONAL SPACER AT CP1015 - CATEGORY CODE 5 - MOD.ENG-71-0059

V2500-ENG-71-0059

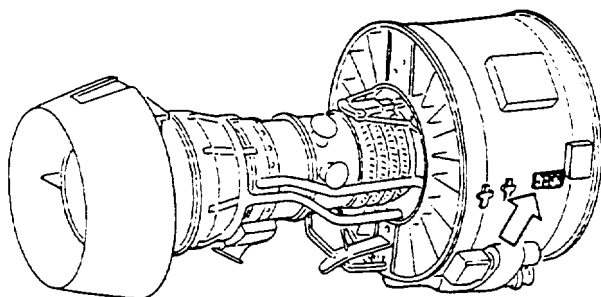
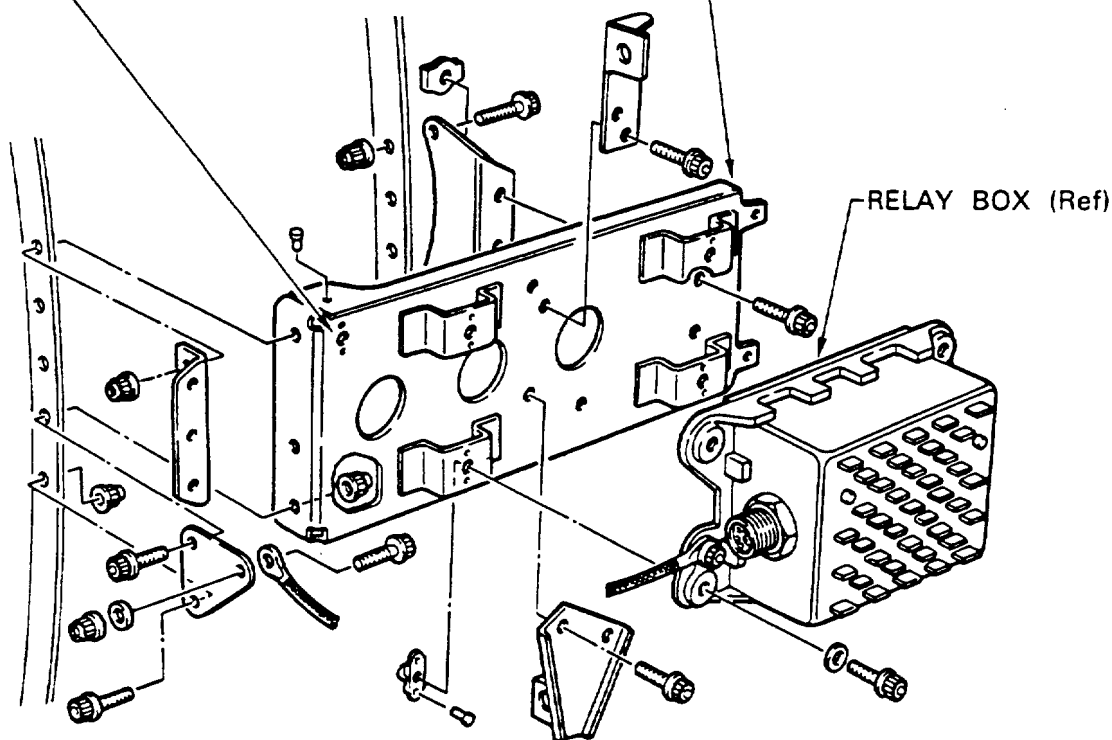
Location of the Relay Box Mounting Bracket
Fig.1

The EEC Fan Harness could contact the Relay Box Mounting Bracket on either side of the CP1015 located on the Bracket.

6A3104 RELAY BOX MOUNTING BRACKET
REPLACE WITH NEW PN
6A4132 RELAY BOX MOUNTING BRACKET

CP1015 (See Figure 2 for Detail)

- (1) Install the new 6A4132, Relay Box Mounting Bracket, A/O, by the approved procedures in the Engine Manual, 72-00-32, Installation, TASK 72-00-32-420-002. (Refer to Figure 1 and 1.K.(2).)
- (2) At CP1015, install the new 4W0110, Bolt, in exchange for the existing 4W0104, Bolt, by the approved procedures in the Engine Manual, 72-00-32, Installation, TASK 72-00-32-420-004. (Refer to Figure 2 and 1.K.(2).)

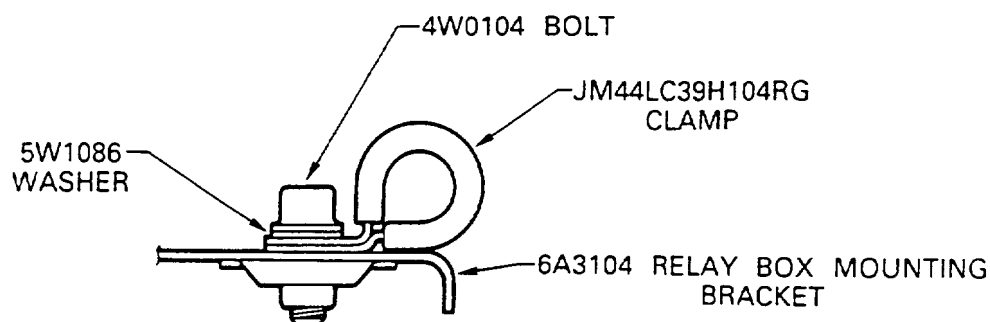
CLIPPING CONFIGURATION AT CP1015
BEFORE ALTERATION

Clipping Detail at CP1015 – Before and After Alteration
Fig.2

- (a) A new Relay Box Mounting Bracket which has the additional spacer at CP1015 is introduced to give an adequate clearance between the Harness and the Bracket. (See Figures 1 and 2.)
- (b) The clipping bolt at CP1015 has been changed with longer bolt in line with the additional spacer welded on the Bracket. (See Figure 2.)
- (2) The new Relay Box Mounting Bracket and the Bolt at CP1015 will be available for future replacement purposes.
