POWER PLANT - ENGINE - PROVIDE AN EEC HARNESS SUPPORT BRACKET AT FLANGE FD - CATEGORY
CODE 6 - MOD.ENG-71-0060

V2500-ENG-71-0060

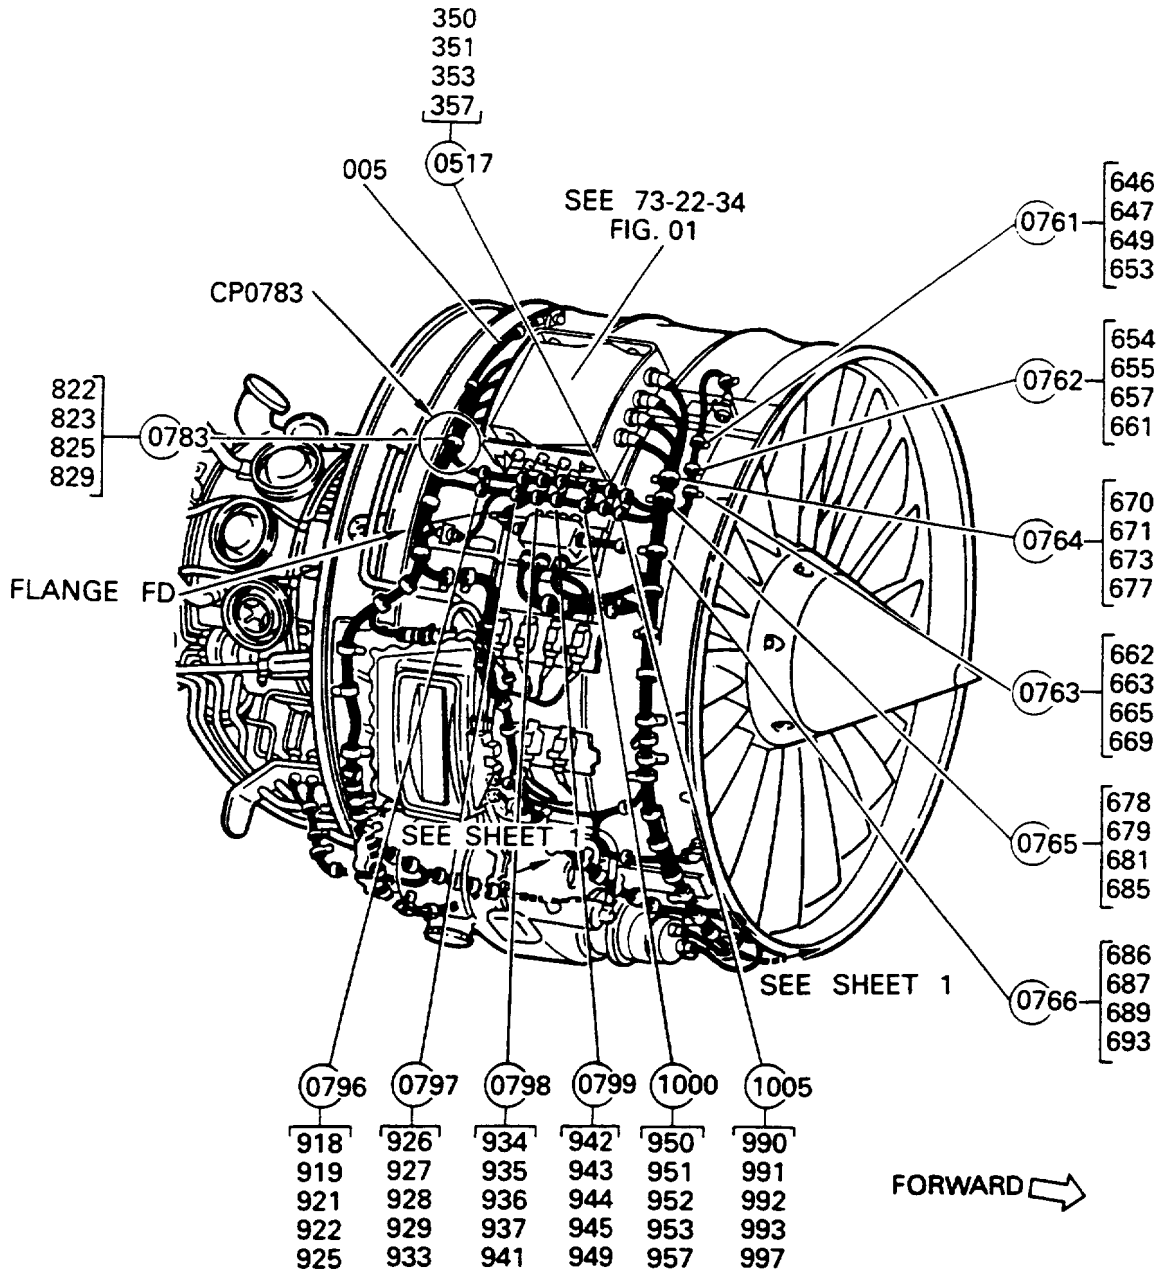
Location of Clipping Position CP0783 and new Clipping Bracket to be installed at Flange FD
Fig.1

The Bracket at CP0783 does not provide sufficient support for the EEC Fan Harness in the area of Flange FD. This may cause the chafing of the EEC Fan Harness.

(a) A new Bracket 5W8395 is installed to the Flange FD support the EEC Fan Harness at new clipping position CP1096. See Figures 1, 2, and 3.)
