POWER PLANT - ENGINE - EGT HARNESS - INTRODUCTION OF IMPROVED CLIPPING FOR CLIPPING
POINTS 5734, 5735 AND 5736 - CATEGORY CODE 4 - MOD.ENG-71-0061

V2500-ENG-71-0061

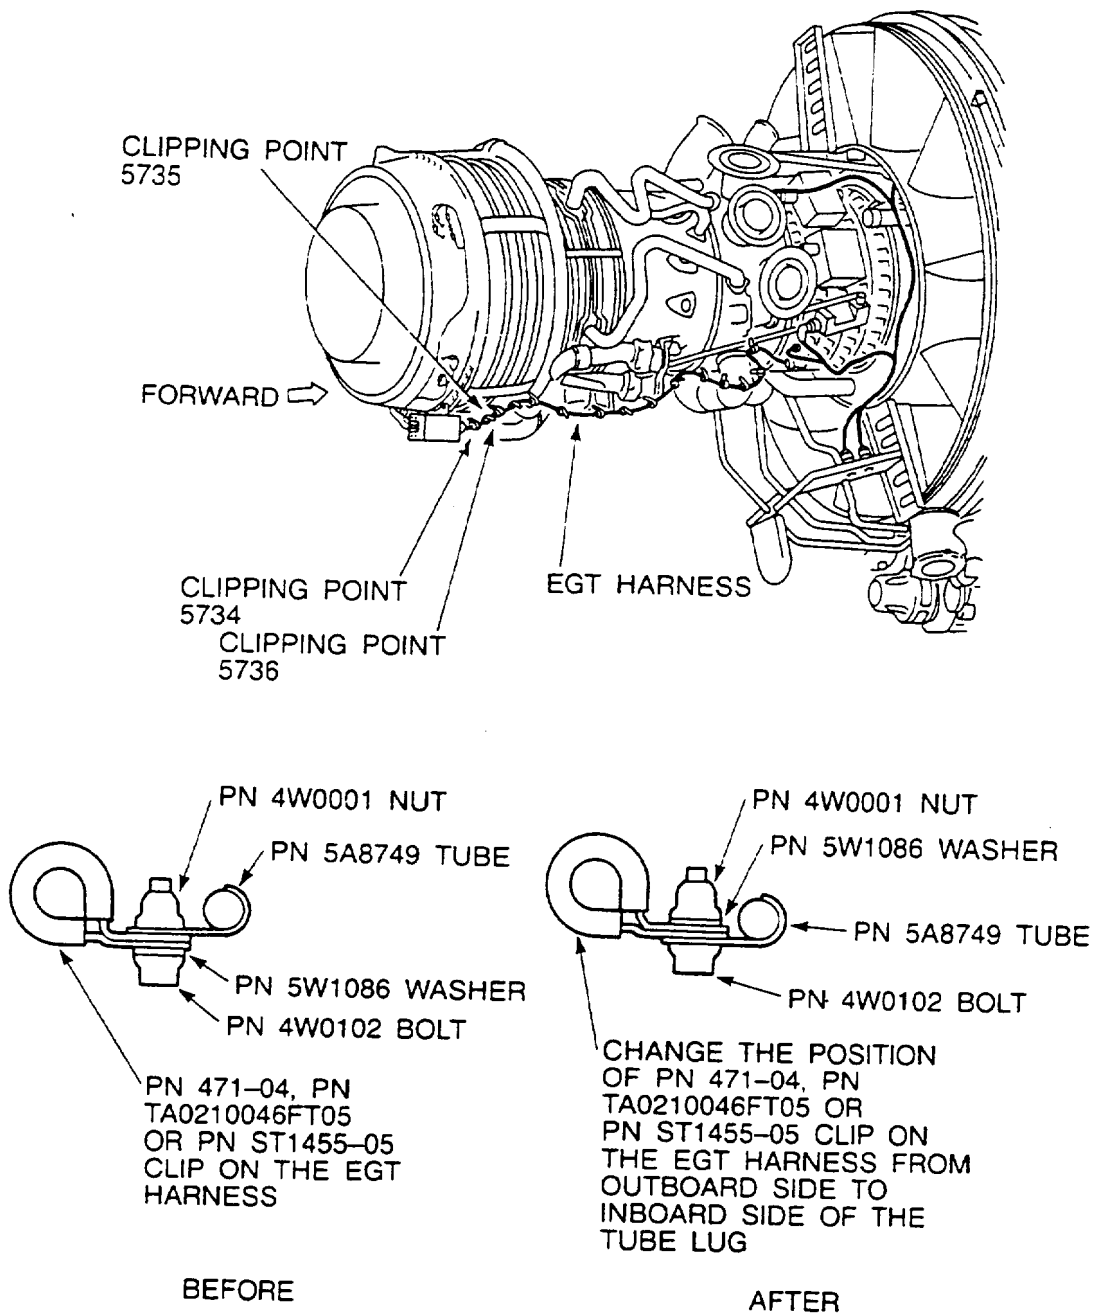
Location of the clipping points 5734, 5735 and 5736 and clipping arrangement
Fig.1

EGT harness may be contacted by the C-duct bumper pads when the ducts are closed.

- (3) Change position of clip at clipping point 5736.
 - (a) Remove 4W0001 Nut, 5W1086 Washer and 4W0102 Bolt and release 471-04, TA0210046FT05 or ST1455-05 Clip with the EGT harness from the lug of 5A8749 Tube.

- (b) Reinstall the clip to the inboard side of the lug using 4W0102 Bolt, 5W1086 Washer and 4W0001 Nut.
