POWER PLANT – ENGINE – EEC HARNESS – FAN AND EEC HARNESS – CORE – INTRODUCTION OF
ADDITIONAL SUPPORT FOR ELECTRICAL CONNECTORS – CATEGORY CODE 4 – MOD.ENG-71-0063

V2500-ENG-71-0063

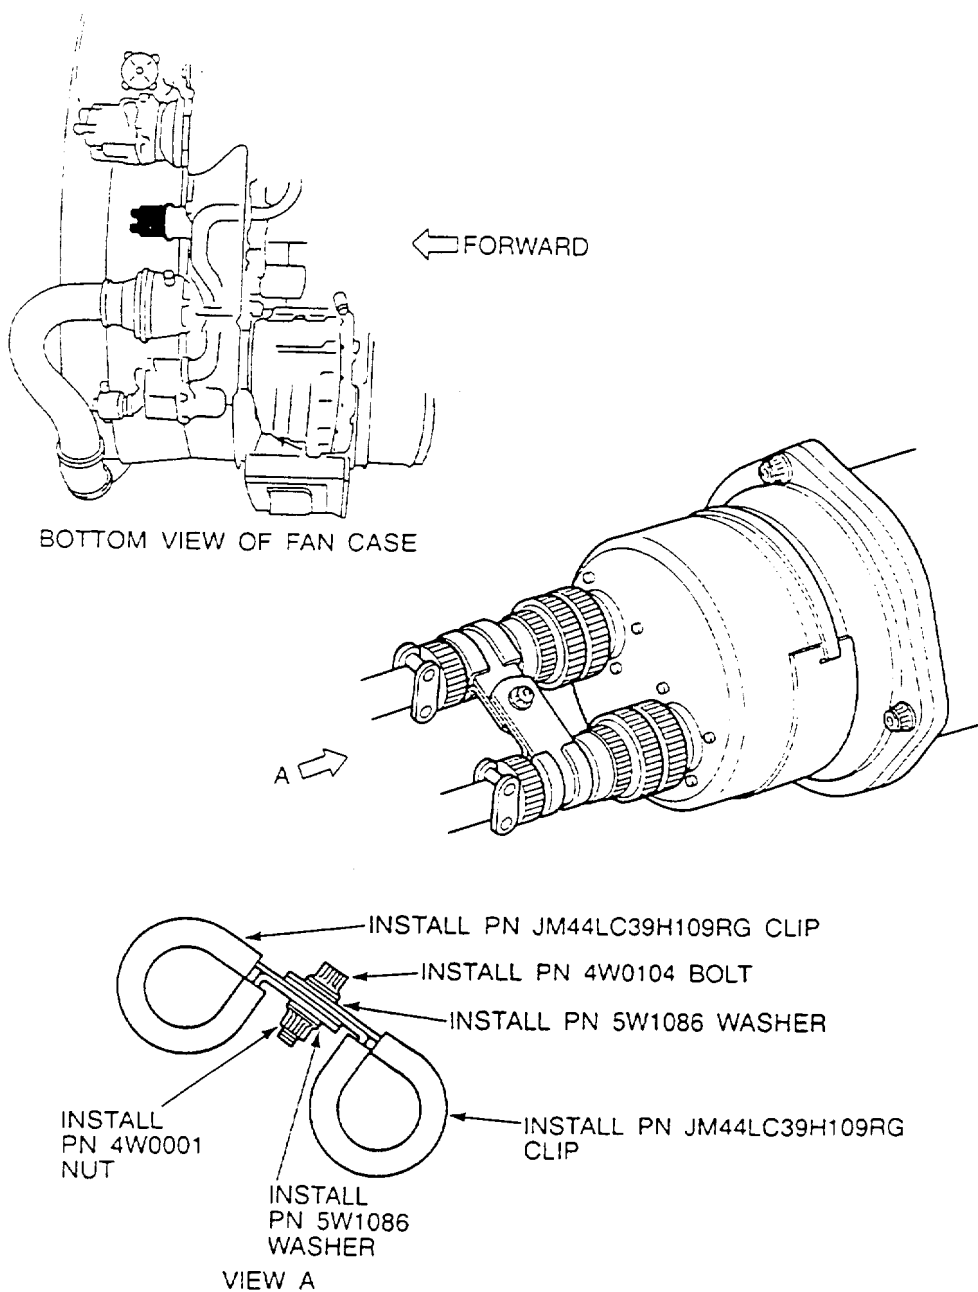
View showing support for electrical connectors
Fig.1

Pins and sockets of electrical connectors at the variable stator vane actuator (VSVA) and the engine dedicated alternator (EDA) have a possible fretting caused by vibration.

Electrical connectors used at the VSA and the EDA have a small backlash of coupling ring latch mechanism under the fully engaged condition. Engine vibration and this backlash may vibrate the plug against the receptacle. Therefore fretting may occur between the pin and socket. Clipping of adjacent two connectors has been provided to prevent vibration of the plug.

- (1) Retain the two fan harness connectors connected to the EDA.
 - (a) Install JM44LC39H109RG Clip to each connector backshell. Retain installed two clips together with 4W0104 Bolt, two 5W1086 Washers and 4W0001 Nut.
