SERVICE BULLETIN

<u>POWER PLANT - ENGINE - POWERPLANT - INTRODUCE A SPACER AT CLIPPING POINT CP0809 - CATEGORY CODE 6 - MOD.ENG-71-0066</u>

V2500-ENG-71-0066

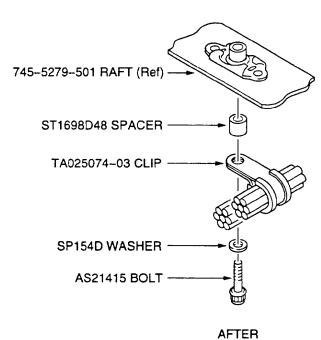
MODIFICATION OF CLIPPING POINT CP0809 Fig.1

Minimum clearance has been observed between the general services harness and flange 'A' on the engine fan case at clipping point CP0809.

The lack of clearance was discovered during assembly in production.

- (1) The changed introduced by this Service Bulletin is as follows:-
 - (a) A spacer is added at clipping point CPO809. The existing bolt is removed and replaced with a longer bolt.

- B. Assembly Instructions
 - (1) Assemble clipping CPO809 to 740-5182-501 raft assembly as shown with an AS21415 bolt, SP154D washer, TAO25074-03 clamp and an ST1698D48 spacer (Refer to Figure 1.)
 - (2) Torque the AS21415 bolt 36 to 45 lbfin (4 to 5 Nm)
- C. Recording Instructions
 - (1) A record of accomplishment is necessary.
