NACELLE - POWER PLANT - EEC COOLING - SUPPORT BRACKETS - REMOVAL/REPLACEMENT OF -
CATEGORY CODE 3 - MOD.ENG-71-0070

Possible freezing of Pb sensing system under certain conditions.

V2500-ENG-71-0070

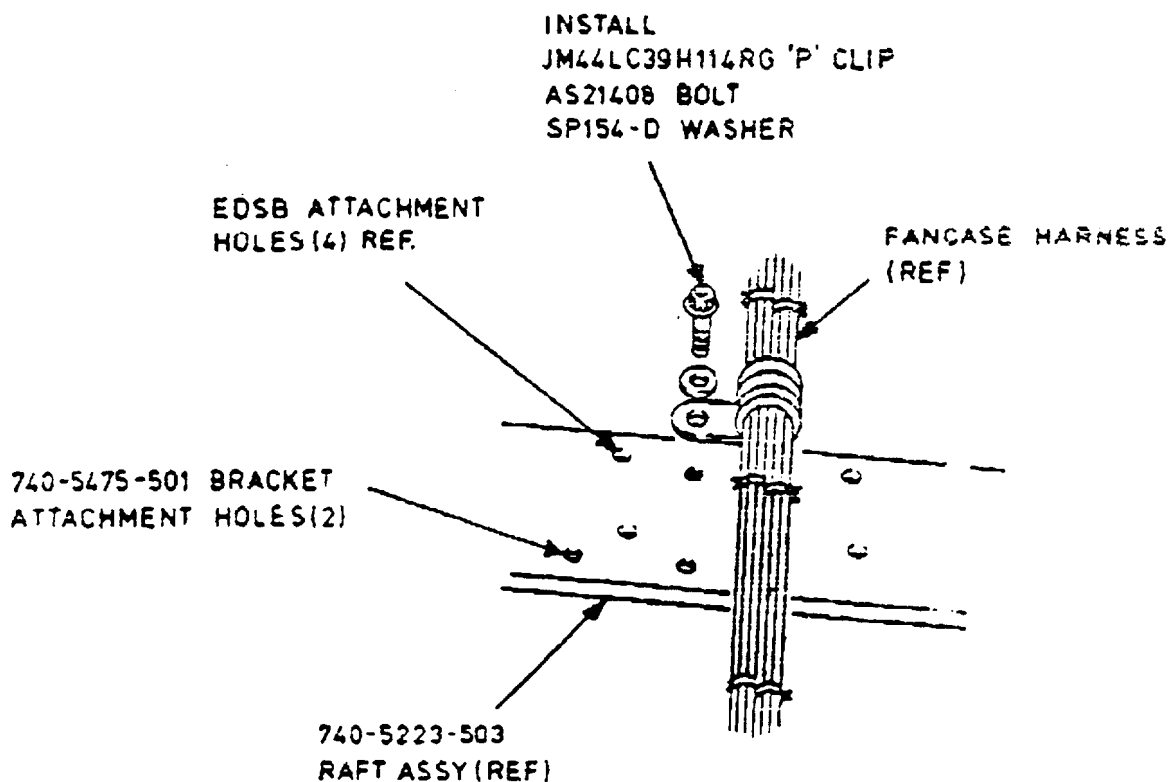
Attachment of the Fancase Harness to the Raft Assembly
Fig.3

NOTE: DO NOT USE THE ATTACHMENT HOLES
OF THE EDSB OR 740-5471-501 BRACKET

- (5) Attach the fancase harness to the 740-5223-503 aft assembly (where shown) with the JM44LC39H114RG 'P' clip, SP154-D washer, and AS21408 bolt (retained in paragraph 2.B.(4)). Torque tighten to 40 lb-in. (4.52 N.m). (Refer to Figure 3.)
