**International
Aero Engines**

**NACELLE - POWERPLANT - GENERAL SERVICES HARNESS -
CLIPPING POINTS - MODIFICATION OF**

V2500-ENG-71-0097

April 30, 1998

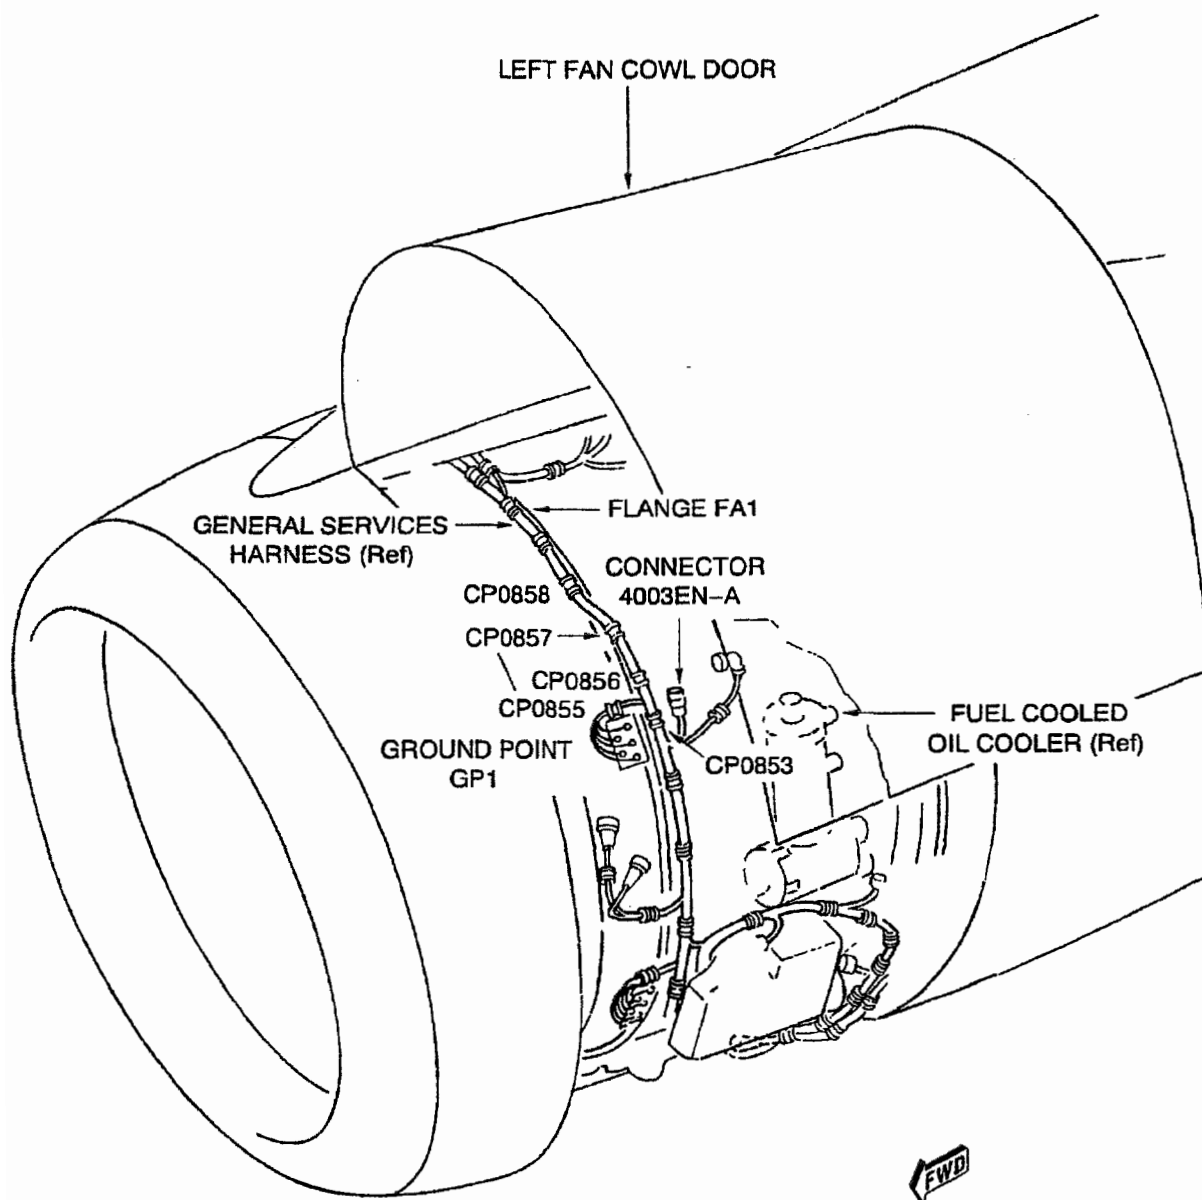
Figure 1 Sheet 1 of 3

Under operating conditions it is possible for the General Services Harness to make contact with the Raft assembly attached to the Fan Case.

MODIFICATION OF CLIPPING POINTS CP0853 AND CP0857

- (1) Open the Left Fan Cowl Door as instructed in the A320 Aircraft Maintenance Manual, Task 71-13-00-010-010.
- (2) Find clipping points CP0853 and CP0857 on the left side of the Engine Fancase (Refer to Figure 1).

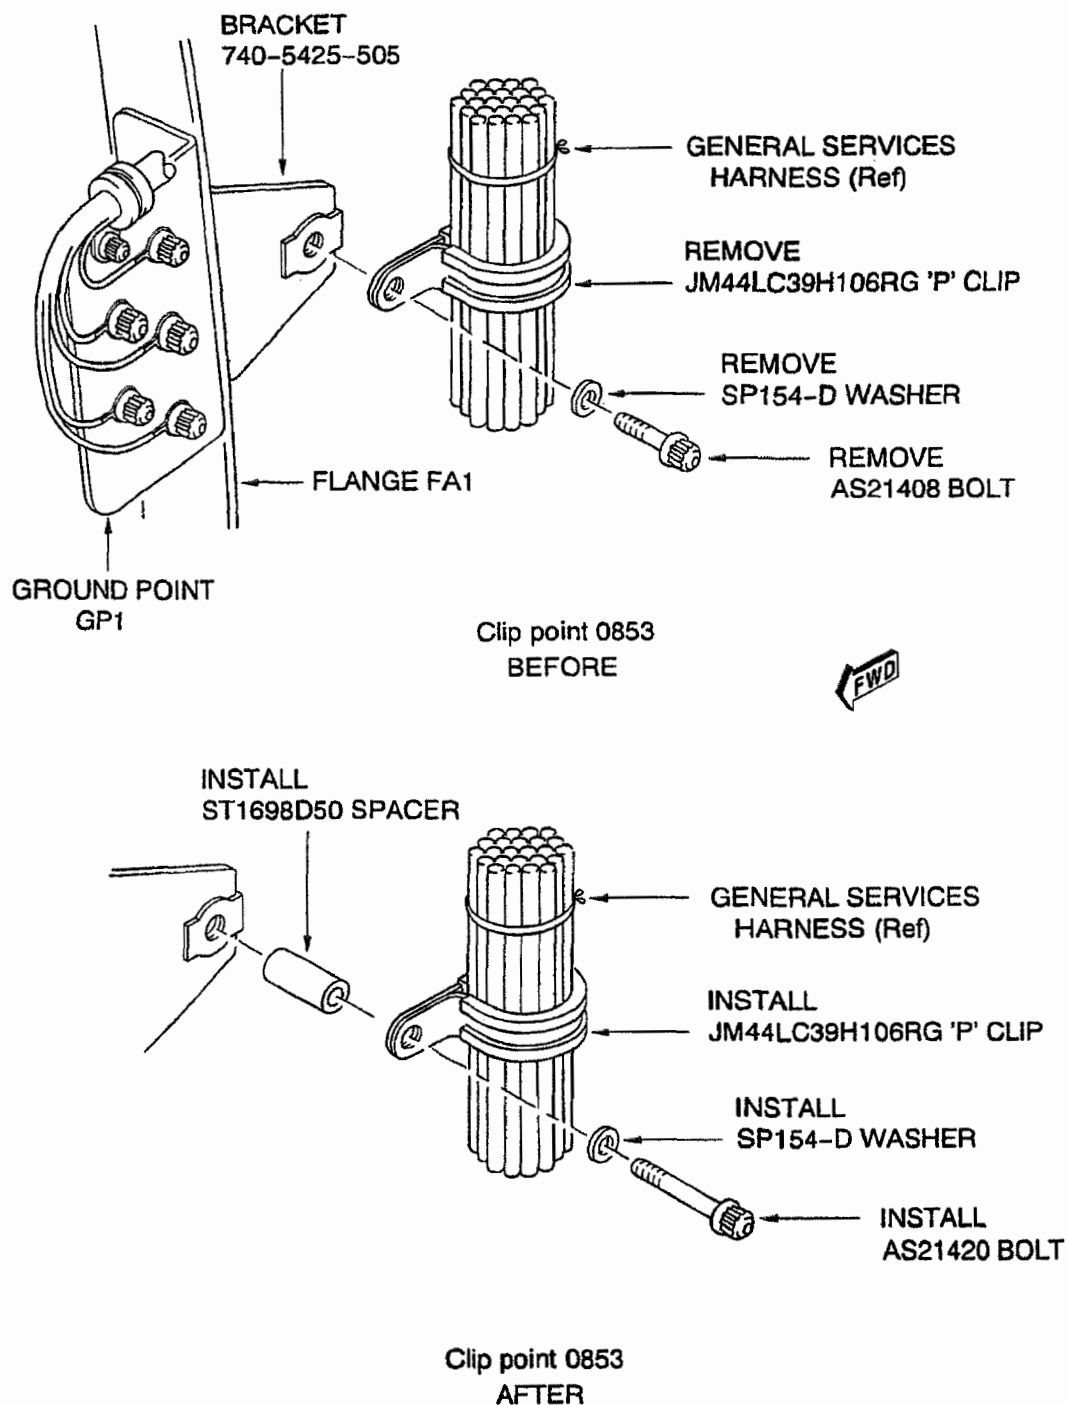
Figure 1 Sheet 3 of 3

MODIFICATION OF CLIPPING POINTS CP0853 AND CP0857

- (a) Clipping points CP0853 and CP0857 on the General Services Harness are disassembled and a 20mm Spacer and longer Bolt is installed at each clipping point.
