POWER PLANT - ENGINE - POWERPLANT - FANCASE RAFT AND BRACKET - REPLACEMENT OF -
CATEGORY CODE 6 - MOD.ENG-71-0104

V2500-ENG-71-0104

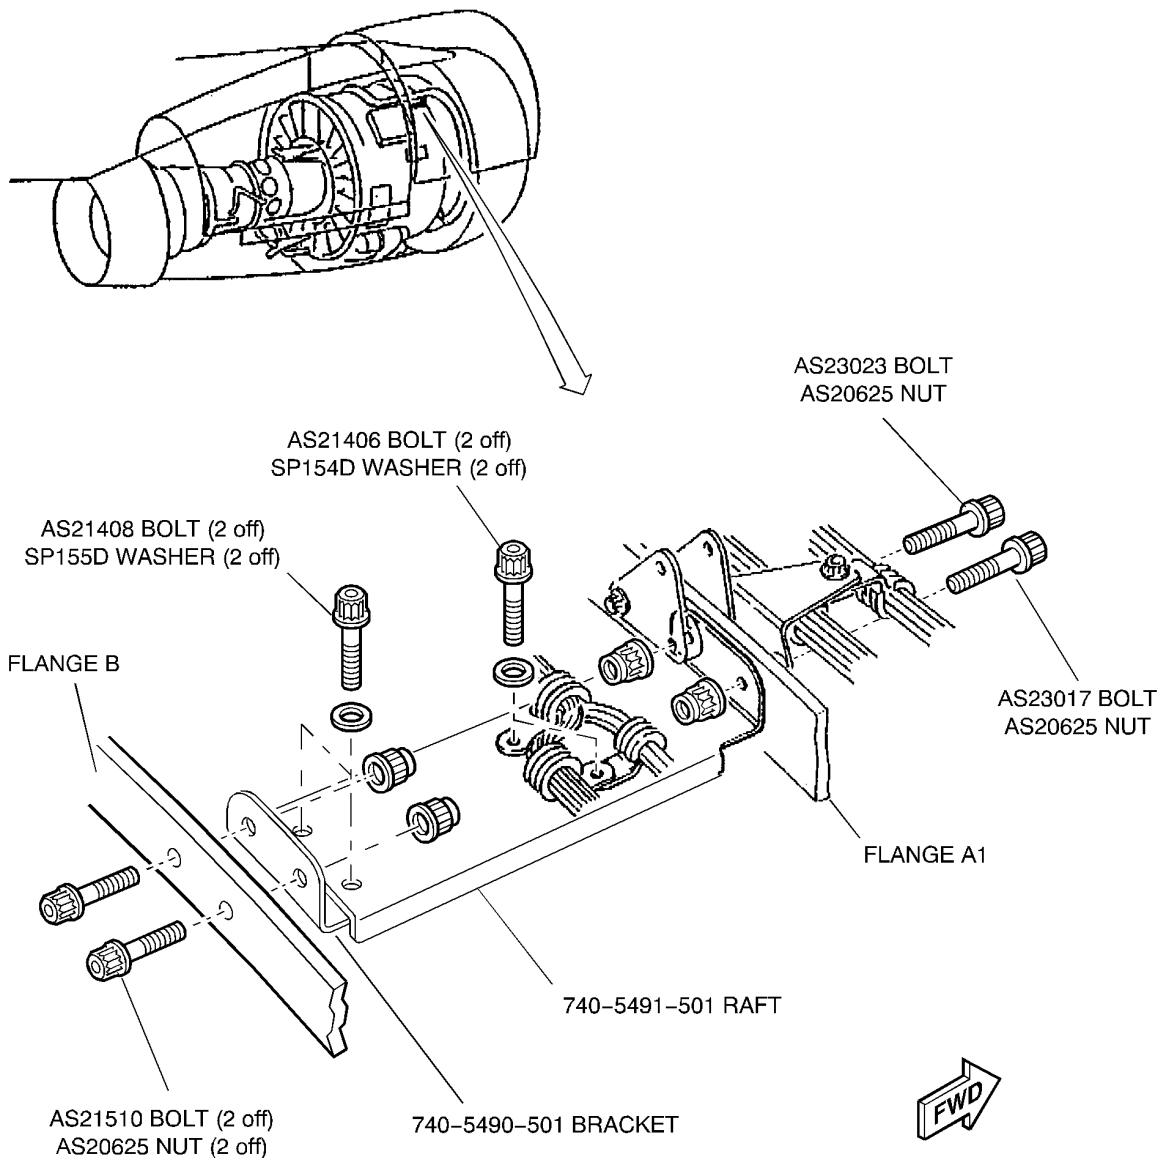
Installation of raft and bracket
Fig.1

Insufficient clearance may exist between a bolt and the engine fancase at engine flange A1.

- (a) The raft and bracket that support the clipping points GP0810 and CP0811 are removed and replaced with a new raft and bracket.

- (1) Install the new raft and bracket by the approved procedures in reference 1.K.(1).
