POWER PLANT - ENGINE - POWERPLANT - INTRODUCE REVISED CLIPPING REQUIREMENTS AT CLIPPING
POINT CP1092 - CATEGORY CODE & - MOD.ENG-71-0105

V2500-ENG-71-0105

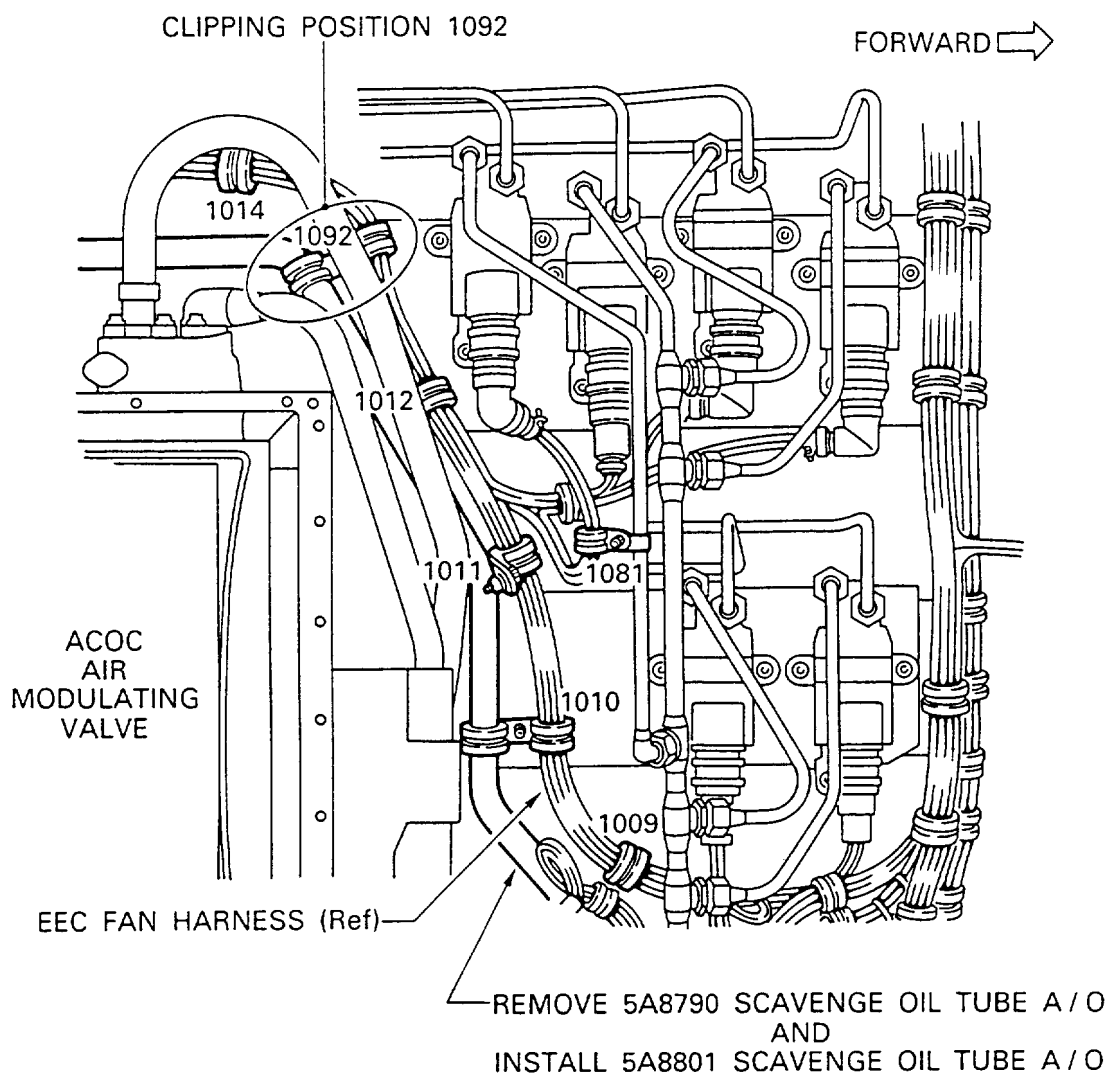
Location of the Scavenge Oil Tube and the Clipping Position 1092
Fig.1

Bending of Lugs on Scavenge Oil Tube and rotation of clipping at CP1092 which holds the EEC Fan Harness could occur. This could potentially cause the chafing of harness.

- (a) A New Scavenge Oil Tube A/O which has the strengthened six lugs has been introduced (See Figure 1).
- (b) With new configuration of the Scavenge Oil Tube A/O, the clipping configuration at CP1092 is changed (See Figure 2).

- (1) Install 5A8801, Scavenge Oil Tube A/O, to the engine by the approved procedures in the Engine Manual, 72-00-32 Installation.
- (2) Install the bolts, the washers, the clips and the nuts at the clipping positions CP0594, CP1009, CP1010, CP1011, CP1012, and CP1014, and torque the nuts by the approved procedures in the Engine Manual, 72-00-32, Installation.
- (3) At CP1092, install 4W0104, Bolt, JM44LC39H109RG, Clamp, and 4W0001, Nut, to the EEC Fan Harness and the Lug on 5A8801, Scavenge Oil Tube (Refer to Figures 1 and 2). Torque the Nut to 36 - 45 lbfin (4 - 5 Nm).
