ENGINE - POWER PLANT - INCORPORATION OF MODIFICATION REQUIREMENTS FOR THE E.E.C. AND
IGNITION SUPPLY HARNESS - CATEGORY CODE 4 - MOD.ENG-71-0107

V2500-ENG-71-0107

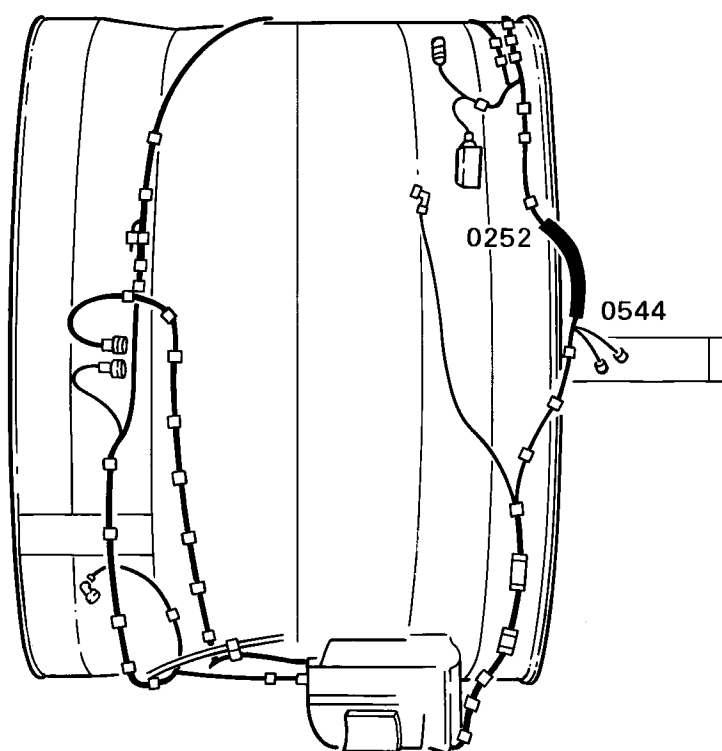
Location of spiral wrapping
Fig.1 (Sheet 1 of 2)

- (a) Chafing of the E.E.C. and ignition supply harness may occur in the region of the bifurcation panel, between clipping points 0252 and 0544.
- (b) A foul may occur between the fan cowl No.4 latch and the fuel metering unit limb of the E.E.C. harness.
- (c) Engine vibration may cause a foul between the union nut on the P2/T2 tube and the limb from the E.E.C. harness to the relay box connector, 4100KS-A.
- (d) A foul may occur between clipping point 1082 and the limb from the E.E.C. harness to the fuel temperature sensor connector 4017KS-A.

- (1) A continuous length of spiral wrapping is installed on the E.E.C. and double ignition harnesses between clipping points 0544 and 0252 extending to a point midway between clipping points 0252 and 0254. The wrapping is applied to two individual limbs on the E.E.C. harness, one limb feeding connector 4008VC-A and the other feeding connectors 4018KS-A and 4018KS-B. The additional spiral wrapping prevents chafing of the harnesses in this area.

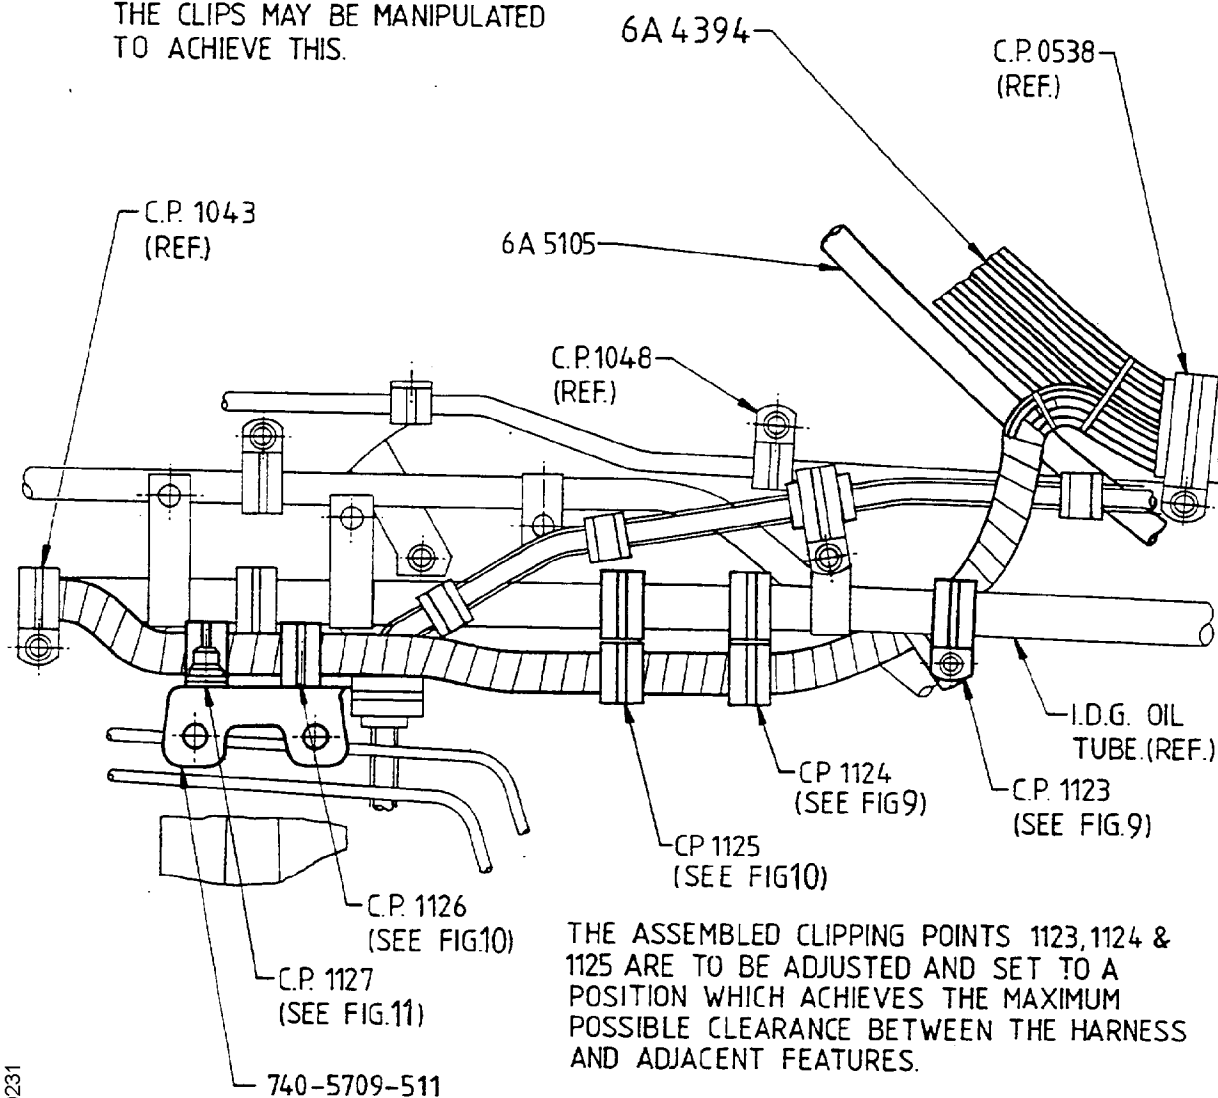
View on E.E.C. fan harness - After alteration
Fig.5

NOTE :- A MINIMUM CLEARANCE OF 0,50mm
(.020in) MUST BE ACHIEVED BETWEEN
THE CLIPS AT C.P. 1126/1127 AND
THE I.D.G. OIL TUBE.
THE CLIPS MAY BE MANIPULATED
TO ACHIEVE THIS.

- (7) Secure the harness assy 6A4394 at re-positioned clipping point 1043 using clamp TA 025074-06 (or alternative clamp AS61904), 4W0103 bolt, 5W1086 washer and 4W0001 nut (refer to Fig.5).

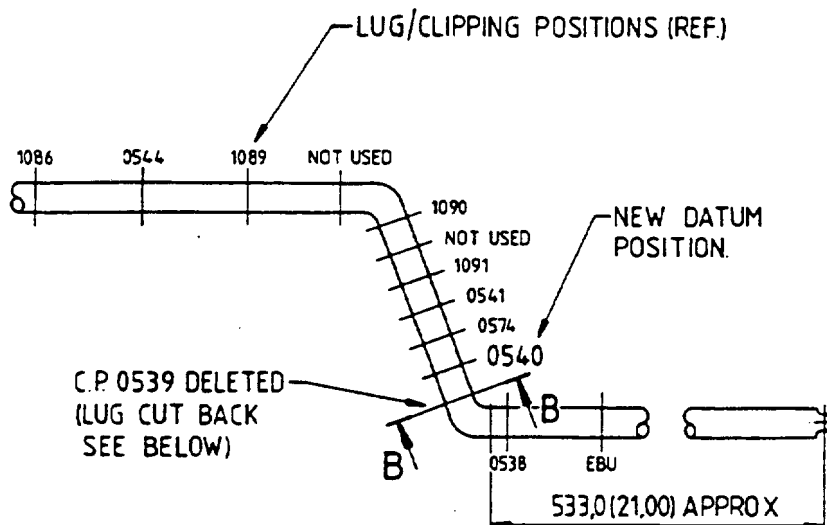
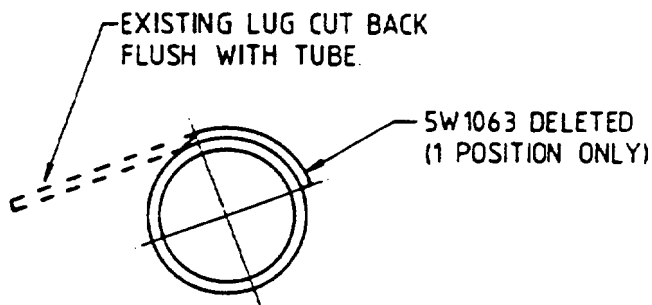
Enlarged section BB showing rework of existing raceway assembly
Fig.19

NOTE: CARE MUST BE TAKEN TO
AVOID DAMAGE TO TUBE.

Procedure	Supplementary Information
(a) Find CP0539 on raceway assembly	See Figures 4 and 19
(b) Cut back lug to align with tube	See Figure 19. Use basic workshop tools
NOTE: Follow steps to prevent damage to tube.	
(c) Make a mark on harness, E.E.C. fan, to identify the position to be reworked	See Figure 20. Use applicable marker
(d) Remove 5A9215, lacing tape, this will release relay box wires	See Figure 20. Use basic workshop tools
(e) Attach wires which go to relay box to harness, E.E.C. fan, use 5A9215 lacing tape, 32 mm (1.26in.) from CP0766	See Figures 14, 15, and 19
(f) Make a mark on harness, E.E.C. fan, both ends, to identify the area to be reworked	See Figures 5 and 12. Use applicable marker
(g) Remove 5A0276, spiral wrapping	See Figure 4
