SERVICE BULLETIN

POWER PLANT - ENGINE - PROVIDE A P2/T2 LINE BRACKET WITH LOCKWIRE HOLES - CATEGORY
CODE 4 - MOD.ENG-71-0108

V2500-ENG-71-0108

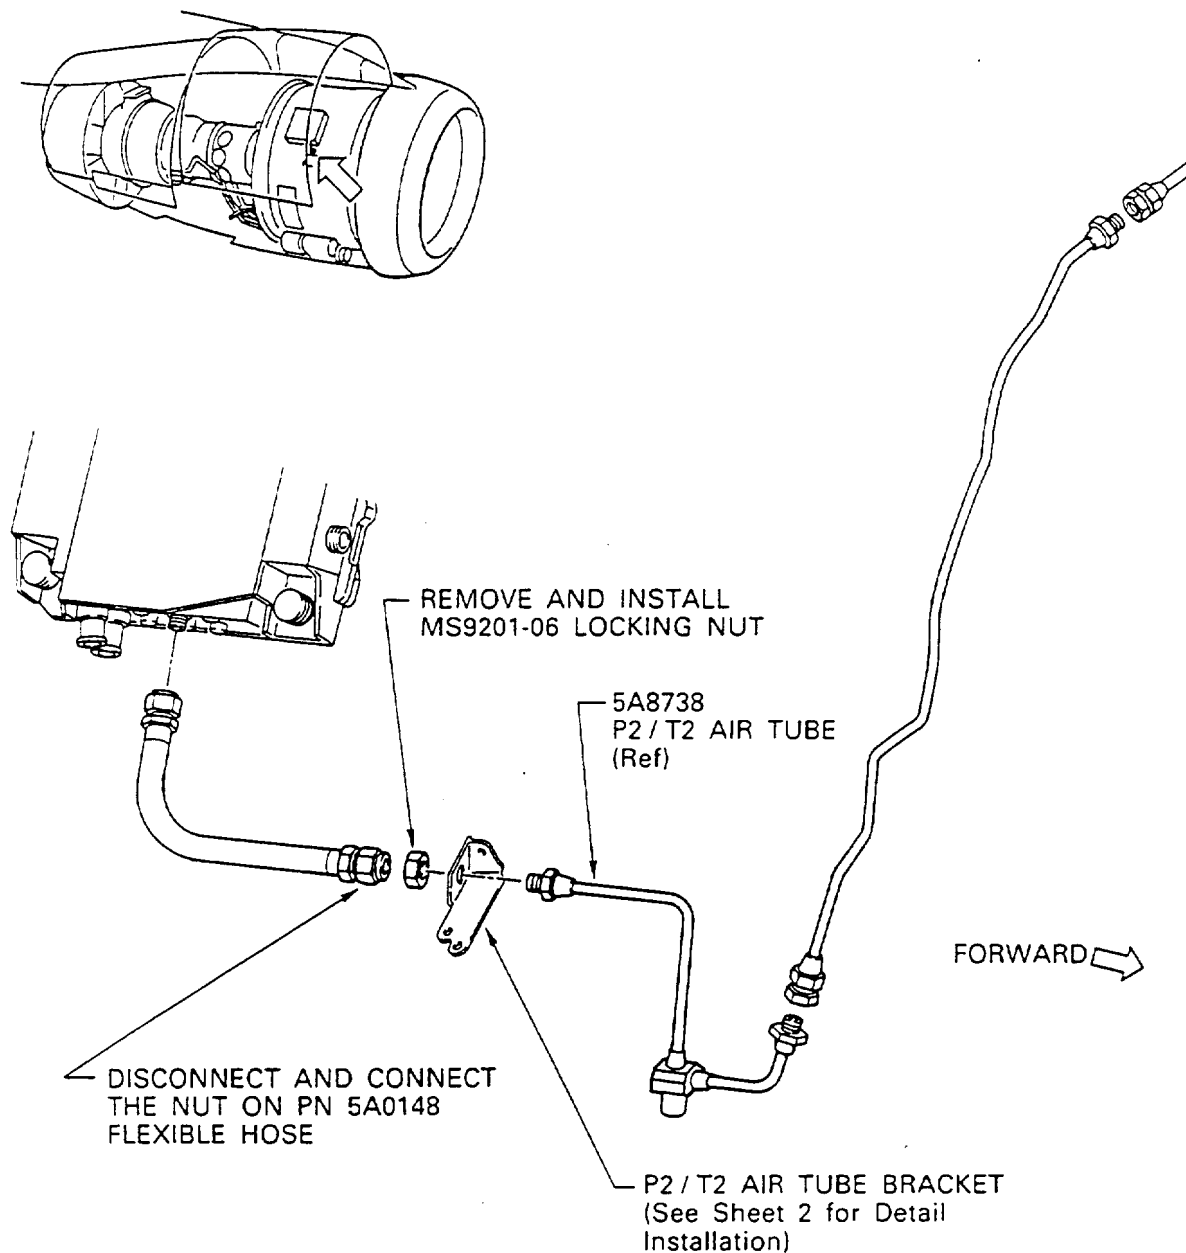
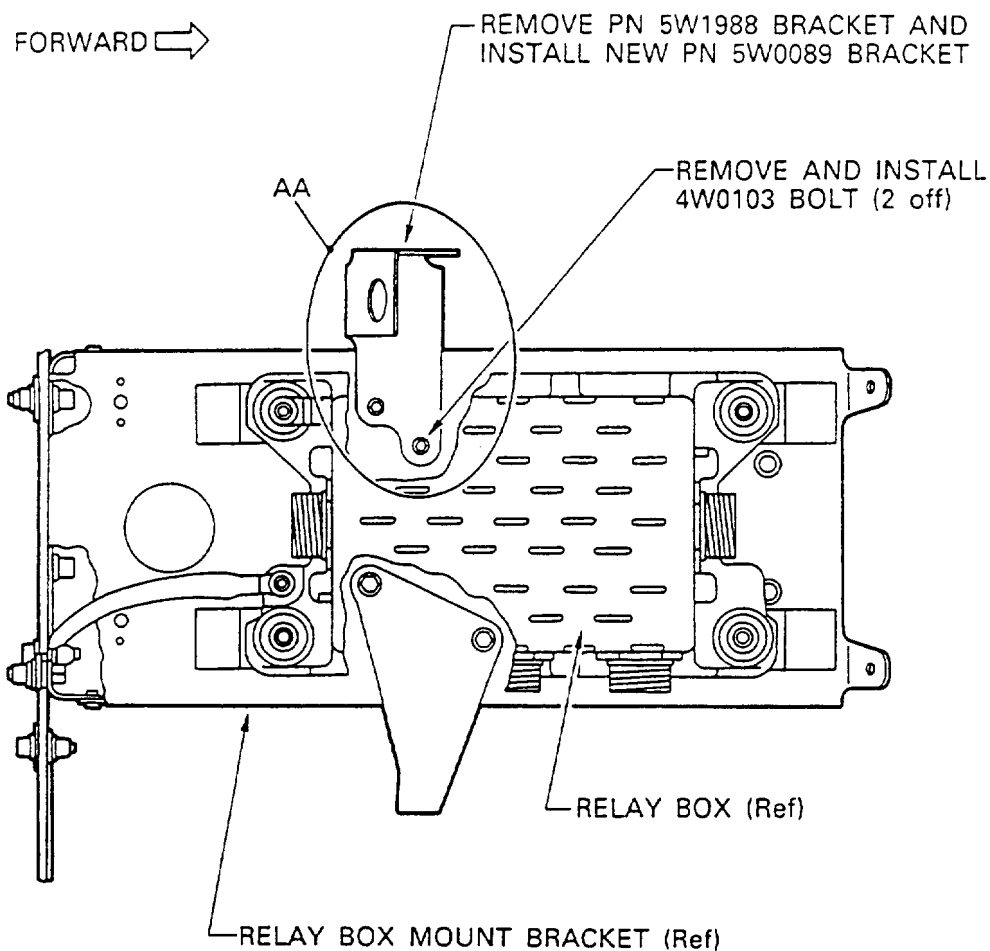
Location of the P2/T2 Air Tube Bracket
Fig.1 Sheet 1 of 2

- (1) Find 5W1988, Bracket, where is attached on the Relay Box Mount Bracket, refer to Fig.1.
- (2) Cut and discard the Lockwire on the Nut on 5A0148, Flexible Hose, and MS9201-06, Nut.
- (3) Disconnect the Nut on 5A0148, Flexible Hose, from 5A8738, P2/T2 Air Tube.
- (4) Remove MS9201-06, Locking Nut, from 5A8738, P2/T2 Air Tube, and 5W1988, Bracket.
- (5) Remove two 4W0103, Bolts, from the Relay Box Mount Bracket.
- (6) Remove 5W1988, Bracket, from the Relay Box Mount Bracket.

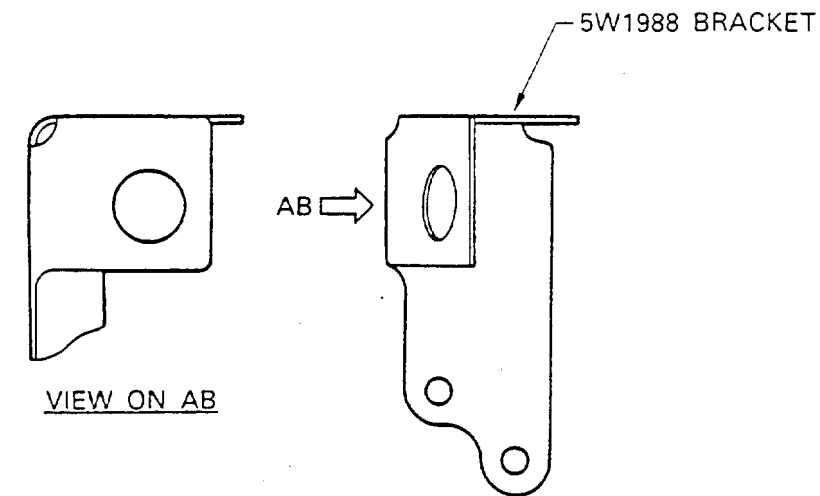
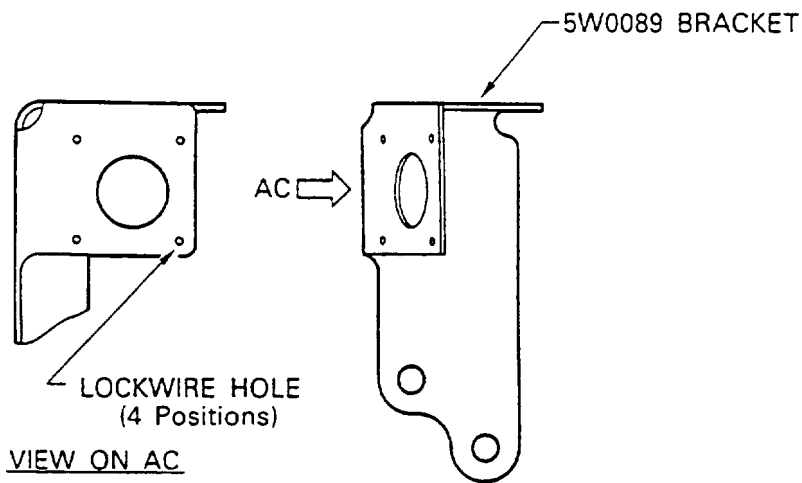
Modification of the P2/T2 Air Tube Bracket - Before and After Alteration
Fig.2

There is a possibility of unsatisfactory wire locking of the P2/T2 flexible hose nut and the locking nut which secures th P2/T2 air tube onto line Bracket.

VIEW AT AA BEFORE ALTERATION

VIEW AT AA AFTER ALTERATION

- (1) The changes introduced by this Service Bulletin are as follows:
- (a) A new Bracket 5W0089 which has the four lockwire holes is introduced to wire-lock the Nut on Flexible Hose and the locking Nut of P2/T2 Air Tube through the lockwire holes, see Fig.2.
- (2) The existing Bracket can be reworked to a new configuration, see Fig.3.
- (3) Revised wire locking for the Nut on Flexible Hose and Locking Nut of P2/T2 Air Tube, see Fig.4.

- (1) Attach the new 5W0089, Bracket, with two 4W0103, Bolts, to the Relay Box Mount Bracket, refer to Fig.2.
- (2) Torque each of two 4W0103, Bolts, to 36 - 45 lbfin (4,00 - 5,00 Nm).
- (3) Install MS9201-06, Locking Nut, to 5A8738, P2/T2 Air Tube, and the new 5W0089, Bracket. Tighten MS9201-06, Locking Nut, with a torque of 70 - 80 lbfin (7,9 - 9,0 Nm).
- (4) Connect the Nut on 5A0148, Flexible Hose, to 5A8738, P2/T2 Air Tube. Tighten the Nut on 5A0148, Flexible Hose, to a torque of 182 - 199 lbfin (20,5 - 22,5 Nm).
- (5) Safety the Nut on 5A0148, Flexible Hose, and MS9201-06, Locking Nut, with CoMat 02-126, Lockwires, independently to the new 5W0089, Bracket, refer to Fig.4 and 1.K.(3).

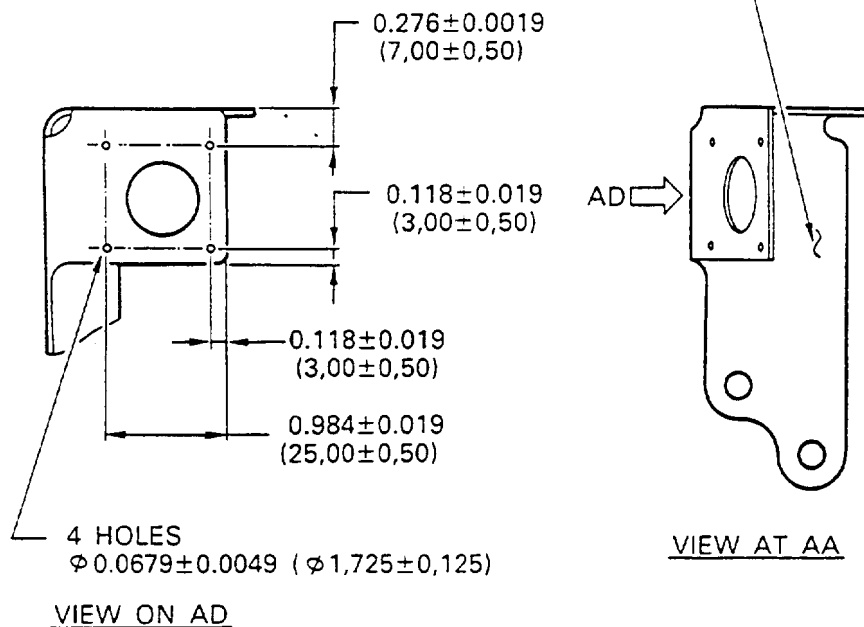
Modification of the P2/T2 Air Tube Bracket
Fig.3

REWORK OF P2 / T2 AIR TUBE BRACKET

Procedure	Supplementary Information				
(1) Mark position of the four holes and center punch the hole centers	Refer to Fig.3				
(2) Drill the four lockwire holes in 5W1988, Bracket	Refer to Fig.3. Clamp the Bracket in the vice on a pillar drill and use 0.063in. (1,6 mm.) drill				
(3) Remove all the burrs from around the drilled holes					
(4) Visually examine the drilled holes for cracks	No cracks are permitted				
(5) Renumber by the Vibro-Peen adjacent to the existing Part Number	Refer to Fig.3 <table><tr><td>Existing</td><td>Renumber</td></tr><tr><td>5W1988</td><td>5W0089</td></tr></table>	Existing	Renumber	5W1988	5W0089
Existing	Renumber				
5W1988	5W0089

MARK NEW PN 5W0089 WITH VIBRO-PEEN
ADJACENT TO OLD PN 5W1988 IDENTIFIED
HERE. MARK TWO LINES (==) ON THE
OLD P / N WITH VIBRO-PEEN TO ERASE IT.

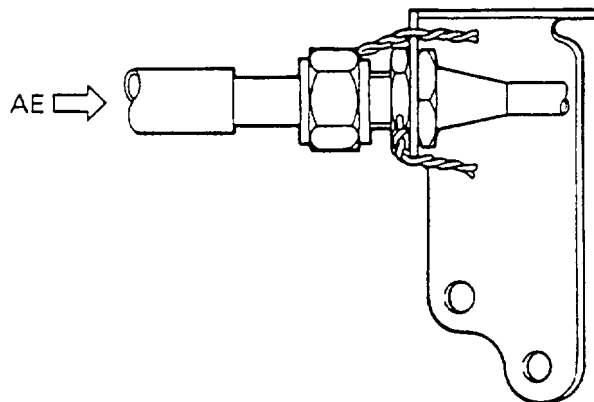
Modification of the P2/T2 Air Tube Bracket
Fig.4

REPEAT VIEW AT AA
SHOWING CONNECTIONS LOCKED
FOR SAFETY WITH LOCKWIRE
AFTER MODIFICATION
