## SERVICE BULLETIN

POWER PLANT - EEC HARNESS FAN/CORE - DELETION OF CLIPPING AT VSVA AND PMA HARNESS CONNECTORS AND INTRODUCTION OF WIRE LOCKING TO SECURE CONNECTORS - V2500-A1=8 - V2500-A5=4 - MOD.ENG-71-0111

# V2500-ENG-71-0111

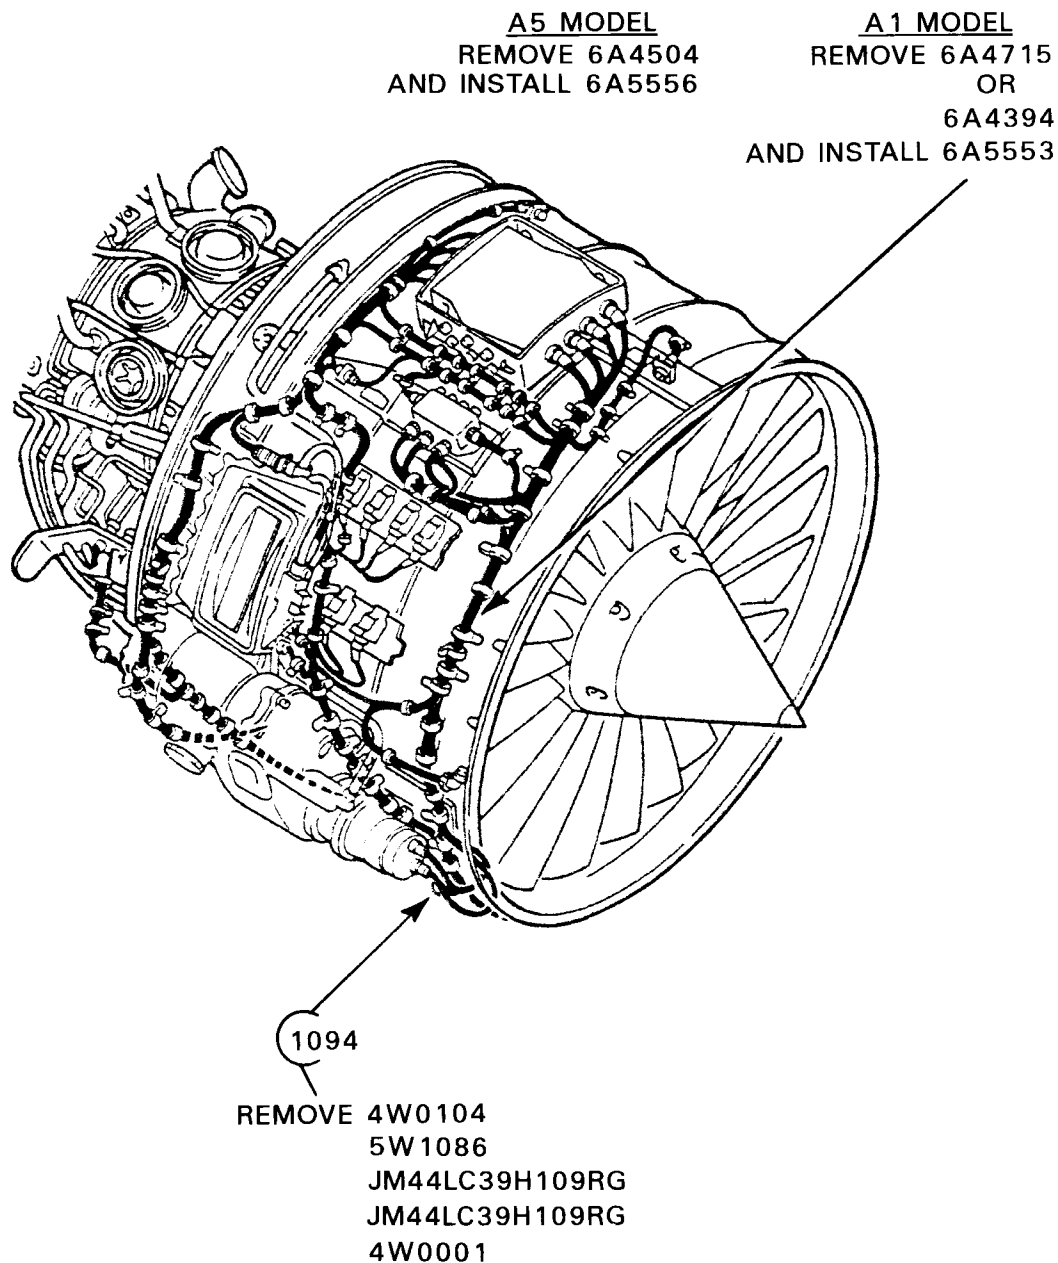
Location of EEC fan harness and clipping position 1094  
Fig.1, Sheet 1 of 2

It has been reported that assembly difficulties could result in deformation of the retaining clamps at the VSVA and PMA harness connectors.

During engine build it was highlighted that on assembly these clamps could possibly be deformed, which might result in poor retention and metal to metal contact between the clamps and connector.

- (1) Locate the back to back clipping arrangement at the VSVA clipping positions 5798, 6060/6061 and the PMA clipping position 1094.
- (2) Remove the 4W0001 nut, 4W0107 bolt, two 5W1086 washers and two JM44LC39H106RG clamps from the VSVA harness backshells at clipping position 5798. Refer to Figures 1 and 2.
- (3) Remove the two 4W0001 nuts, two 4W0107 bolts, four 4W2621 washers, 5W2166 bracket and two JM44LC39H110RG clamps from the VSVA harness backshells at clipping position 6060/6061. Refer to Figures 1 and 2.
- (4) Remove the 4W0001 nut, 4W0104 bolt, two 5W1086 washers and two JM44LC39H109RG clamps from the PMA harness backshells at clipping position 1094. Refer to Figures 1 and 3.
- (5) Remove the connectors at the input and output sides of the VSVA and at the PMA.

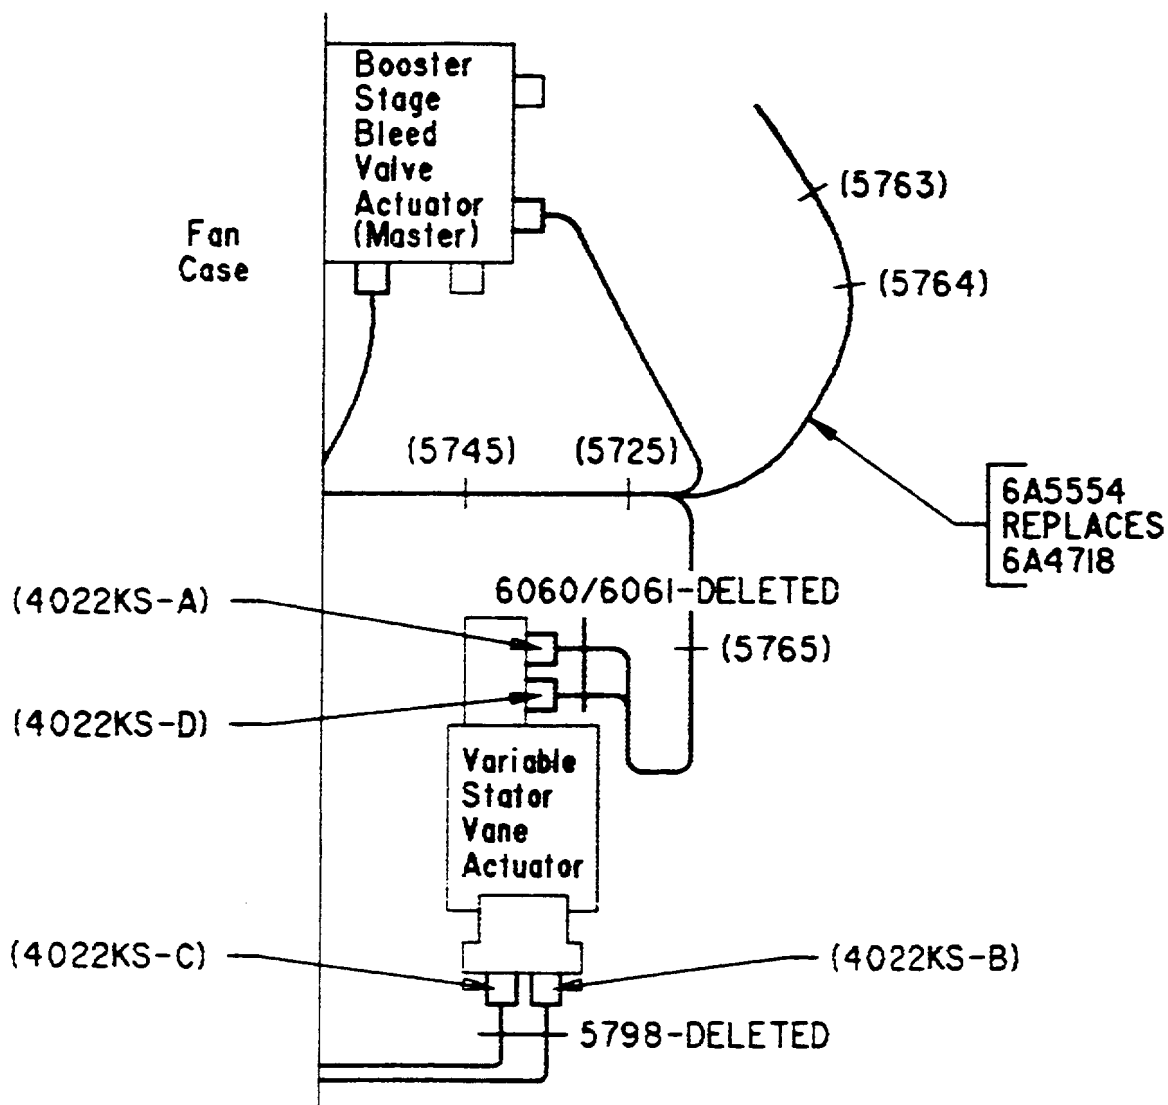
Fig.2

Schematic view of core harness showing location of deleted clipping positions 5798 and 6060/6061

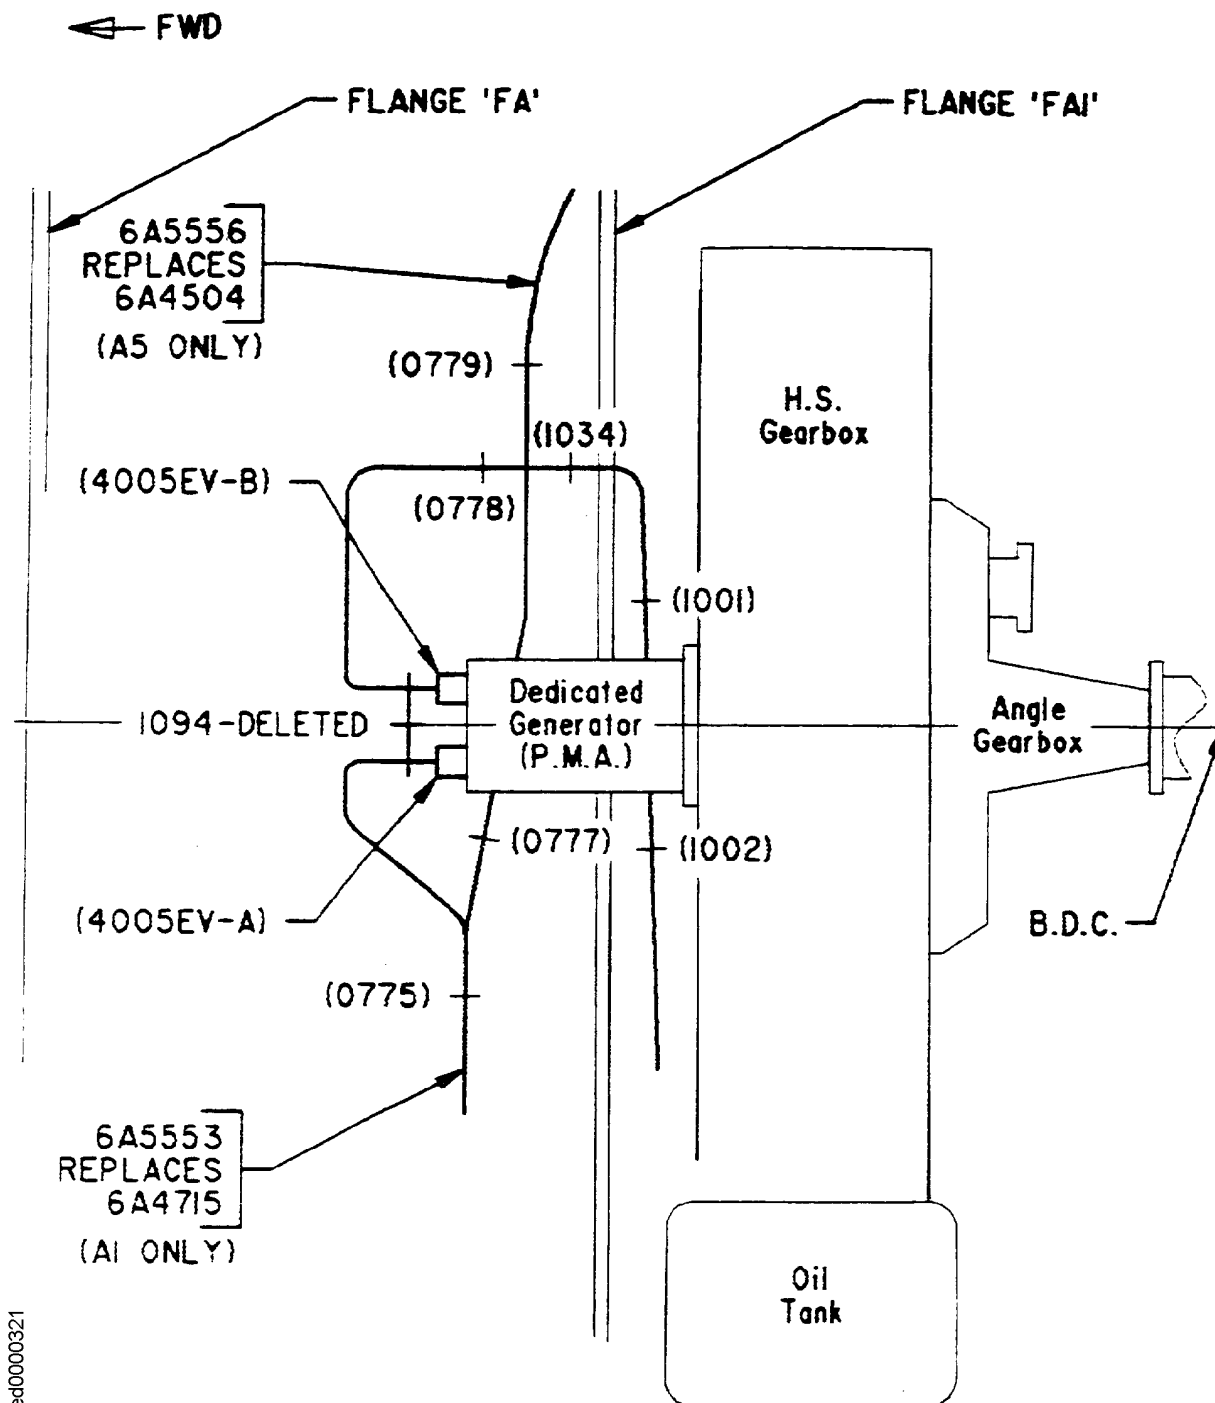
Schematic view of fan harness showing location of deleted clipping position 1094  
Fig.3

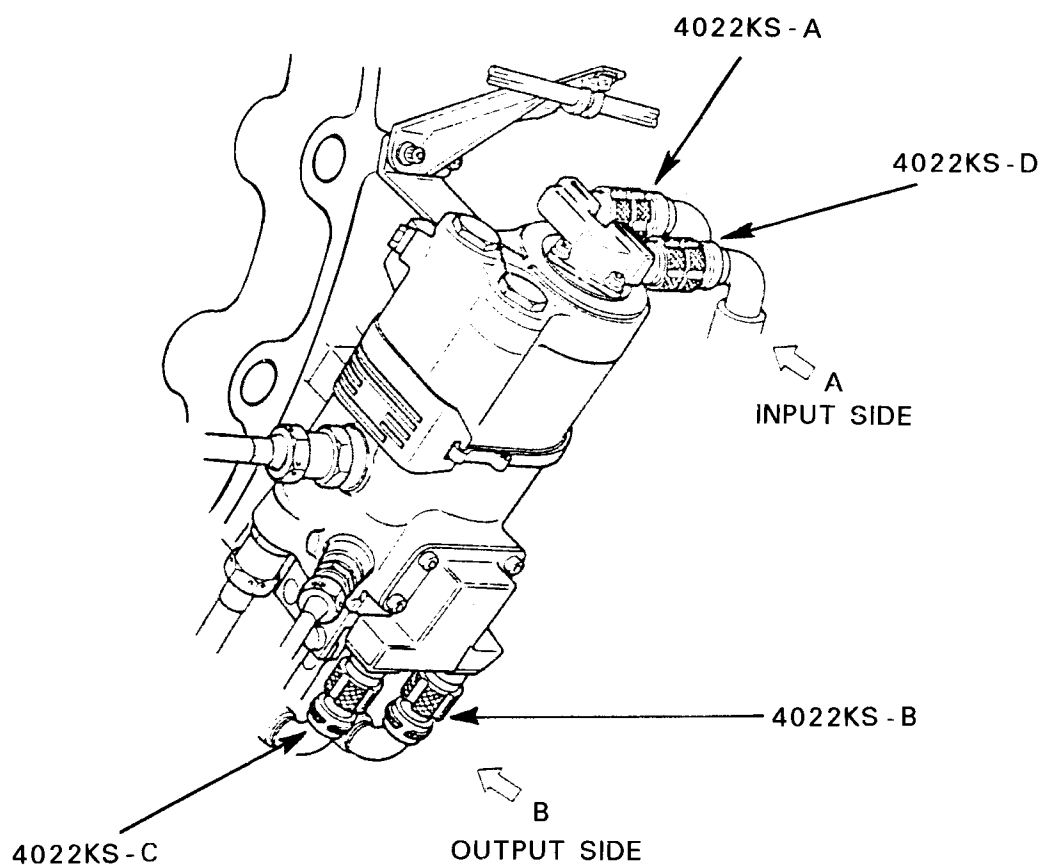
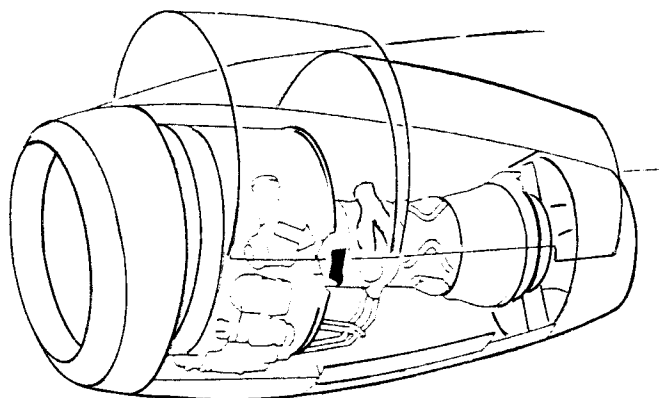
View showing VSVA connectors  
Fig.4

CONNECTOR	TORQUE TIGHTEN TO
4022KS -A	12lbf/ins
4022KS -B	8lbf/ins
4022KS -C	8lbf/ins
4022KS -D	12lbf/ins

- (1) Install the input and output side connectors to the VSVA and tighten the retaining collar on each connector to the required torque value. Refer to Figure 4.
- (2) Install the connectors to the PMA and tighten the retaining collar on each connector as instructed in the Aircraft Maintenance Manual, TASK 73-22-38-400-010, SUBTASK 73-22-38-430-401.
- (3) Safety the four VSVA connectors and the two PMA connectors with CoMat 02-126 lockwire, as instructed in the Aircraft Maintenance Manual, TASK 70-40-11-911-012, Example 22.
