POWER PLANT - RELAY BOX - MOUNTING BRACKET WITH INCREASED HEIGHT SUPPORTS AND ALTERED CLIPPING LUGS - CATEGORY CODE A5 MODEL:6 - CATEGORY CODE A1 MODEL:7 - MOD.ENG-71-0113

V2500-ENG-71-0113

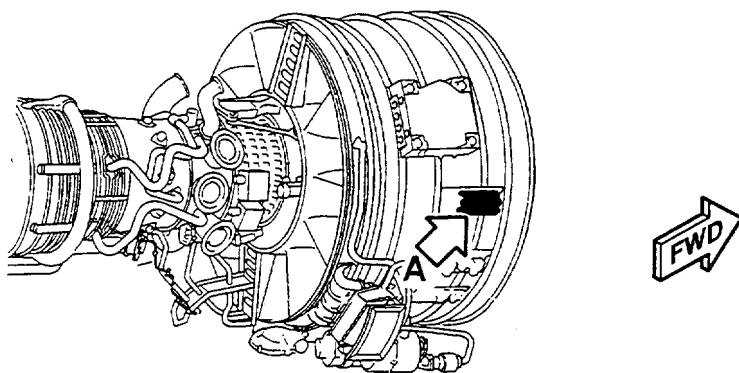
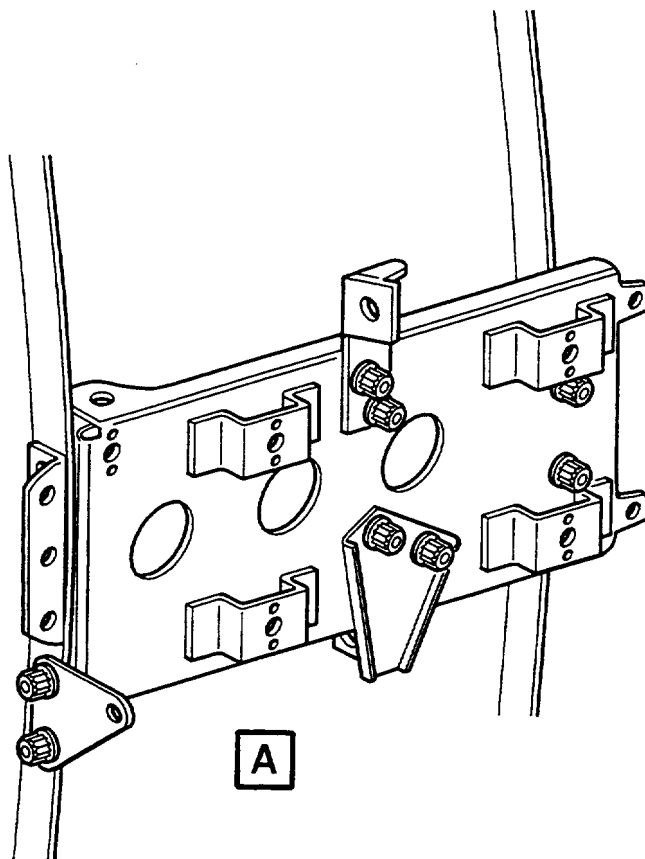
Location of relay box support bracket
Fig.1

During build of the V2500-A5 first production engine it was highlighted that the clearance between the two harness retaining clips supported from lugs on the relay box mounting bracket and the fan case was limited.

Install the new 6A5626 relay box mounting bracket to the fan case by the approved procedures in the Engine Manual, 72-00-32, Installation (Refer to Figure 1 and 1.K. (2)).

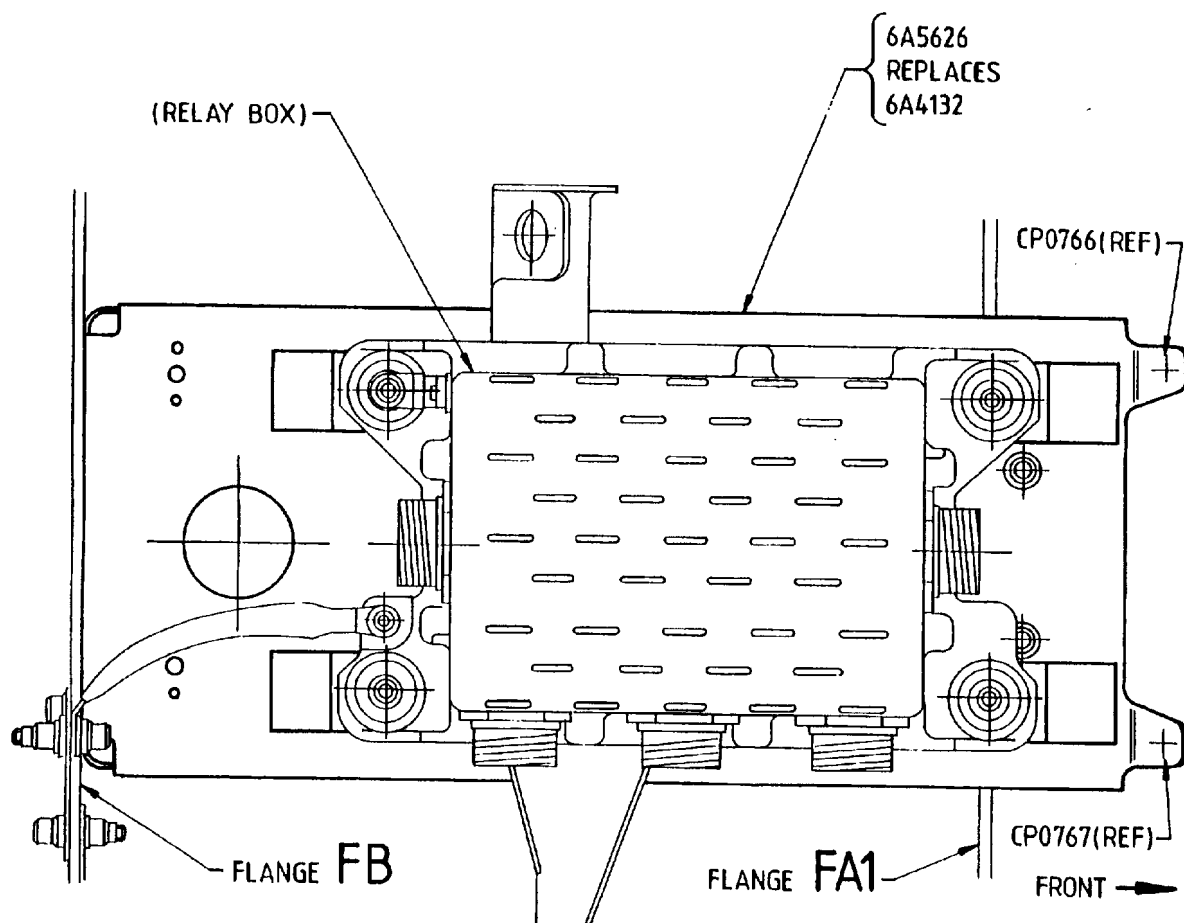
Relay box support bracket - before and after alteration
Fig.2

A possible interface condition between the clips and the fan case has been reported on engine build of the V2500-A5.

The four bracket supports are increased in height by 0.314 in. (8 mm). The clipping lugs (for CP 0766 and CP 0767) are set at an angle of 25 degrees minimum instead of 20 degrees minimum.

A new relay box mounting bracket is introduced.
