POWER PLANT - VARIOUS - TO ANNOUNCE THE INTRODUCTION OF MODIFIED SUPPORT BRACKETS AND MOUNTING RAFTS ON THE FAN CASE - CATEGORY CODE 6 - MOD.ENG-71-0114

V2500-ENG-71-0114

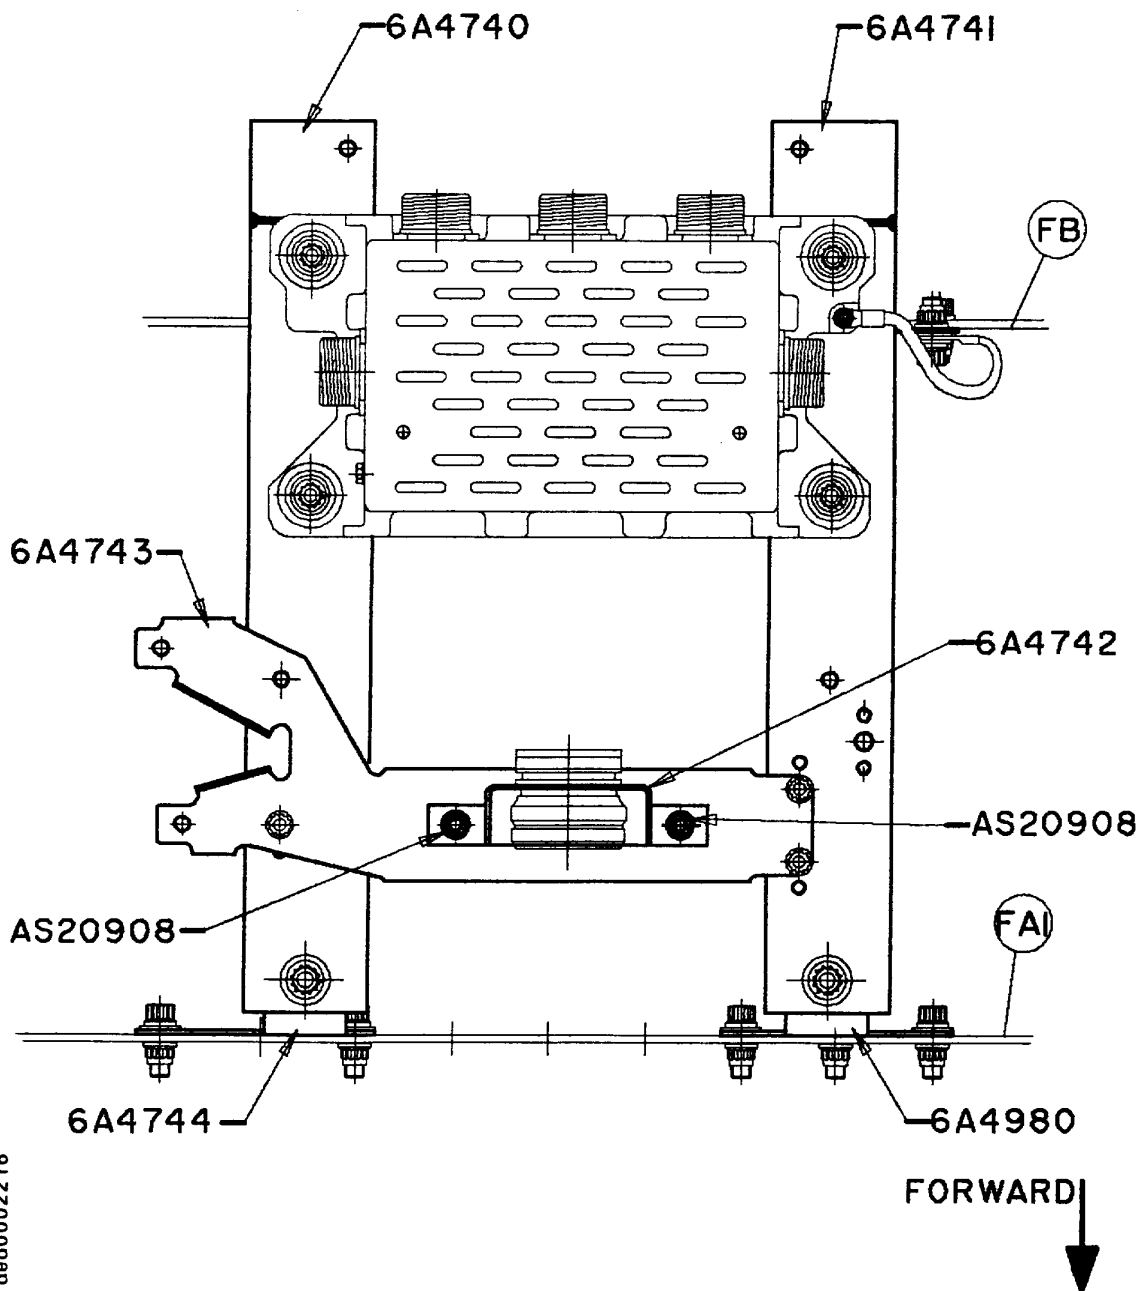
View AB (Figure 2) - Relay box mounting bracket (Rotated thru 90 degrees for convenience) - Before alteration
Fig.3

- (a) The clearance between the mounting rafts of the high energy igniter relay box and two tubes which are routed below it is not sufficient.
- (b) Vibration of the disconnect bracket of the harness loom which is bolted to a cross-raft supported from the relay-box mounting rafts, has been found.
- (c) The clearance between the mounting bracket of the oil scavenge-filter pressure-switch and adjacent tubes is not sufficient.
- (d) The securing bolt of the filter cover for the fuel cooled oil cooler (FCOC) nearest to the fan case flange cannot be removed until adjacent bracketry is removed.
- (e) The clip support brackets located at the left hand side and right hand side bifurcation box fire and fume seal have 0.250 in. mounting holes. The securing bolts (and bifurcation box anchor nuts) are 0.190 in. diameter.
