## SERVICE BULLETIN

POWER PLANT - BRACKETS AND RACEWAYS, HARNESS SUPPORT, FAN - INTRODUCTION OF MODIFIED  
SUPPORT BRACKET AND SPACER FOR HARNESS RACEWAY ADJACENT TO EEC - CATEGORY CODE 6 -  
MOD.ENG-71-0116

V2500-ENG-71-0116

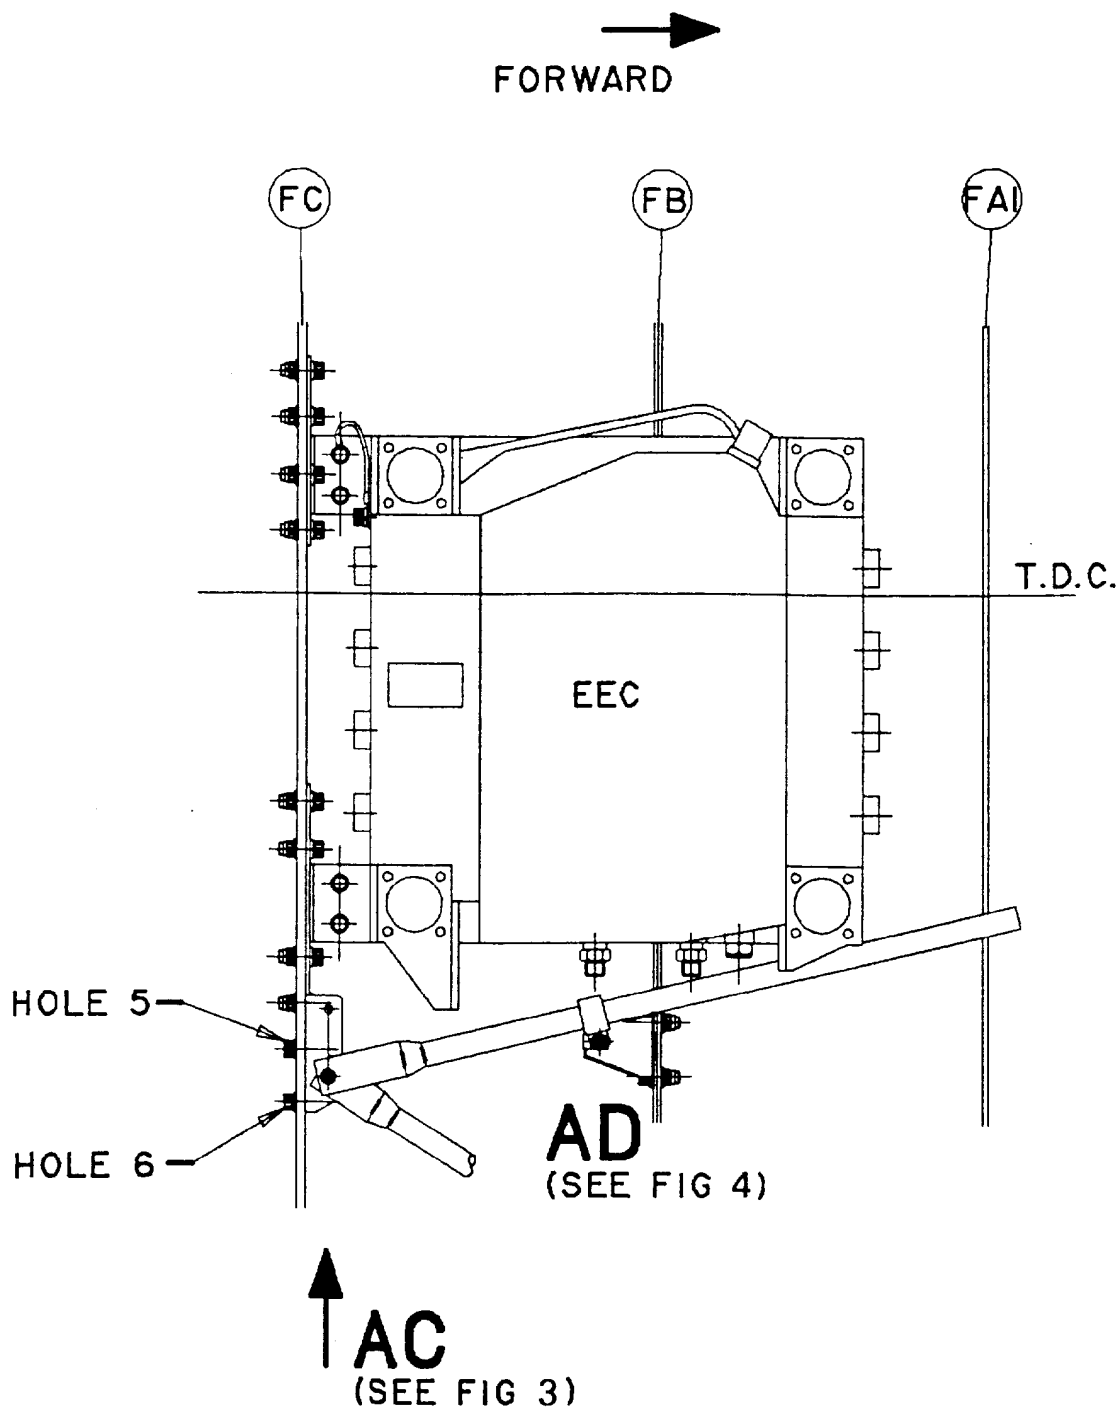
Enlarged view at AB - Position of support brackets of harness raceway - Before and after alteration  
Fig.2

- (1) A 0.200 in. (5 mm) aluminium spacer and longer bolt at clip point 2277.
- (2) A raceway support bracket with a decrease in height at flange FB and with the clipping hole for clip point 2432 in a different position.

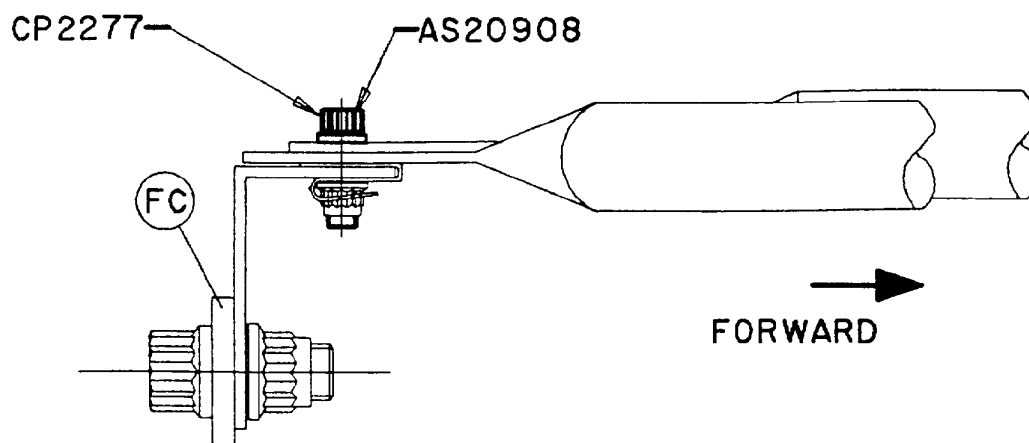
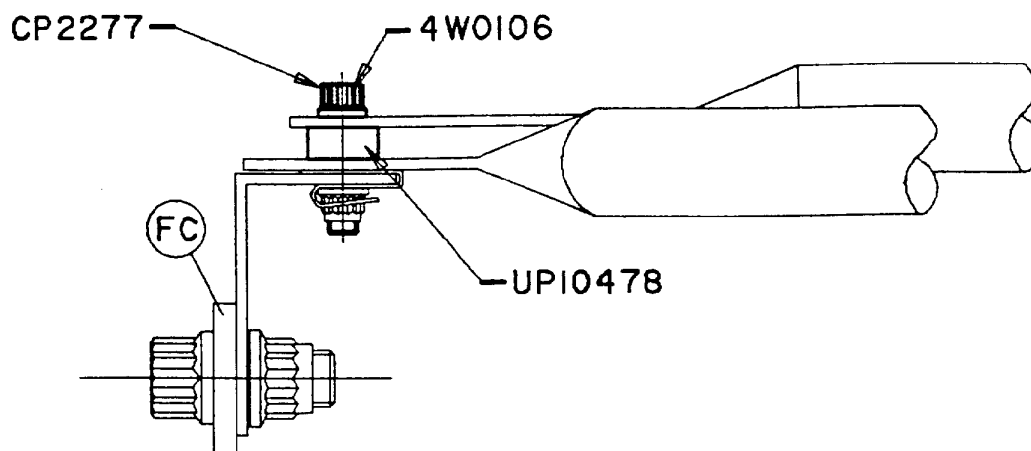
VIEW ON ARROW **AC**  
BEFORE ALTERATION

VIEW ON ARROW **AC**  
AFTER ALTERATION

Enlarged view at AC - Support bracket of harness raceway - Before and after alteration  
Fig.3

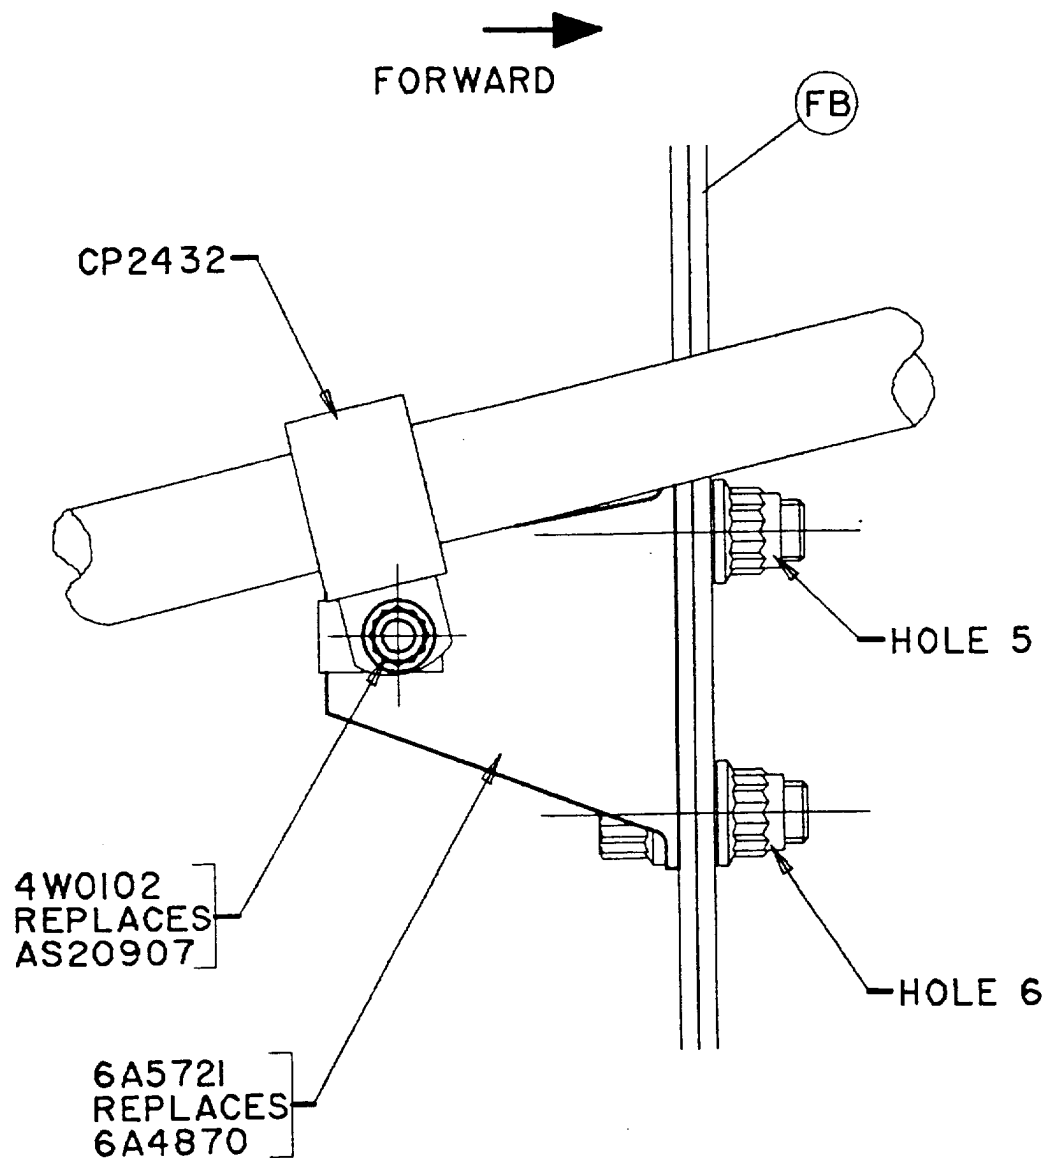
VIEW AT **AD**

Enlarged view at AD - Support bracket of harness raceway - Before and after alteration  
Fig.4
