ENGINE - POWER PLANT - REVISED CLIPPING TO PROVIDE INCREASED CLEARANCE BETWEEN OIL  
QUANTITY TRANSMITTER AND EEC HARNESS - CATEGORY CODE 6 - MOD.ENG-71-0118

V2500-ENG-71-0118

International Aero Engines

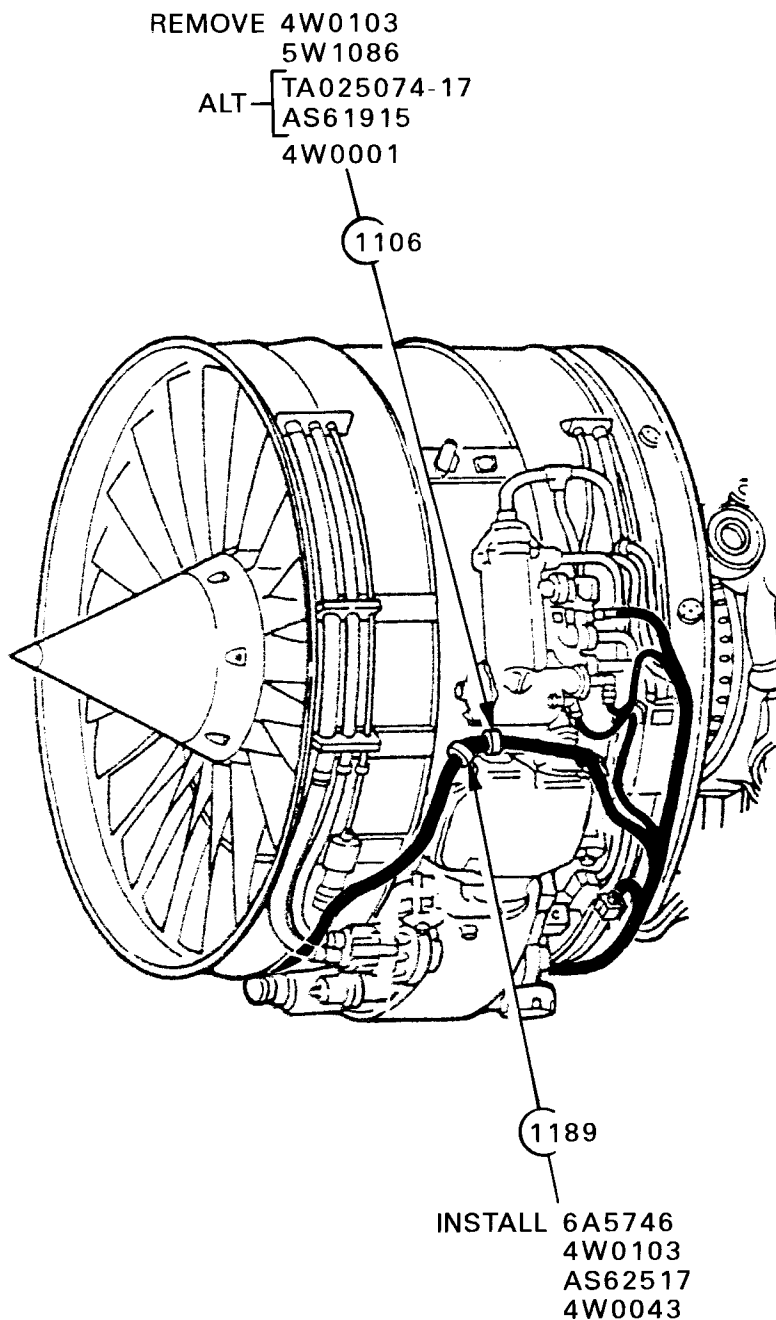
The EEC, general services and ignition supply harness bundle which was clipped from an oil tube lug at Clip Point 1106 is now clipped to a new bracket at Clip Point 1189. The bracket is secured by 2 of the oil quantity transmitter attaching bolts.

. Location of clip point 1106 and new clip point 1189  
Fig 1

- (1) Remove the bolt, washer, clip and nut from clipping point 1106. Refer to Figures 1, 3 and 4.
- (2) Remove the two oil quantity transmitter securing bolts adjacent to the EEC, general services and ignition supply harness bundle.
- (3) Install the new 6A5746 bracket onto the oil quantity transmitter using the two bolts removed at step (2). Refer to figures 5 and 6.
- (4) Torque the bolts to 100 lbfin (11,3 Nm).
- (5) Attach the EEC, general services and ignition supply harness bundle to the 6A5476 bracket at clipping point 1189 using the 4W0103 bolt, AS62517 clip and 4W0043 clip nut. Refer to Figures 5 and 7.
- (6) Torque the bolt at clipping point 1189 to 36 to 45 lbfin (4 to 5 Nm).

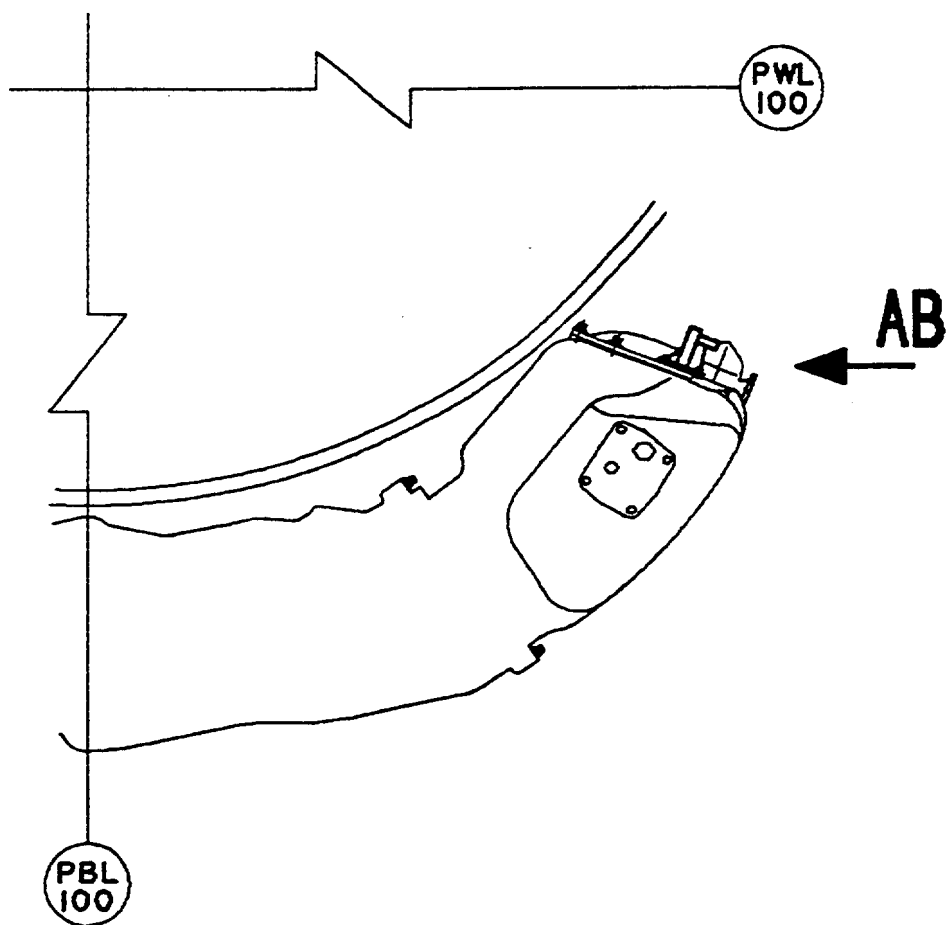
. View looking rearwards on oil quantity transmitter  
Fig 2

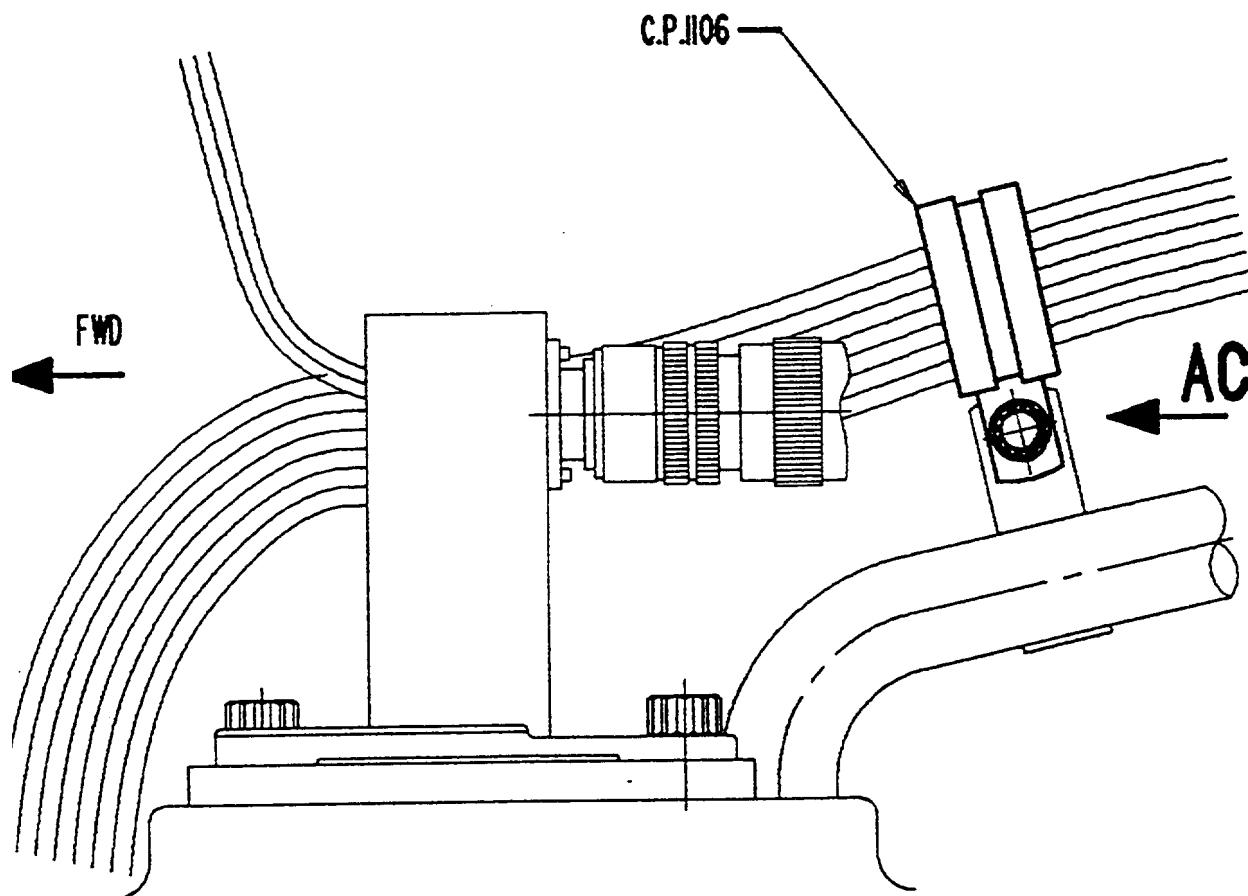
It has been reported that there is insufficient clearance between the oil quantity transmitter electrical connector backshell and the adjacent harness looms.

View on arrow AB showing harness location - Before alteration  
Fig.3

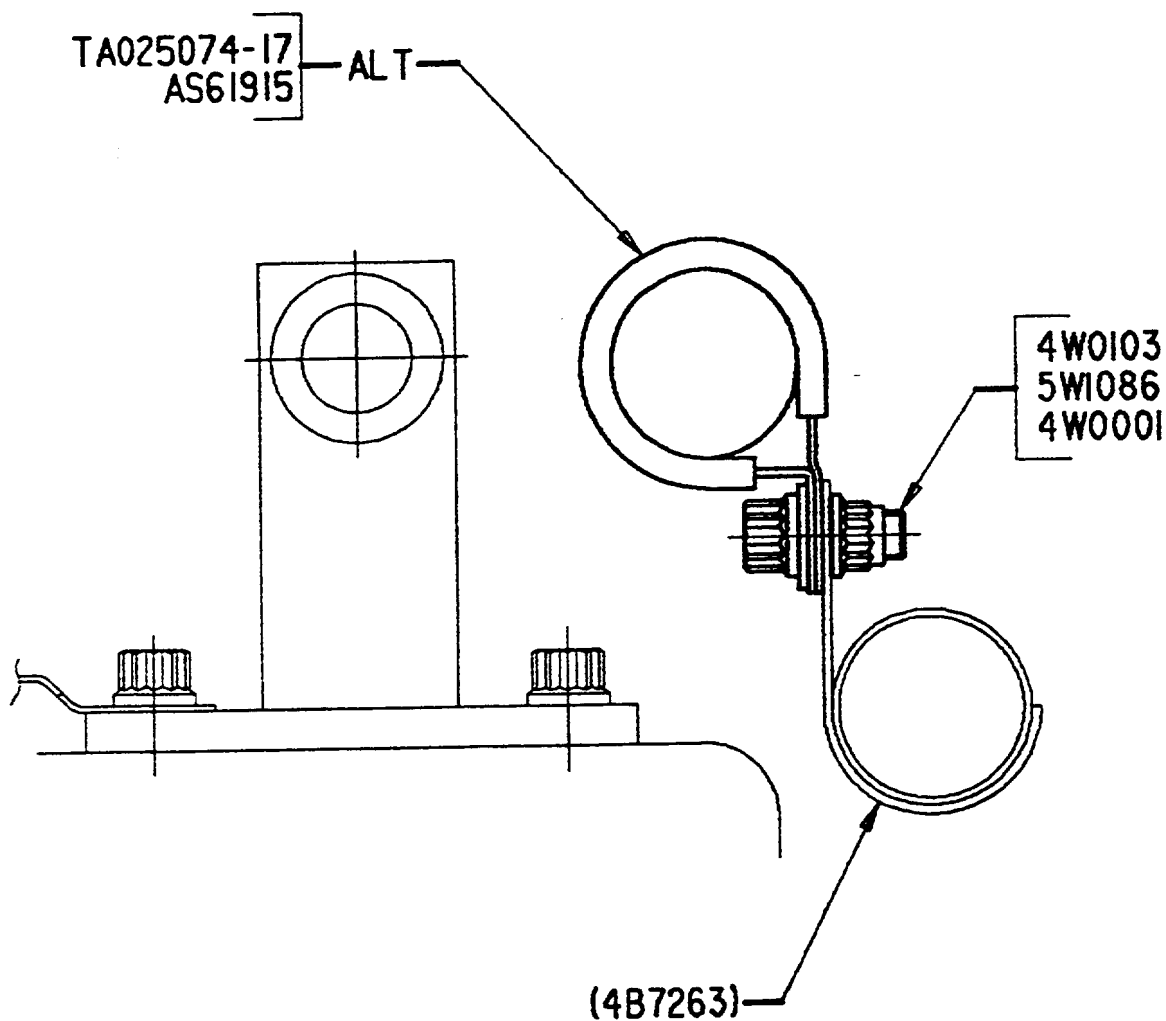
View on arrow AC - Before alteration  
Fig.4

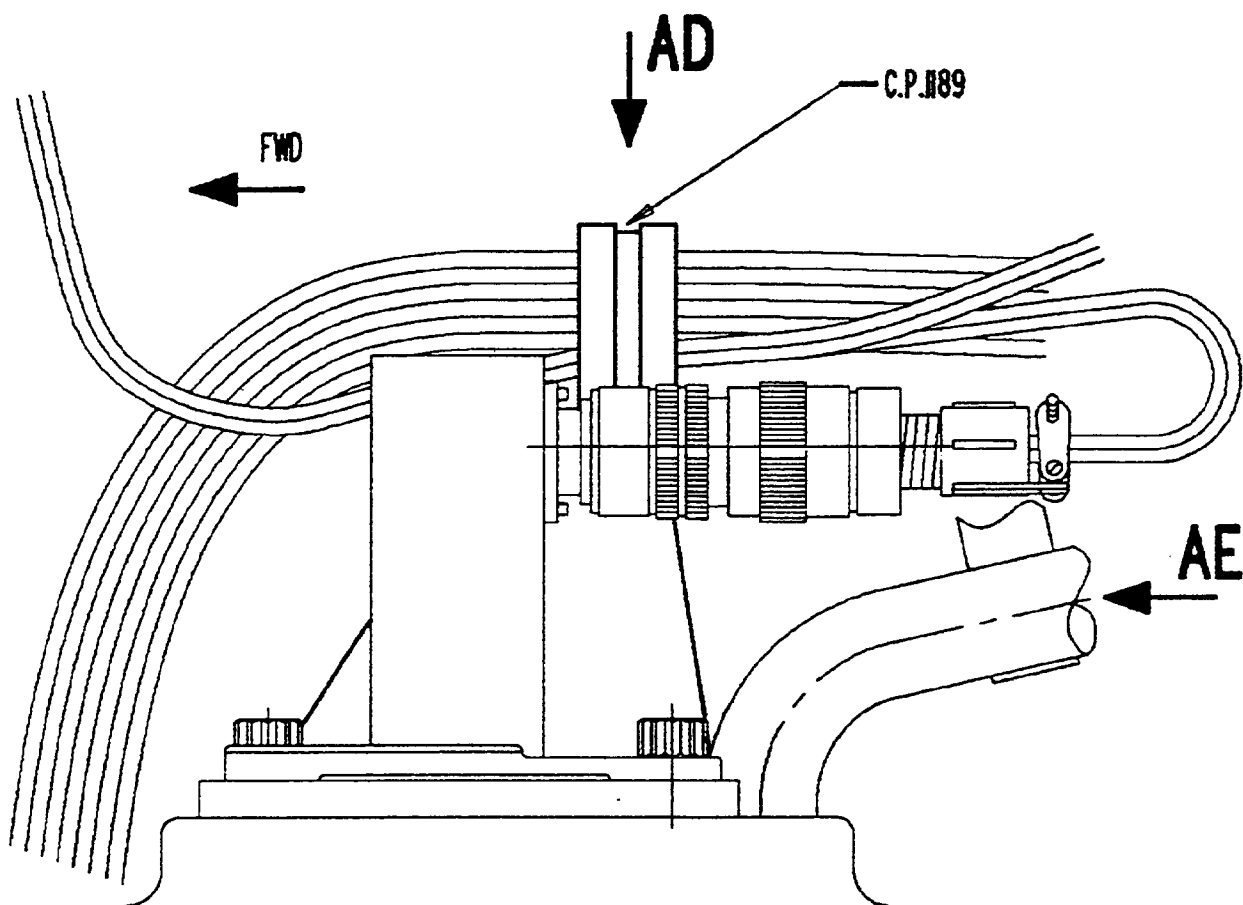
View on arrow AB showing harness location - After alteration  
Fig.5

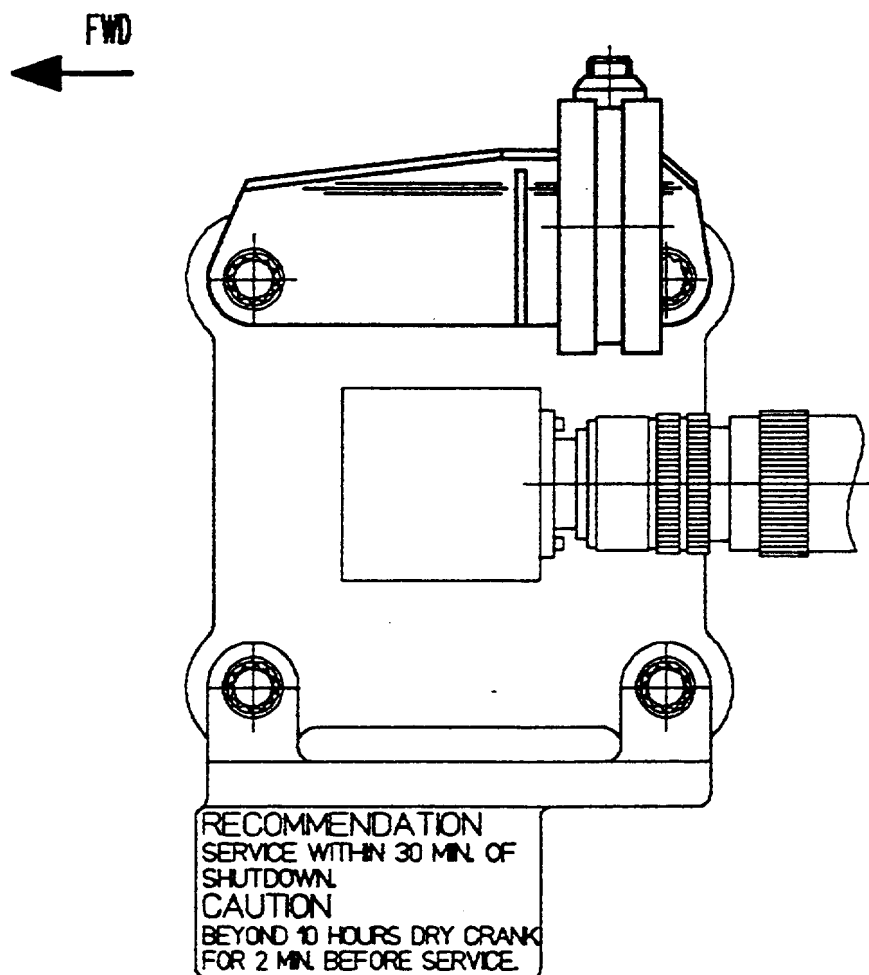
View on arrow AD showing location of new bracket - After alteration  
Fig.6

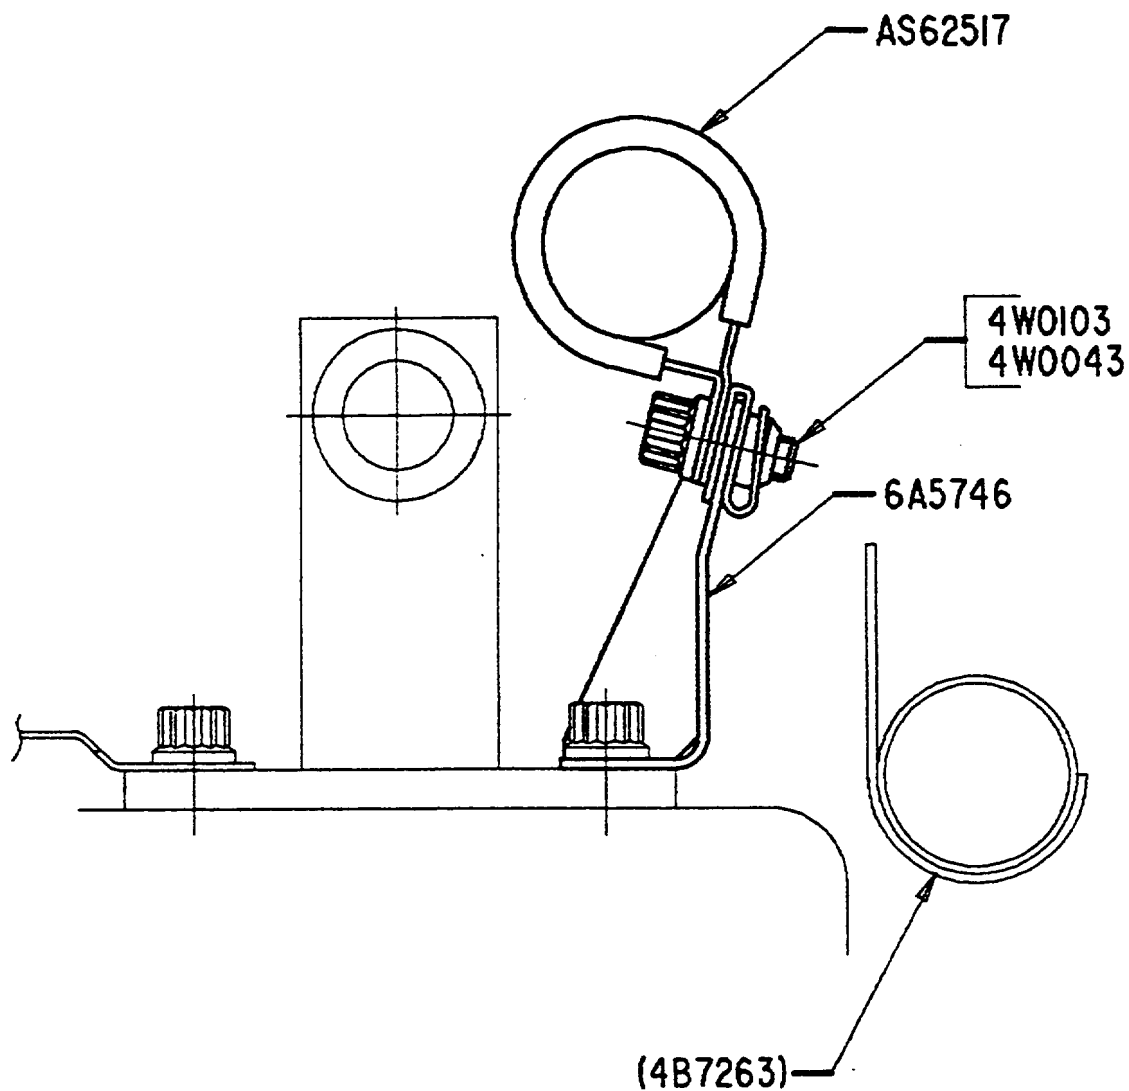
View on arrow AE - After alteration  
Fig.7
