# International Aero Engines SERVICE BULLETIN

Subject: Transmittal of Revision 1 to Service Bulletin No. V2500-ENG-71-0119

## V2500-ENG-71-0119

ENGINE - POWER PLANT - INTRODUCE REVISED EEC HARNESS  
CLIPPING TO PROVIDE SUFFICIENT CLEARANCE BETWEEN  
HARNESS AND FLANGE FD IN AREA ADJACENT TO EEC

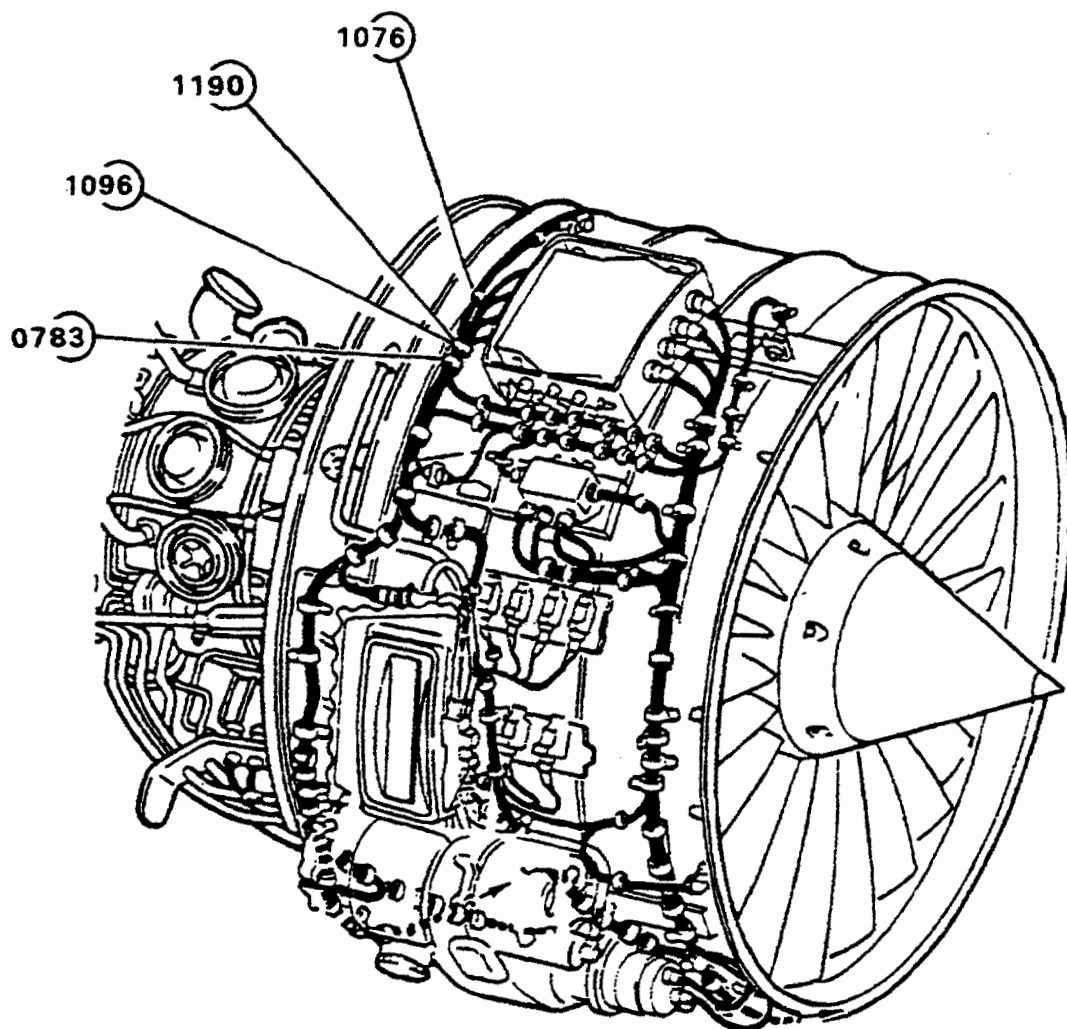
Figure 1

Location of clipping points 0783, 1076,  
1096 and 1190

- (1) The EEC harness is re-clipped between clip points 0796 and 1075.
- (2) Clip points 0783 and 1076 are altered, clip point 1096 is deleted and clip point 1190 is added.
- (3) The brackets at clip points 0783, 1076 and 1096 are deleted and three new brackets are added at clip points 0783, 1076 and 1190.

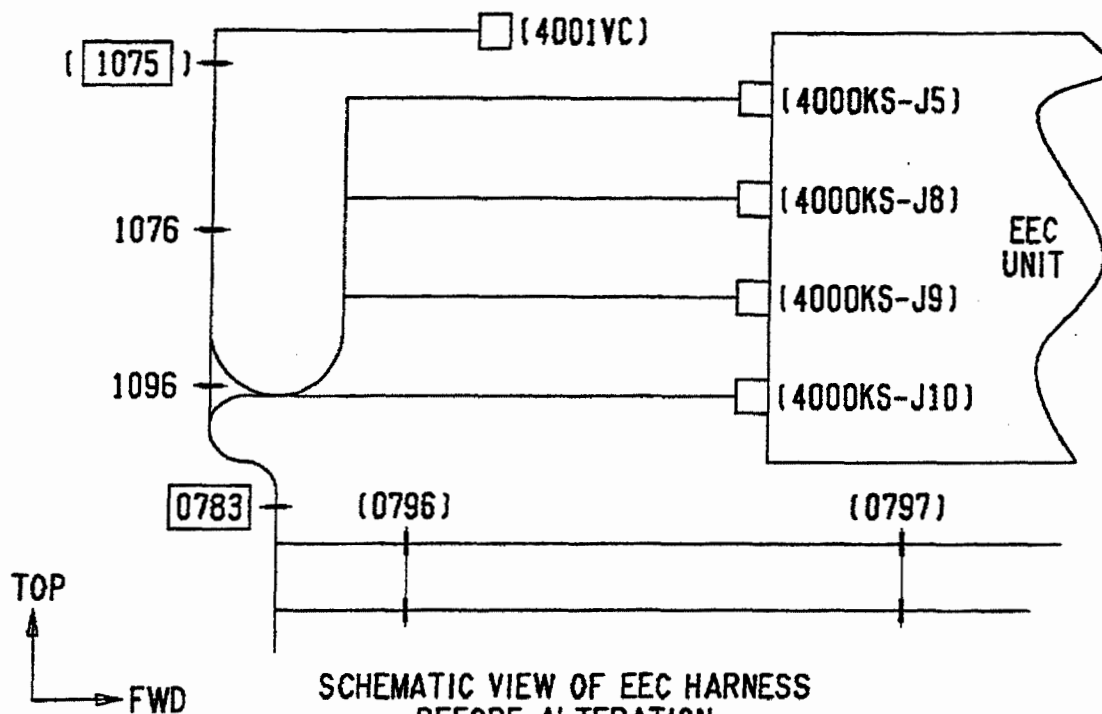
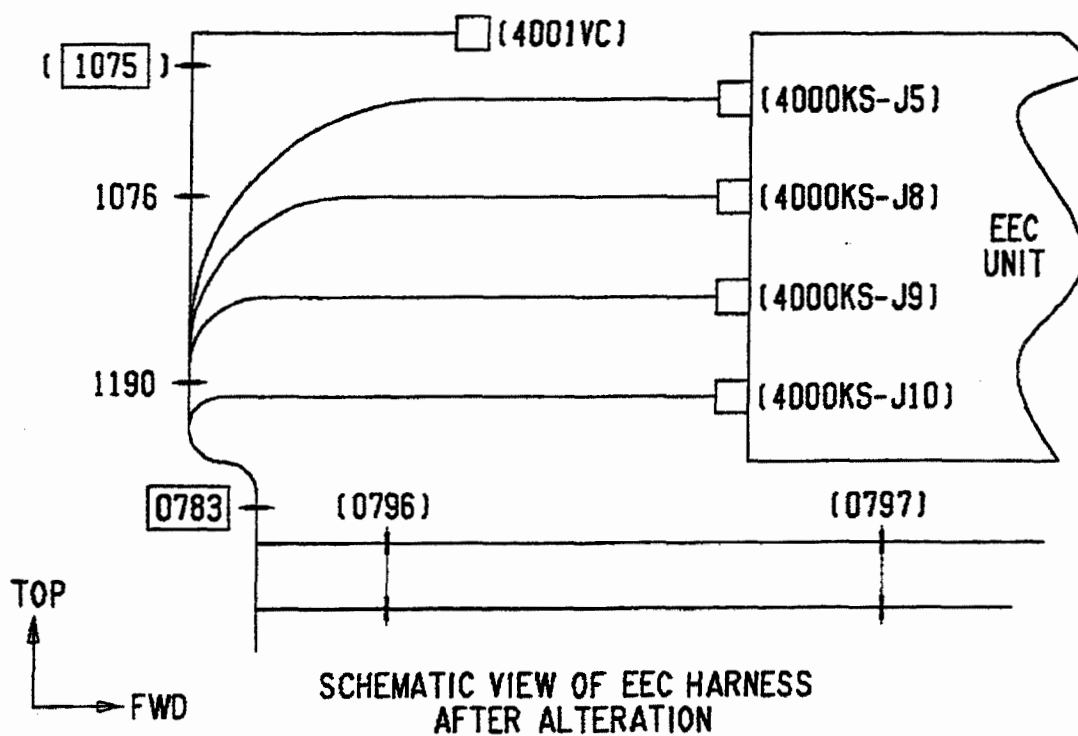
Schematic view of EEC harness  
- Before and after alteration

- (4) Install the ignition supply harness and EEC harness to the 6A5743 bracket at clipping point 0783 using the new 4W0102 bolt, AS62521 clip and existing 4W0043 clipnut. Discard the existing 5W1086 washer. Torque the bolt to 36 to 45 lbfin (4 to 5 Nm). Refer to Figure 2 and Figure 3.

- (5) Install the ignition supply harness and EEC harness to the 6A5740 bracket at new clipping point 1190 using the 4W0103 bolt, AS62519 clip and 4W0043 clipnut. Torque the bolt to 36 to 45 lbfin (4 to 5 Nm). Refer to Figure 2 and Figure 5.

- (6) Install the ignition supply harness and EEC harness to the 6A5742 bracket at clipping point 1076 using the new 4W0102 bolt, AS62507 clip and 4W0043 clipnut. Discard the existing 5W1086 washer. Torque the bolt to 36 to 45 lbfin (4 to 5 Nm). Refer to Figure 2 and Figure 4.

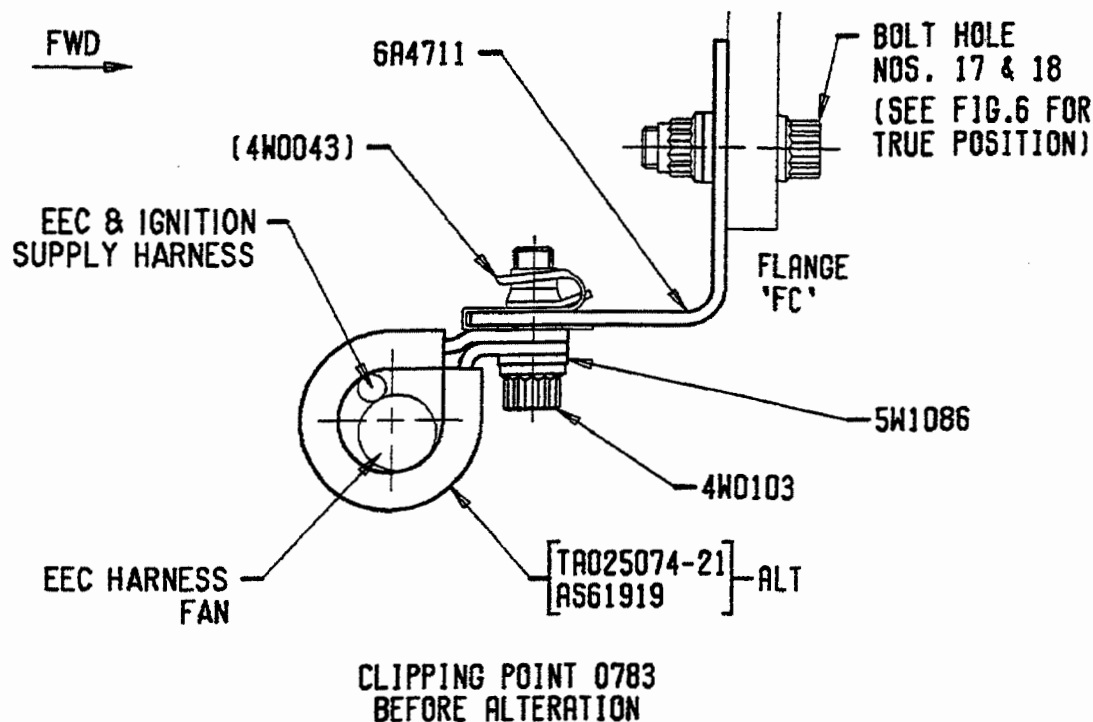
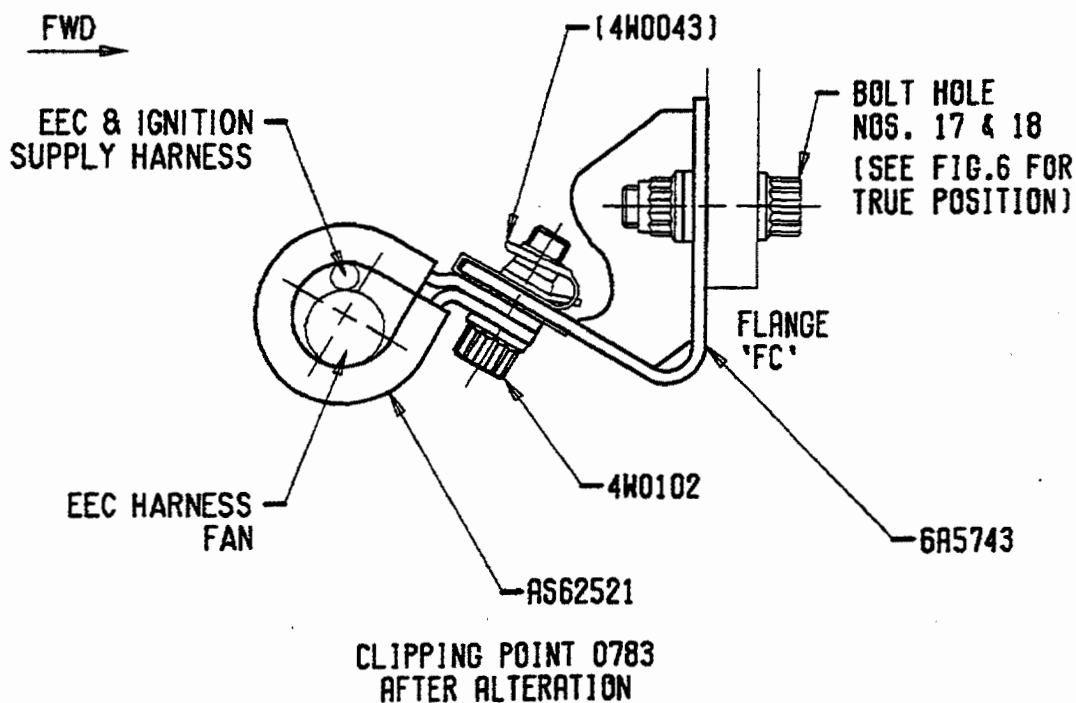
Clipping point 0783  
- Before and after alteration

- (1) Install the new 6A5743 bracket to the fan case flange 'FC' at bolt holes 17 and 18 by use of approved procedures, Engine Manual, TASK 72-00-32-420-001-A00 or TASK 72-00-32-420-001-B00. Refer to Figure 3 and Figure 6.

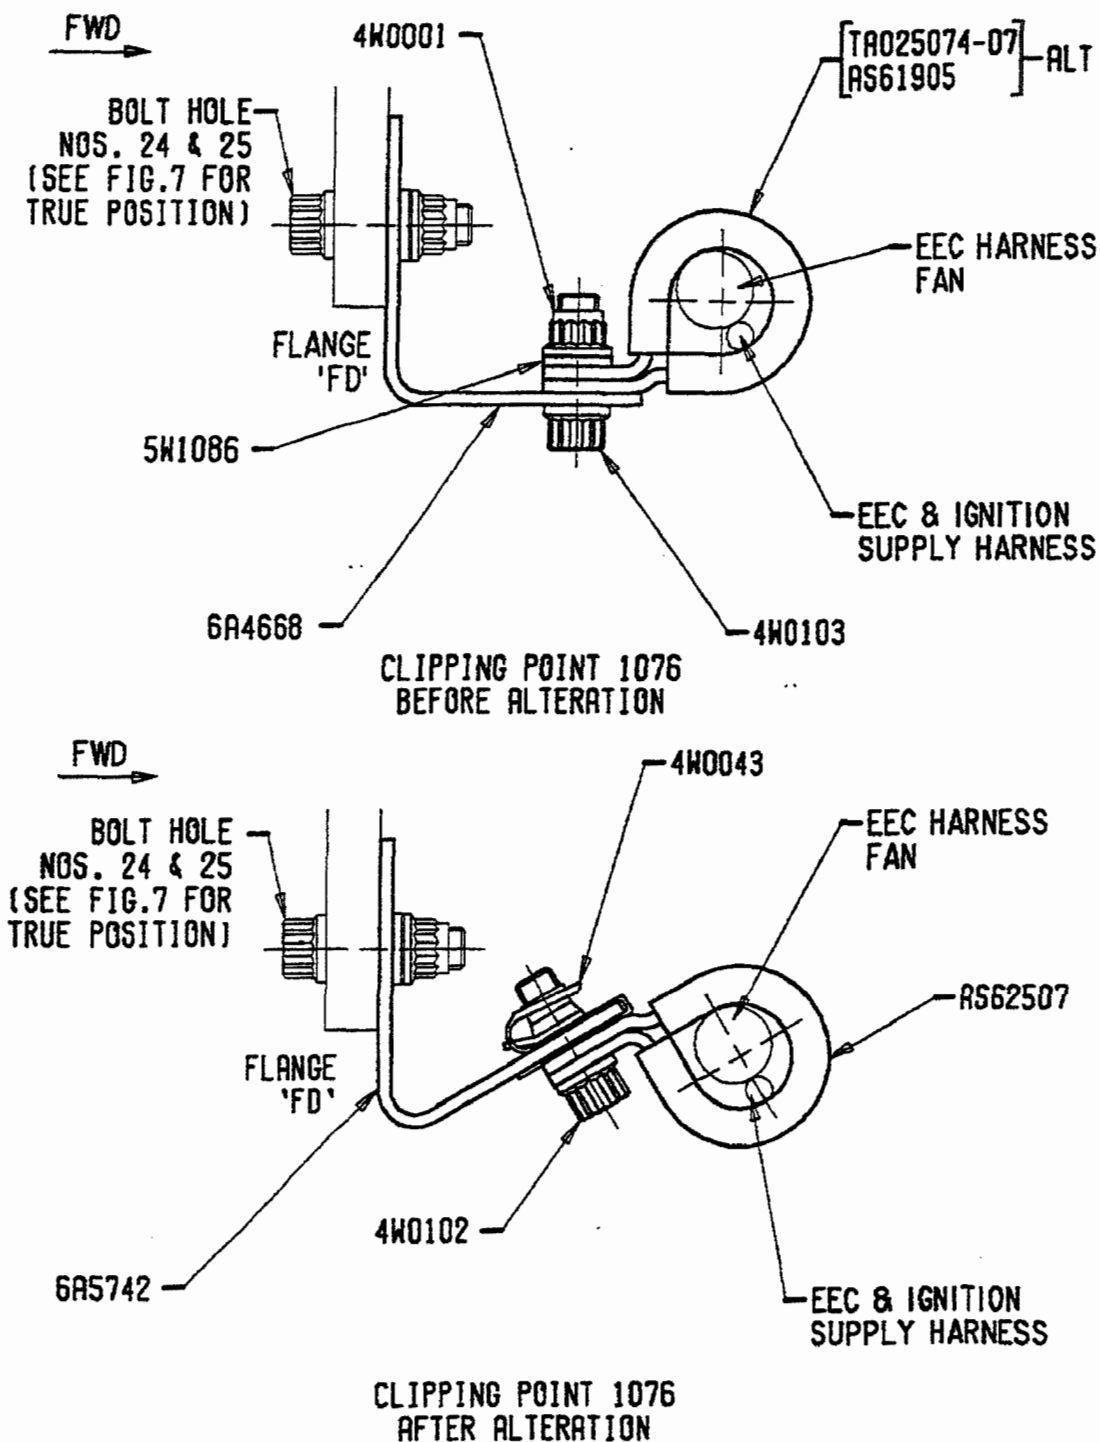
Clipping point 1076  
- Before and after alteration

- (2) Install the new 6A5742 bracket to the fan case flange 'FD' at bolt holes 24 and 25 by use of approved procedures, Engine Manual, TASK 72-00-32-420-001-A00 or TASK 72-00-32-420-001-B00. Refer to Figure 4 and Figure 7.

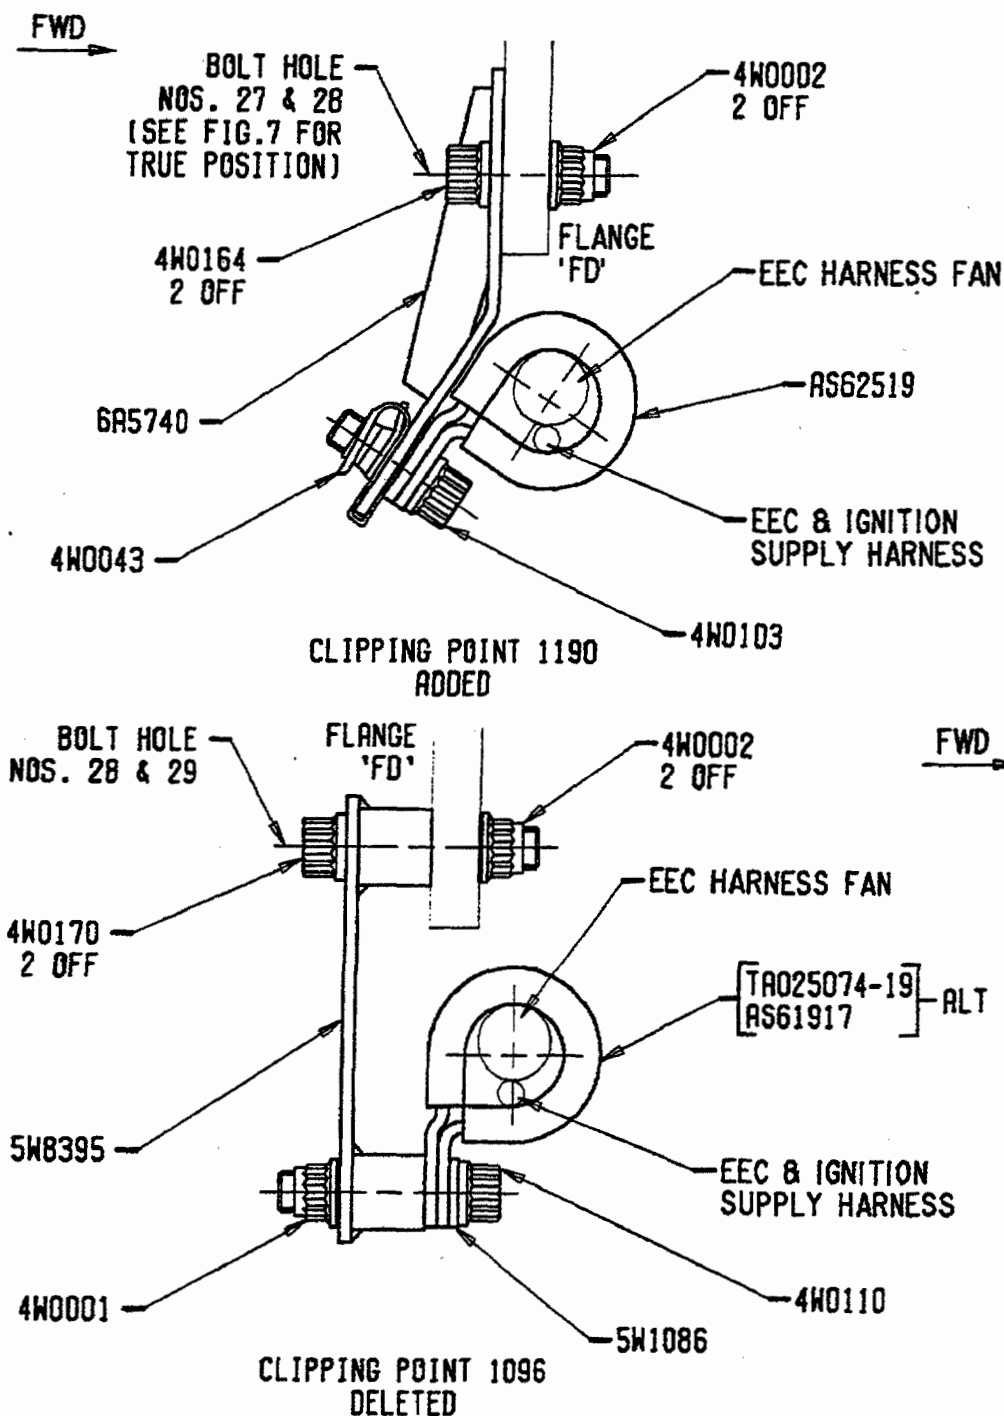
New clipping point 1190 and deleted clipping point 1096

- (3) Install the new 6A5740 bracket to the fan case flange 'FD' at bolt holes 27 and 28 using the 4W0164 bolts (2 off) and 4W0002 nuts (2 off). Torque the nuts to 85 to 105 lbfin (10 to 12 Nm). Refer to Figure 5 and Figure 7.

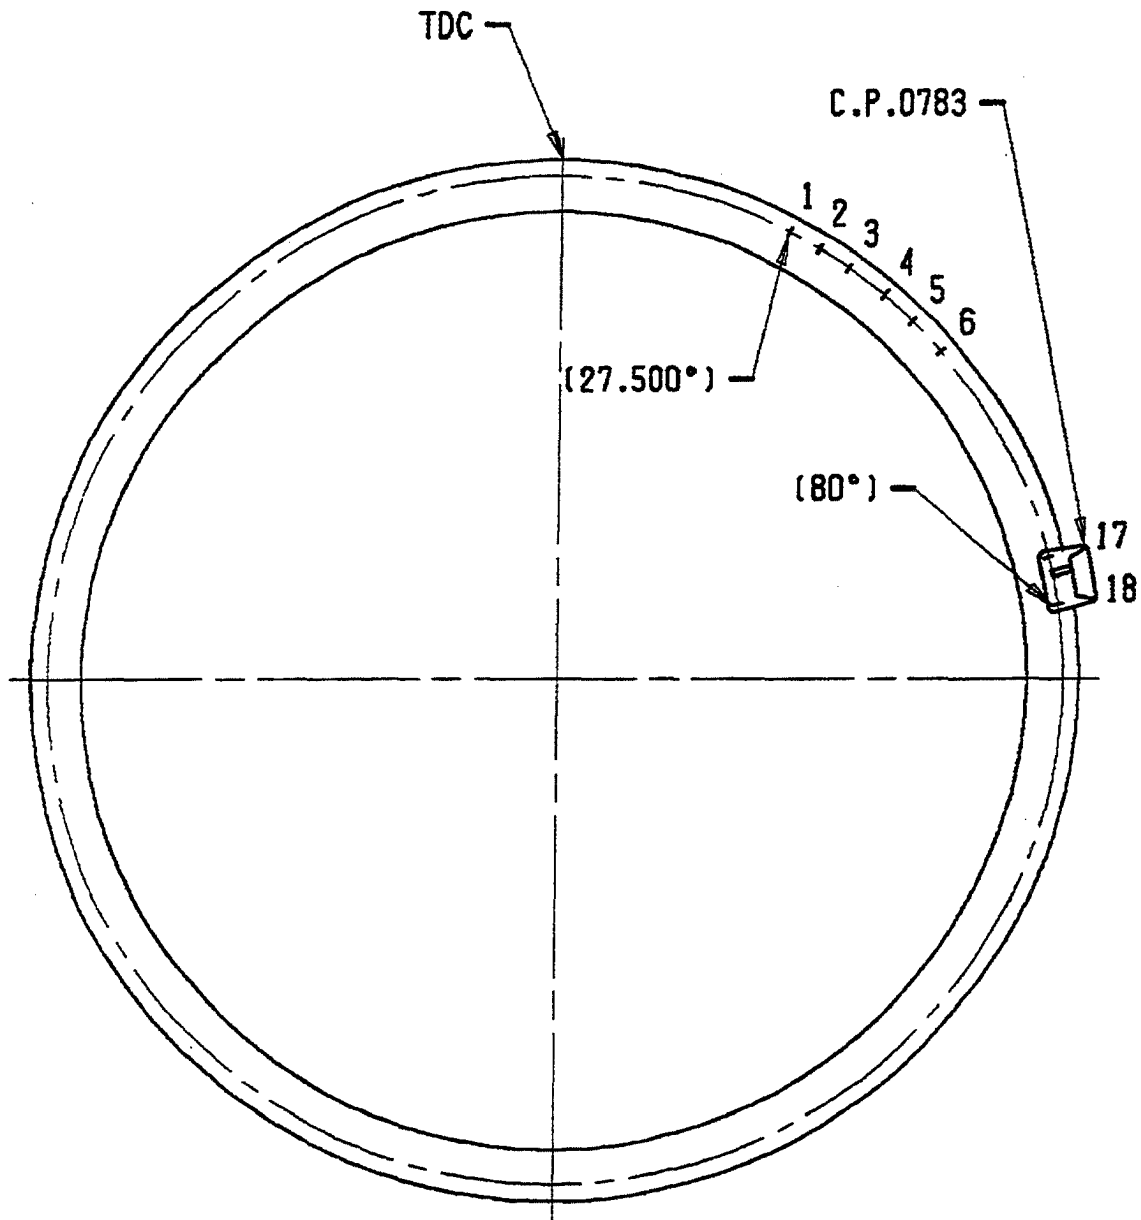
**Figure 6**

**Flange FC (looking forward)**

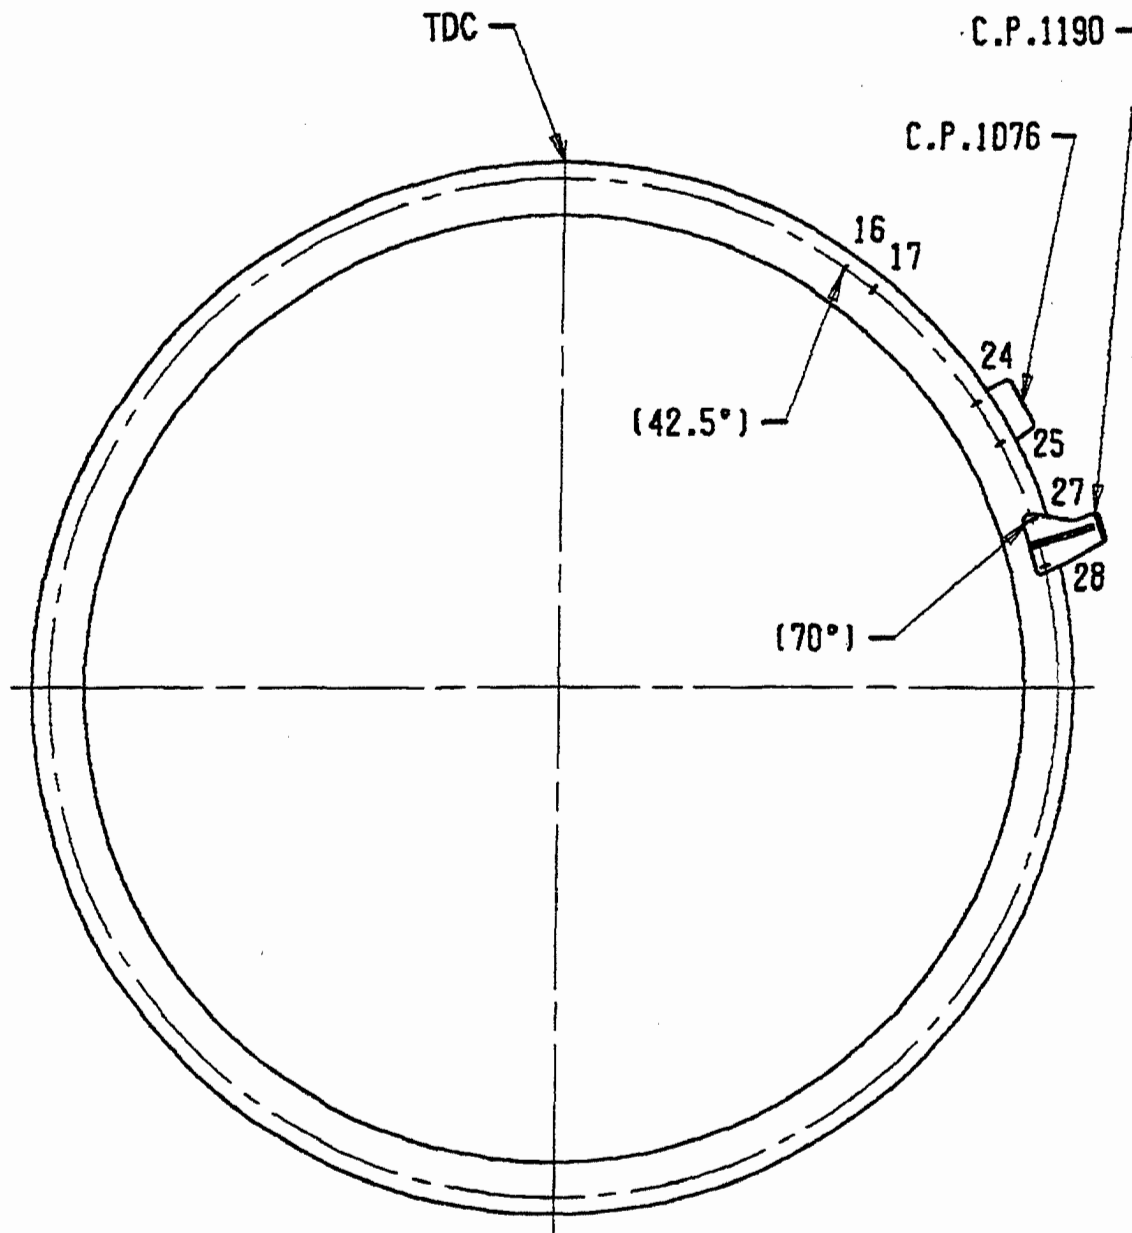
**Figure 7**

**Flange FD (looking forward)**
