POWER PLANT - ENGINE - REROUTE THE CORE HARNESS TO ENSURE ADEQUATE CLEARANCE BETWEEN THE HARNESS AND VARIOUS TUBES - CATEGORY CODE 6 - MOD.ENG-71-0120

V2500-ENG-71-0120

SERVICE BULLETIN

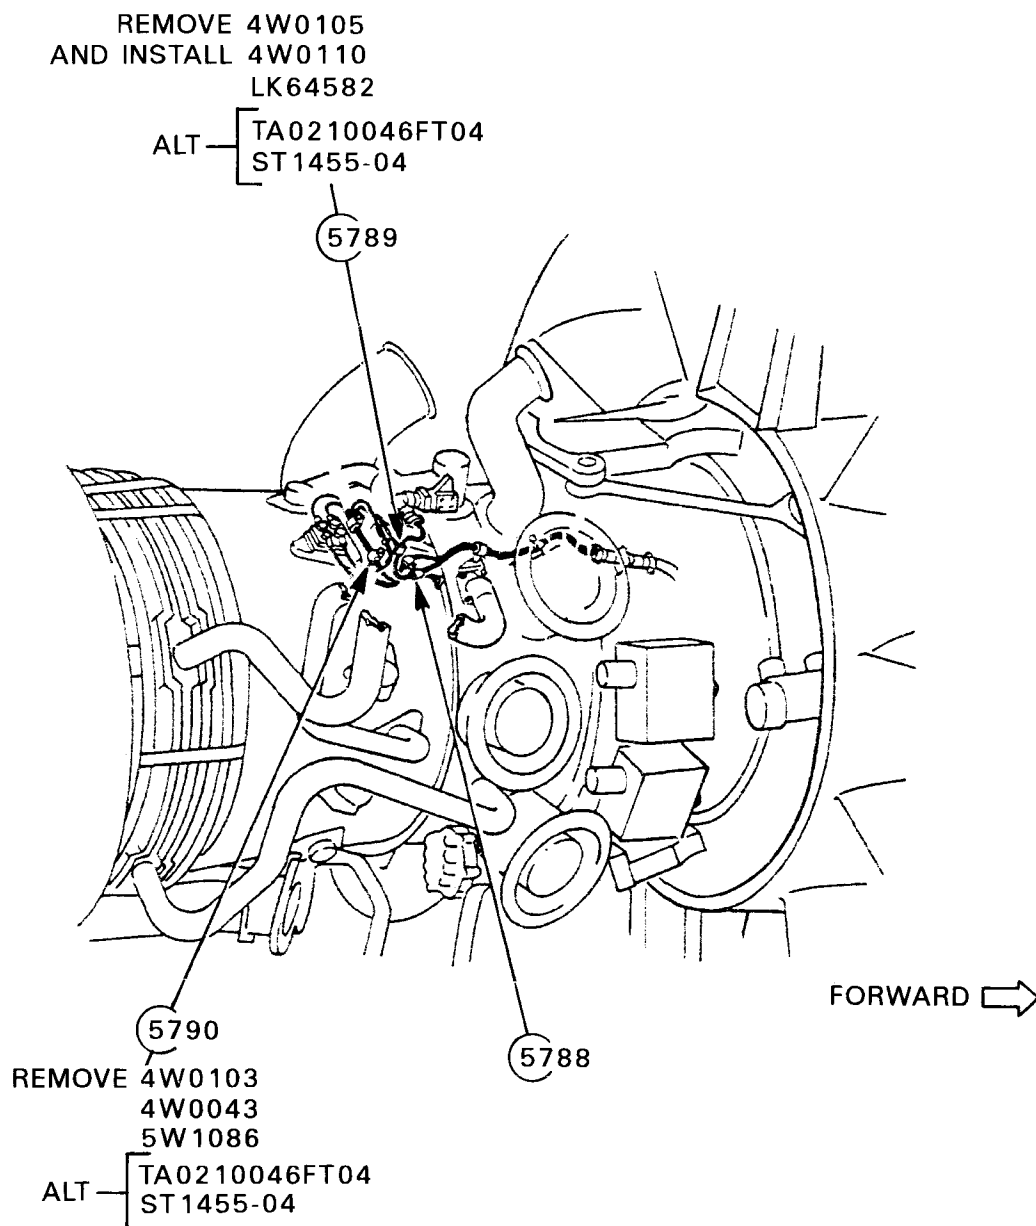
Location of clip points 5788, 5789 and 5790
Fig.1

- (1) Disassemble clipping point 5790. Discard the bolt, the washer and the nut, but keep the TA0210046FT04 or ST1455-04 clip. Refer to Figure 1 and Figure 4.

- (2) Disassemble clipping point 5789. Discard the 4W0105 bolt but keep the remaining parts. Refer to Figure 2 and Figure 3.
- (3) Disassemble clipping point 5788 sufficiently to remove the two limbs of the 6A4719 harness. Move the two harness limbs so that they go into the opposite clips. Assemble clipping point 5788 with the 6A4719 harness limbs in their new positions using the existing clipping point components. Refer to Figure 1 and Figure 2.

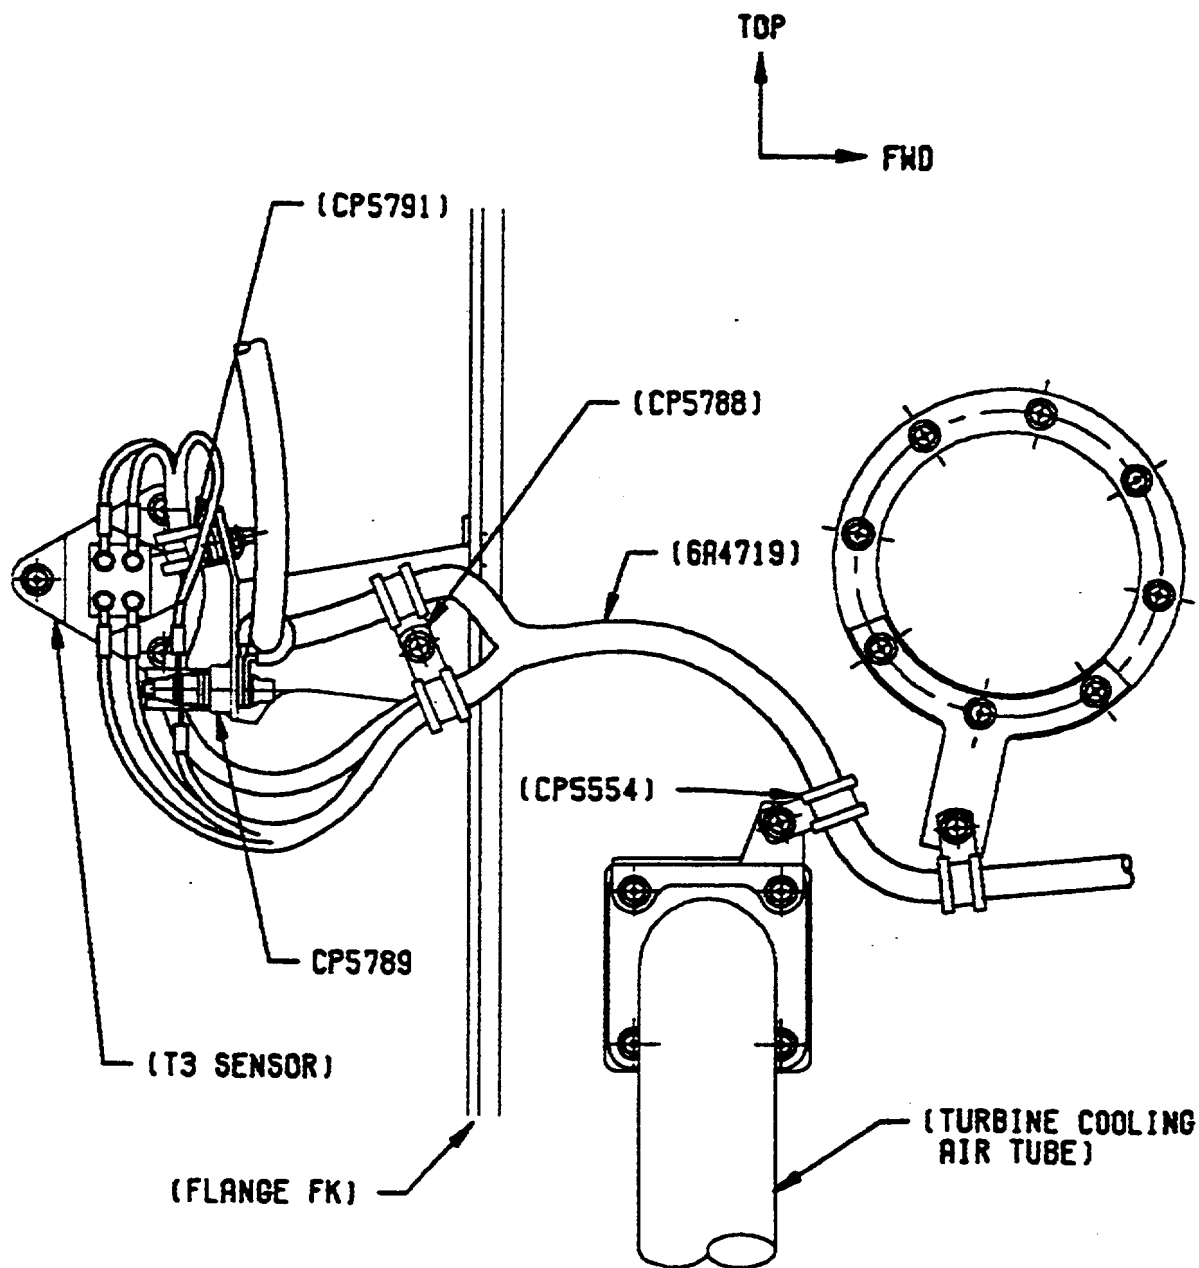
View on EEC link harness in the region of the T.3. sensor - After alteration
Fig.2

- (4) Assemble clipping point 5789 using the parts kept from step (2), the TA0210046FT04 or ST1455-04 clip removed from clipping point 5790 in step (1) and the new LK64582 spacer and the new 4W0110 bolt. Refer to figure 2 and Figure 3.

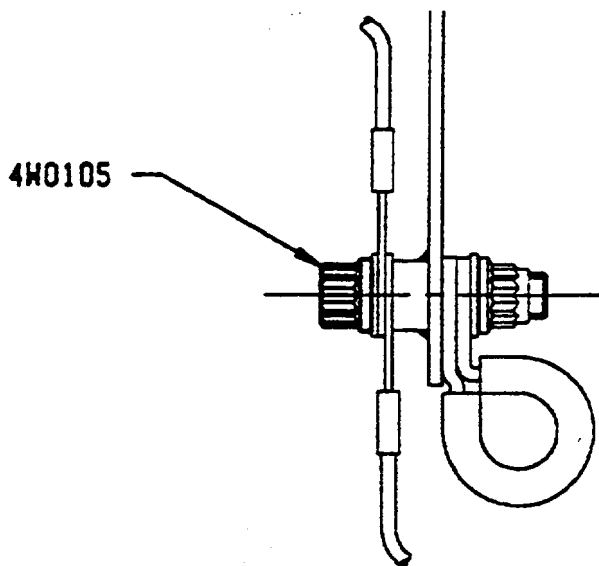
During the build of V2500-A5 engines two possible fouls on the EEC harness leads to the T3 sensor were identified. These were with the stage 10 make-up valve (R.H.S.) air tube and a fuel manifold tube.

VIEW SHOWING C.P. 5789
BEFORE ALTERATION

View showing clip point 5789 – Before and after alteration
Fig.3

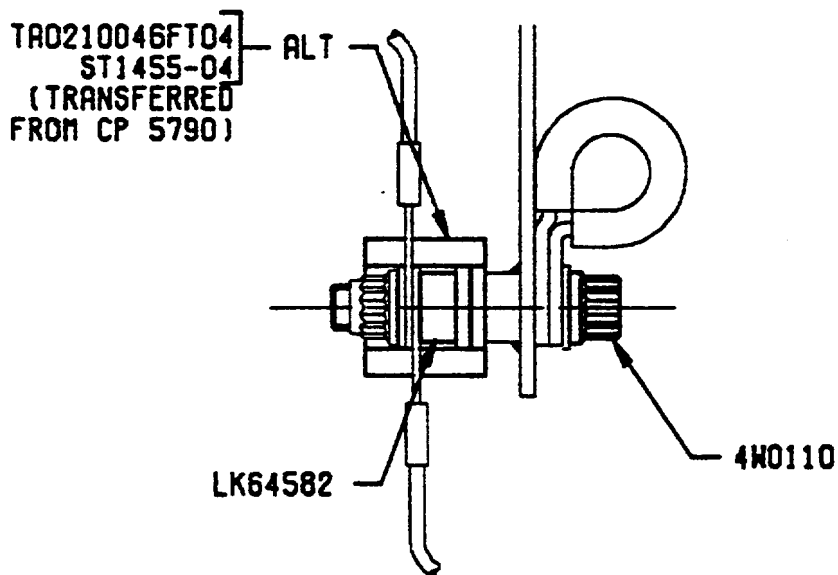
VIEW SHOWING C.P. 5789
AFTER ALTERATION

- (a) Clip point 5790 is deleted and the lead clipped at this point has been incorporated into Clip Point 5789 to provide improved clearance with the adjacent fuel manifold tube.
- (b) A clip and spacer are added to Clip Point 5789. The spacer has been added to lift the earthing tags away from the bracket and prevent damage to the tags during tightening of the securing bolt.
- (c) Clip Point 5788 remains unchanged but the harness leads in each clip are transposed to create a greater clearance with the R.H.S. air supply tube from the stage 10 make-up valve.

- (5) Torque the nuts at clipping points 5788 and 5789 to 36 to 45 lbfin (4 to 5 NM).

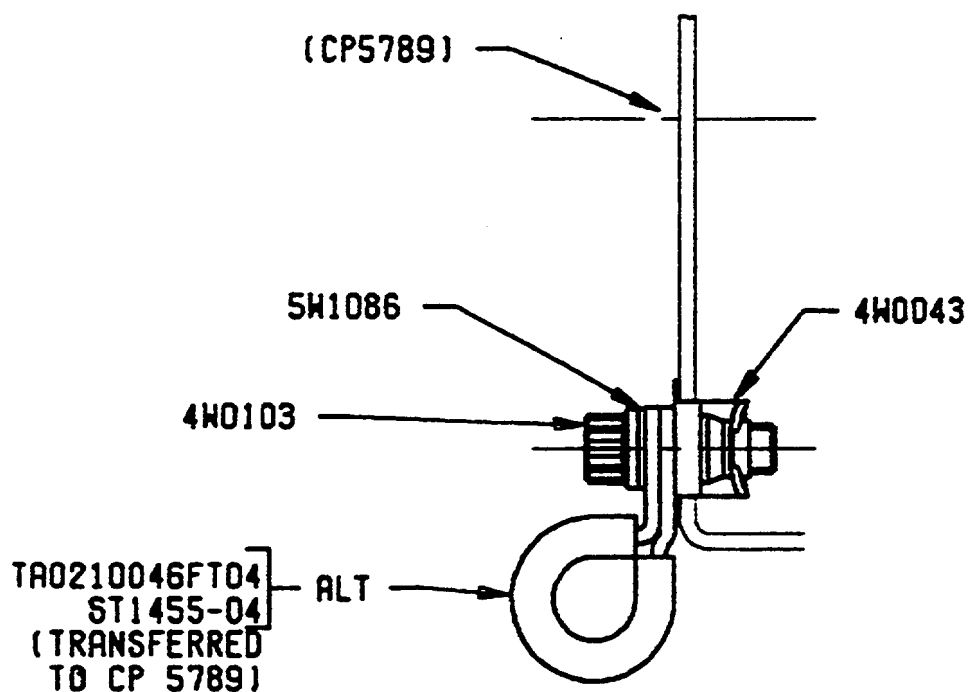
View showing deleted clip point 5790
Fig.4
