POWER PLANT - POWERPLANT - ENGINE - INTRODUCTION OF A LONGER BOLT AT CLIPPING POINT
5523 - CATEGORY CODE 6 - MOD.ENG-71-0122

V2500-ENG-71-0122

SERVICE BULLETIN

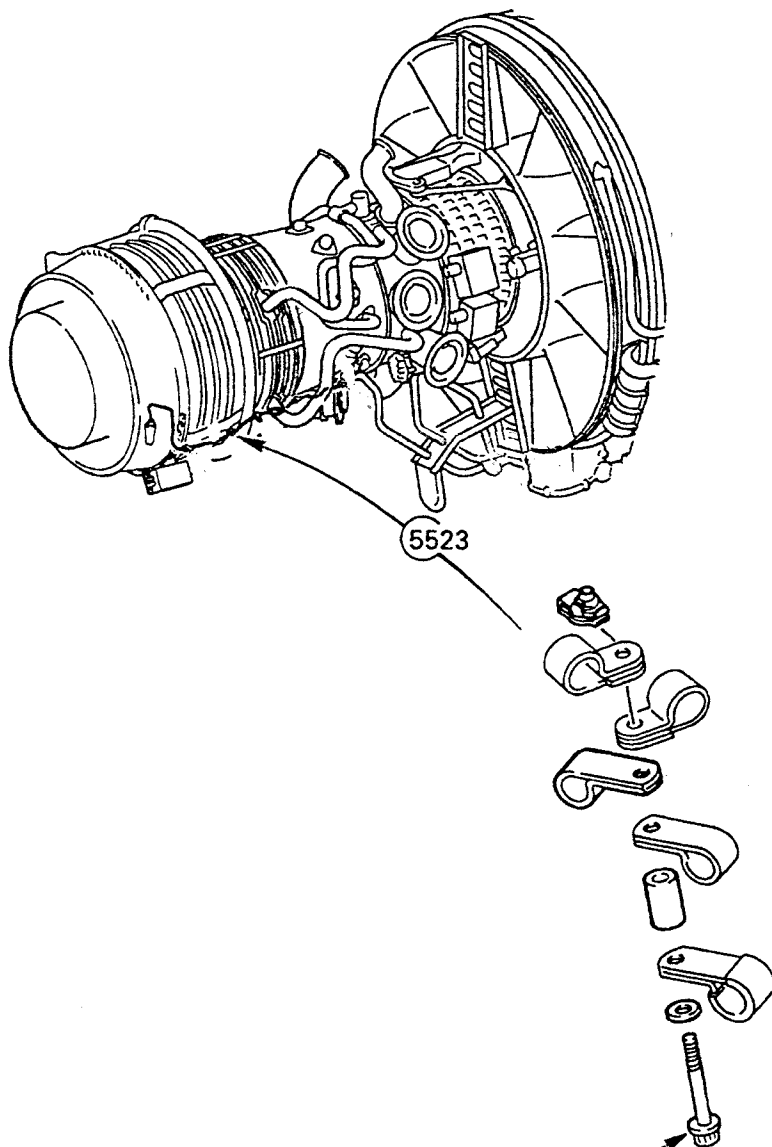
Location of bolt
Fig.1

Service experience has shown that the bolt currently installed at clipping point 5523 is too short to ensure adequate thread protrusion.

REMOVE 4W0116 AND
INSTALL 4W0117

A longer bolt replaces the existing bolt at clipping point 5523.

- (1) Install the 4W0017 bolt in accordance with approved procedures, Engine Manual (E-V2500-1IA), Task 72-00-50-420-005-A00 and 72-00-50-420-005-B00.
- (2) Refer to Figures 1 and 2 of this Service Bulletin

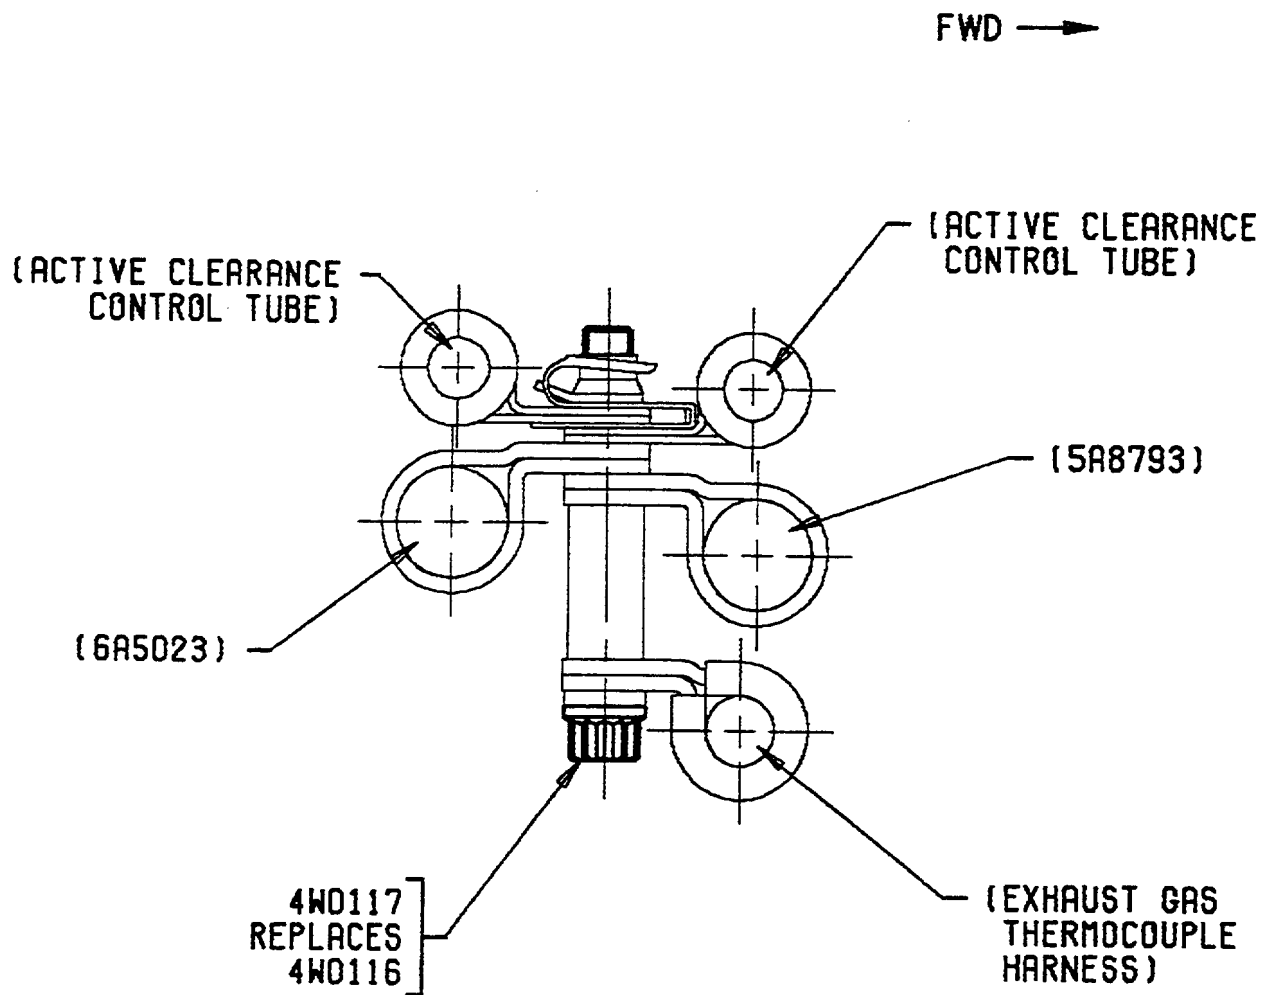
Clipping point 5523 Before and after alteration
Fig.2

Difficulty in assembly may occur when installing the bolt at clipping point 5523 due to insufficient length of the bolt.
