**V2500-A5 SERIES PROPULSION SYSTEMS SERVICE BULLETIN**

**V2500-ENG-71-0148**

ENGINE – POWERPLANT – MODIFICATION OF THE EEC HARNESS SUPPORT BRACKET

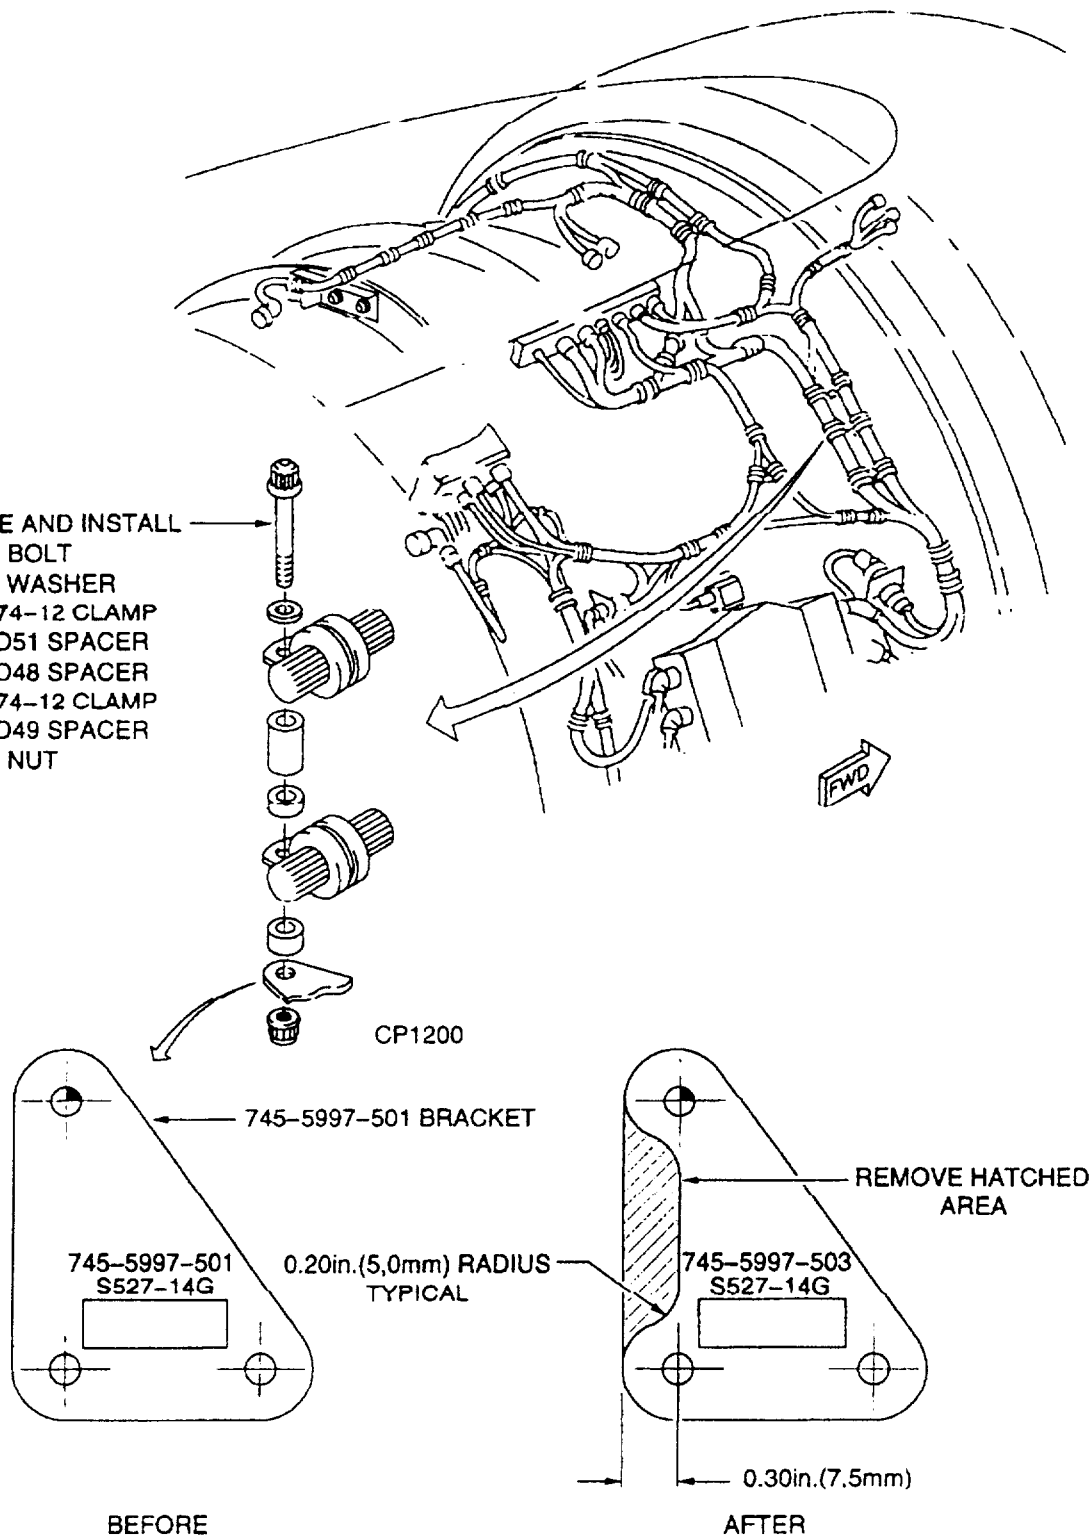
Rework of harness support bracket  
Fig 1

Insufficient clearance may exist between a support bracket for the EEC harness and an adjacent bracket at clipping position CP1200

The existing bracket which supports clipping point CP1200 is removed and modified to the new configuration (refer to Fig 1)

- (1) Trim the bracket 745-5997-501 as shown (Refer to Fig 1)
- (2) Use a file and remove any sharp corners or burrs
- (3) Identify the bracket to the new part number as shown with ink (CoMat 06-073) and a rubber stamp. Refer to IAE V2500 Standard Practices/Processes Manual, Chapter 70-09-00.
- (4) Install the bracket 745-5997-503 on the FA engine flange with two 4W0002 nuts and two AS21516 bolts as shown. Torque the bolts to 63 to 70 lbfin (7 to 8 Nm). Refer to the A320/A321 Aircraft Maintenance Manual, 70-23-11 on torque tightening techniques
- (5) Install clipping point CP1200 on the bracket 745-5997-503 as shown, with a 4W0132 bolt, SP154D washer, two TA025074-12 clamps, ST1698D51 spacer, ST1698D48 spacer, ST1698D-49 spacer and a 4W0001 nut. Torque the bolts to 20 to 25 lbfin (2 to 3 Nm). Refer to the A320/A321 Aircraft Maintenance Manual, 70-23-11 on torque tightening techniques
