POWER PLANT - ENGINE - INCORPORATION OF CLIPPING POINT 2449 AND BRACKET AT CLIPPING
POINT 2587 - CATEGORY CODE 6 - MOD.ENG-71-0149

- (1) Aircraft: (a) McDonnell Douglas MD-90
- (2) Engine: (a) V2500-D5 Engines prior to Serial No.V20009.

V2500-ENG-71-0149

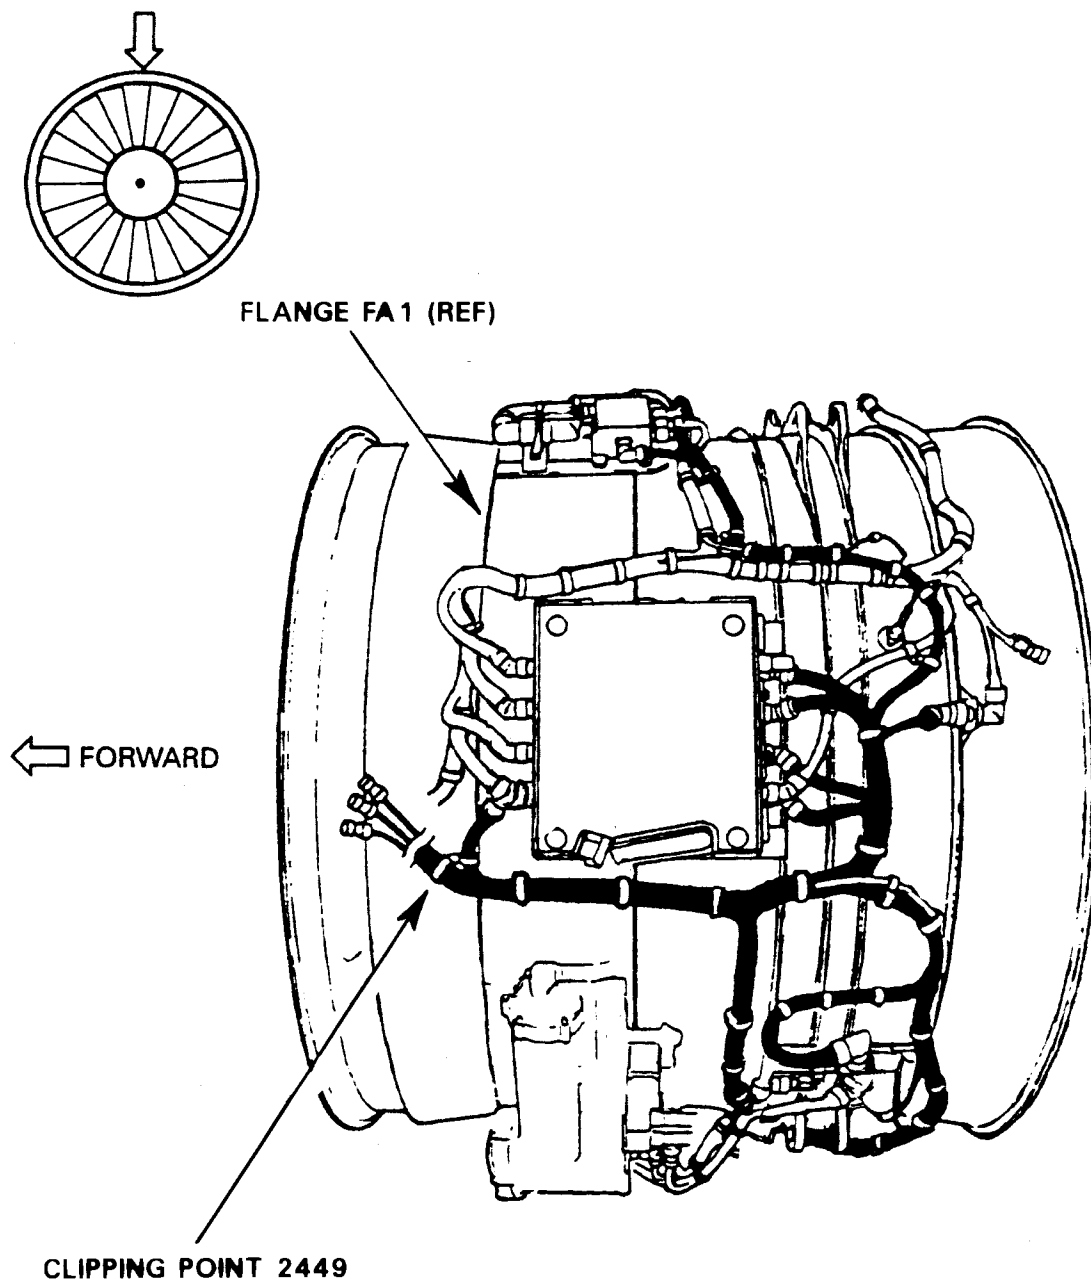
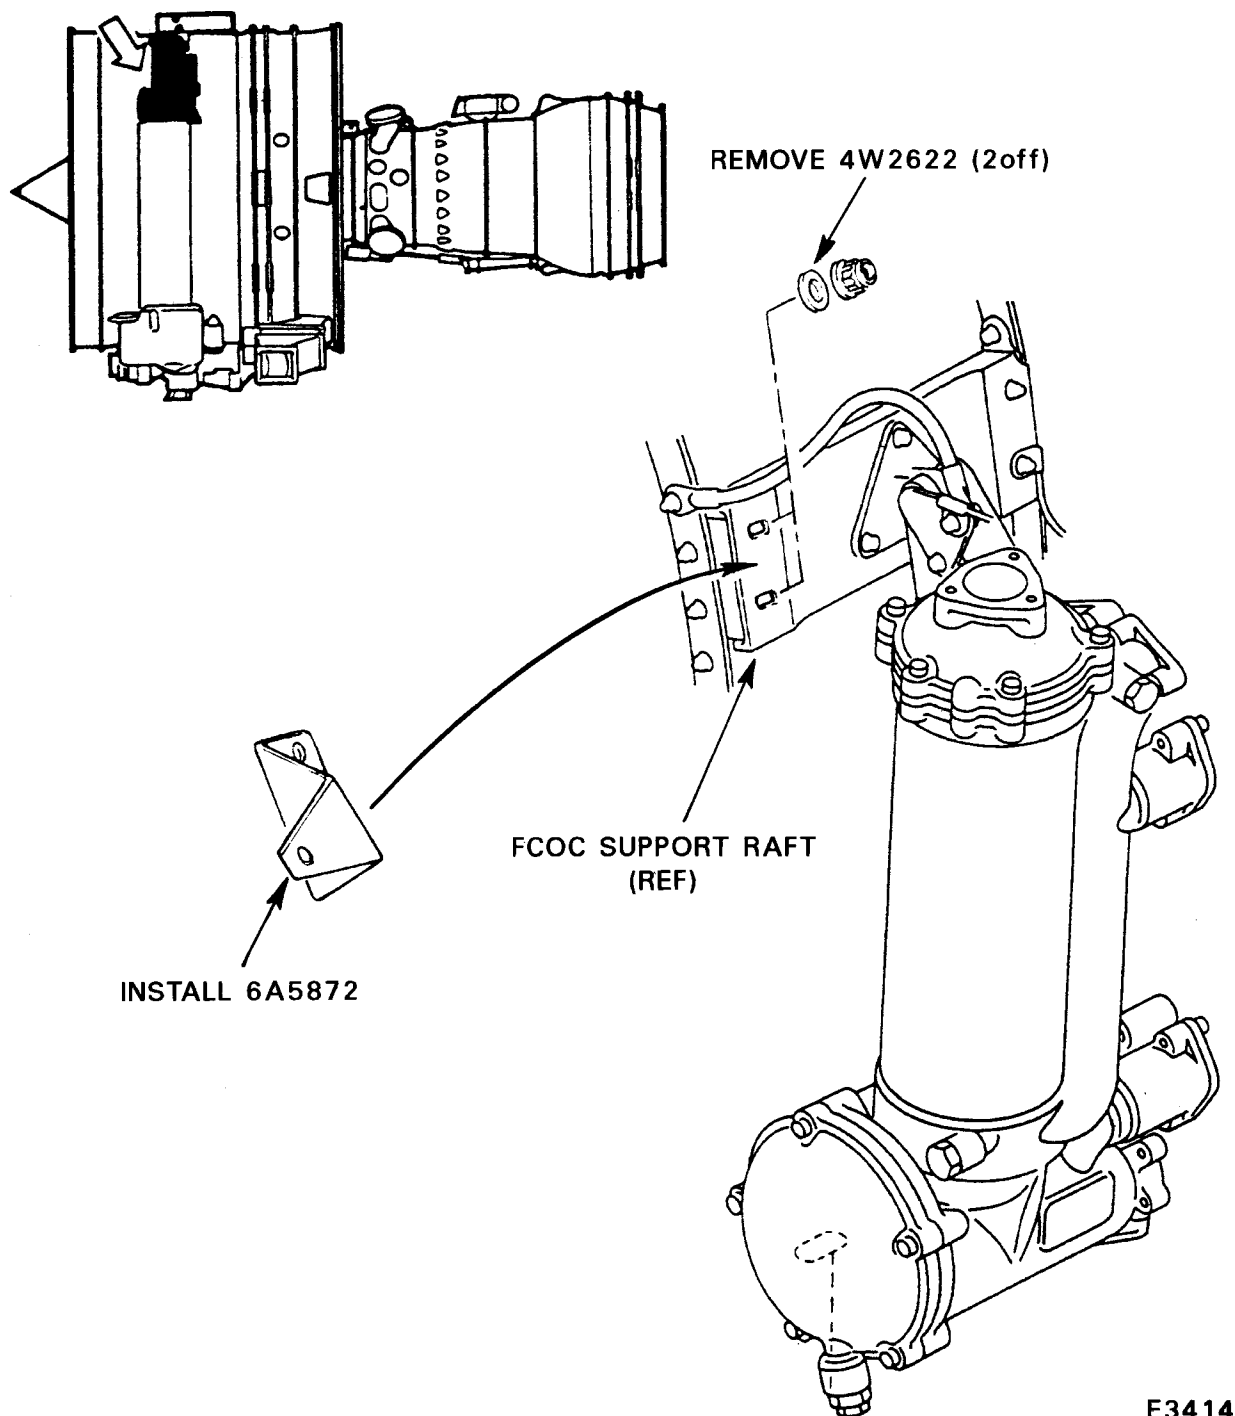
Clipping point 2449 and the bracket for clipping point 2587 have been omitted from the build of engines prior to V20009.

Location of clipping point 2449 and bracket for clipping point 2587
Fig.1 (Sheet 1 of 2)

Location of clipping point 2449 and bracket for clipping point 2587
Fig.1 (Sheet 2 of 2)

- (1) Find the support bracket for clipping point 2449 on flange FA1. Refer to Figure 1 and Figure 2.
- (2) Install the 4W0135 bolt, the 6A4824 spacer, the AS62518 clip, the UP10480 spacer, the AS62511 clip, the UP10480 spacer and the 4W0043 clipnut at clipping point 2449. Torque the bolt to 36 to 45 lbfin (4 to 5 Nm). Refer to Figure 2 and Figure 3.
- (3) Find the 6A4631 fuel cooled oil cooler (FCOC) support raft. Refer to Figure 1.
- (4) Disassemble the bolts (2 off), washers (2 off) and nuts (2 off) that attach the 6A4631 support raft to the bracket on flange FA1. Discard the washers. Refer to Figure 1.
- (5) Install the new 6A5872 bracket on to the 6A4631 support raft, using the bolts and the nuts removed at step (4). Torque the nuts to 85 to 105 lbfin (10 to 12 Nm). Refer to Figure 1 and Figure 4.

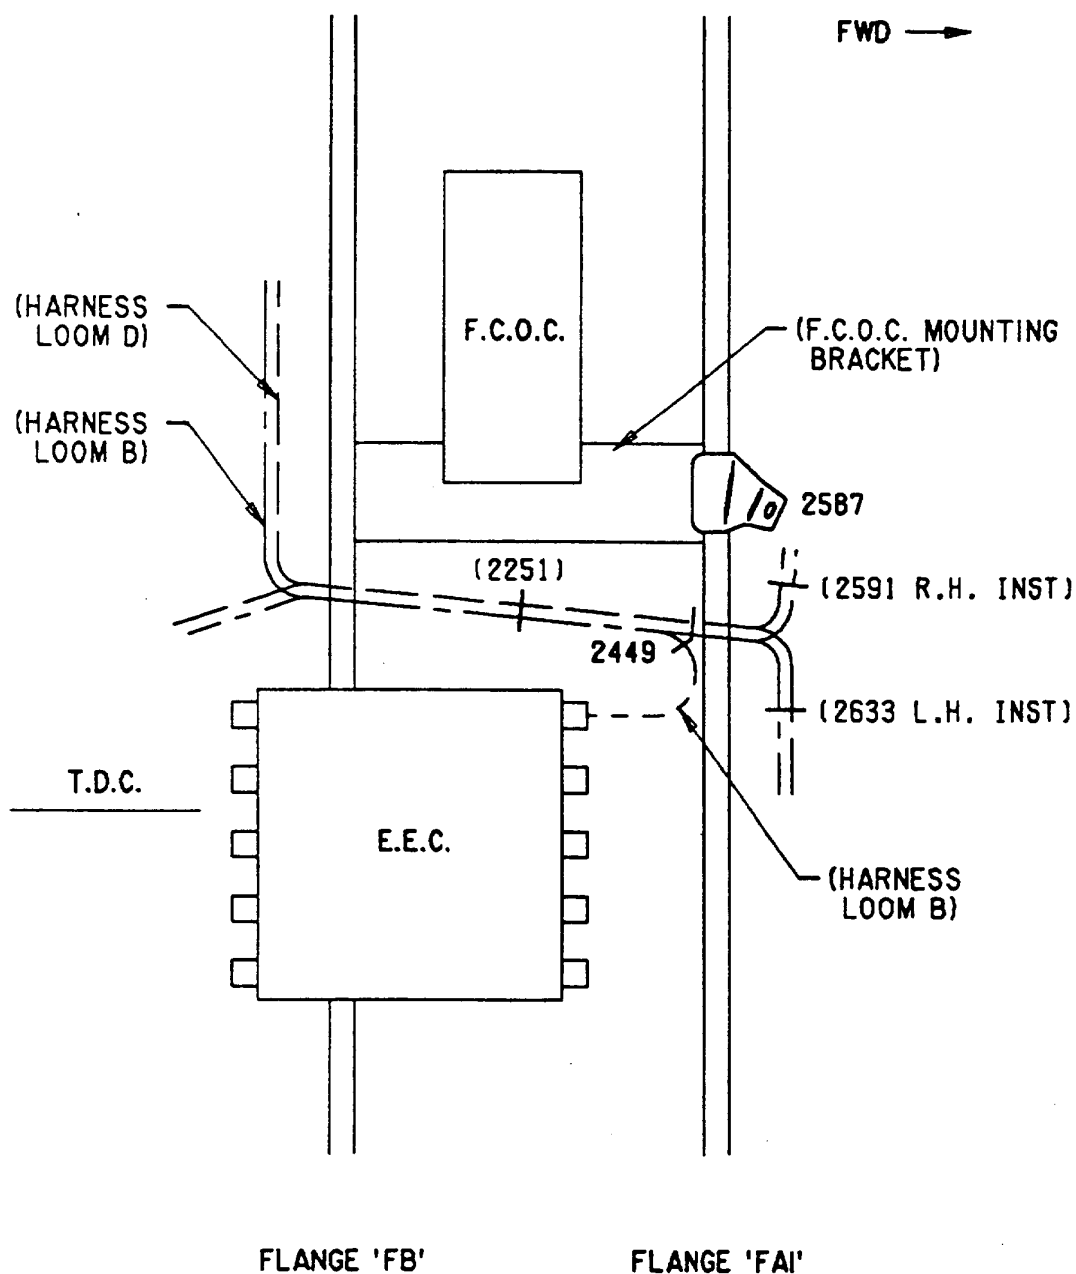
Schematic view showing locations of CP2449 and bracket for CP2587
Fig.2

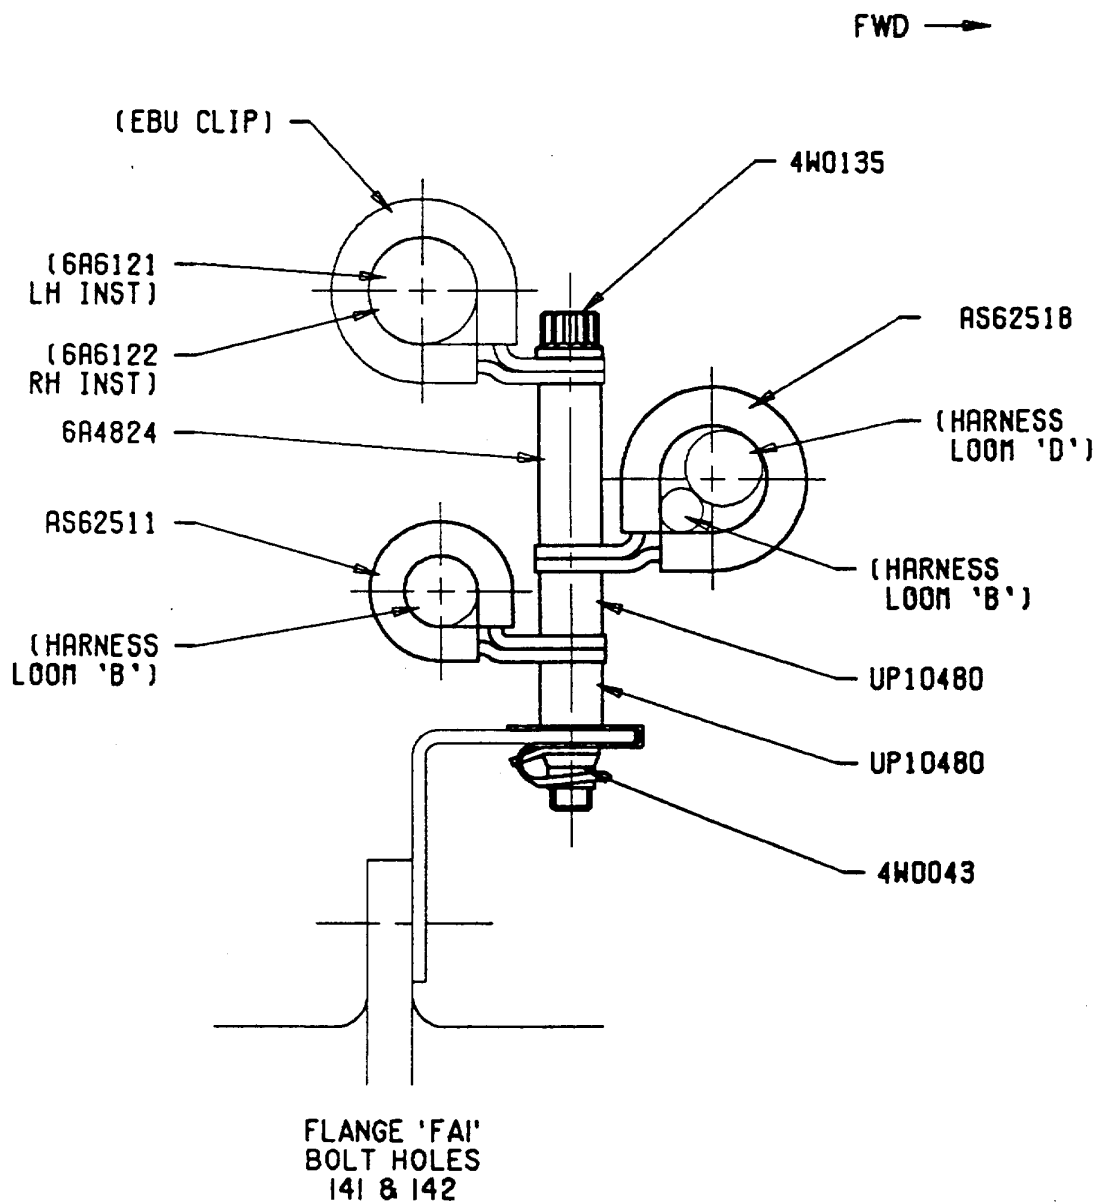
Clipping point 2449 - additional
Fig.3

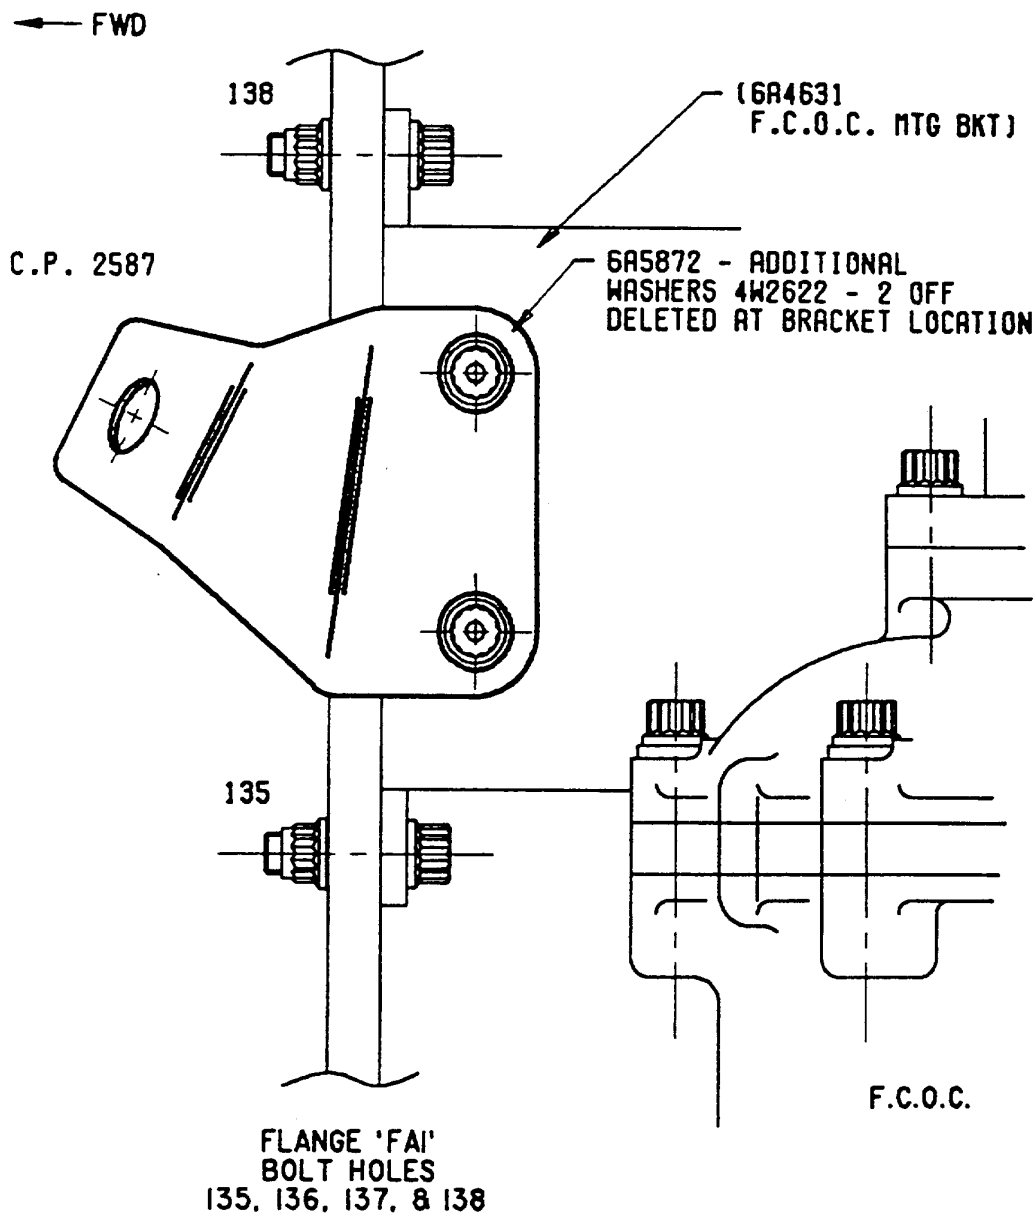
View on fuel cooled oil cooler mounting bracket showing bracket location of clipping point 2587
Fig.4
