POWER PLANT - DRAINS TUBES AND MAST - RESET OIL SCUPPER DRAINS TUBE AND MODIFIED
SUPPORT BRACKETS AT CLIPPING POINT 2607 - CATEGORY CODE 7 - MOD.ENG-71-0151

V2500-ENG-71-0151

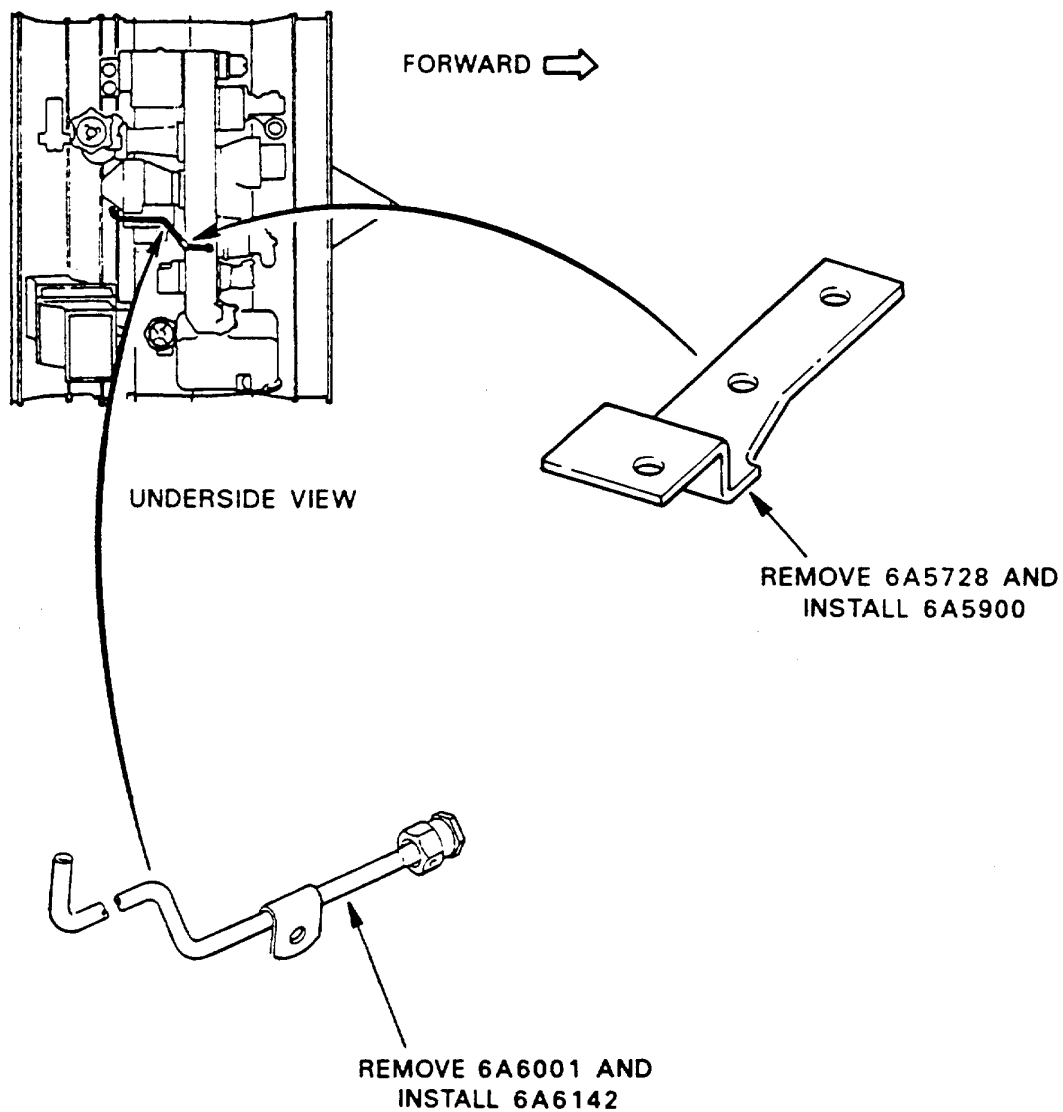
Location of Tube assembly and support bracket
fig.1

A foul may occur between the oil scupper drains tube outlet and the fan cowl vent louvres, also between the tube and the support bracket at CP2607.

- (1) Find the clipping points CP2381, CP2608 and CP2607. Refer to Figures 1 and 2.
- (2) Disassemble the clipping points sufficiently to allow removal of 6A6001 tube.

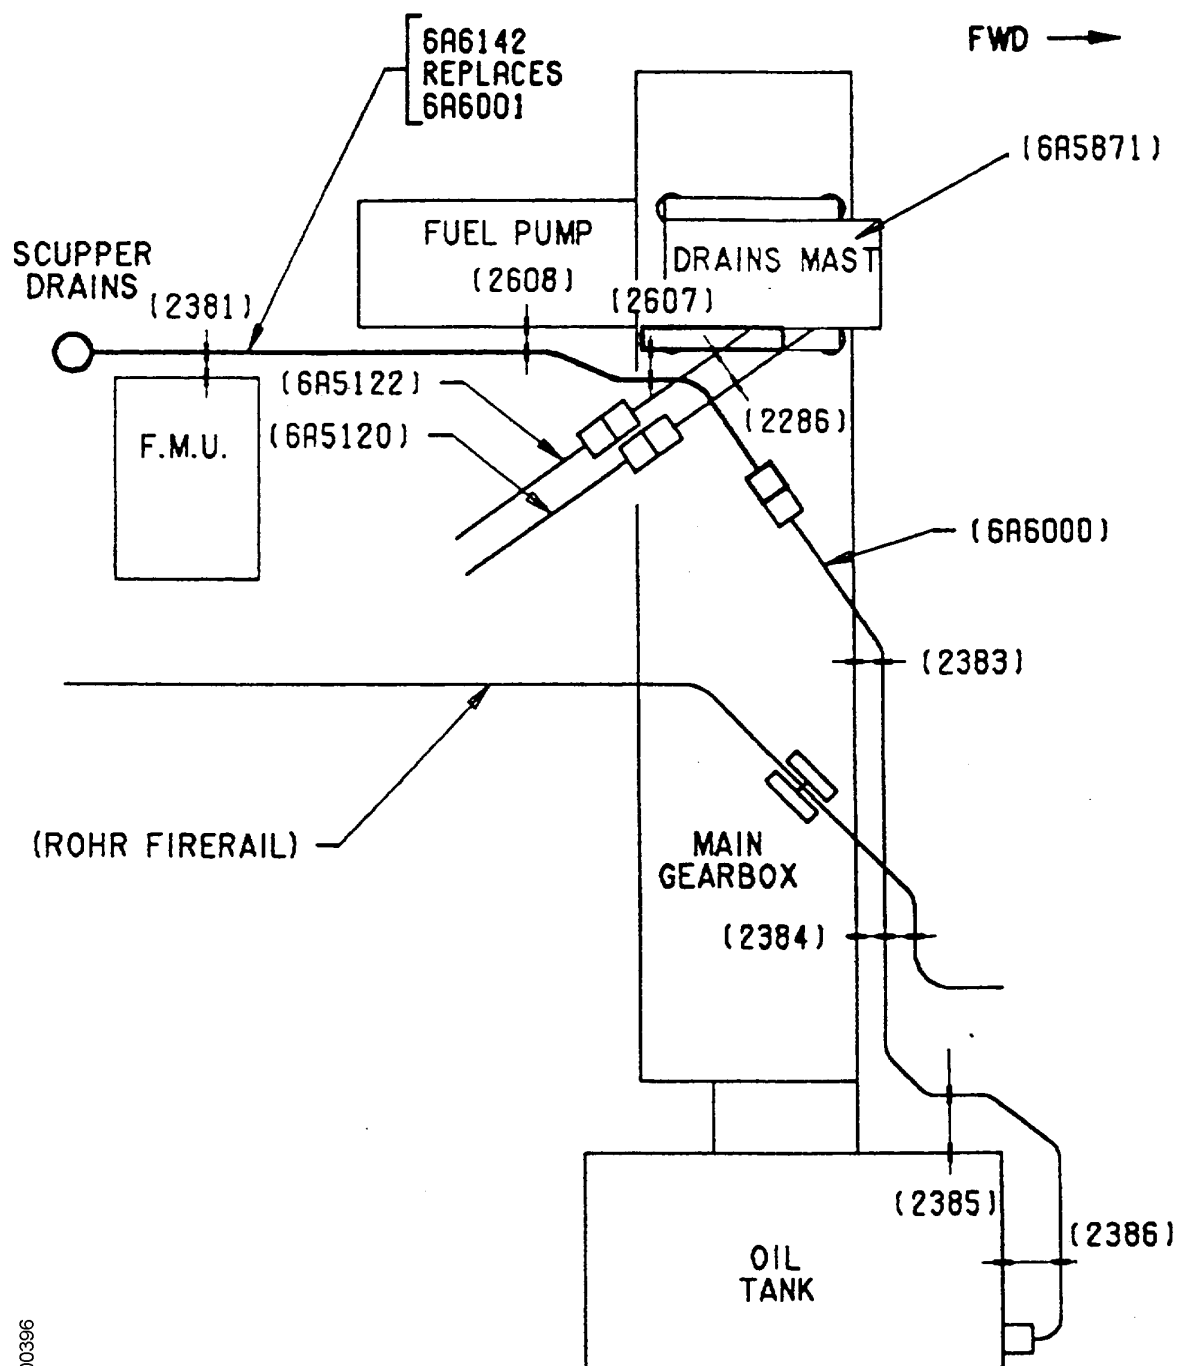
Schematic view of scupper drains tubes - Before and after alteration
fig.2

- (a) A new tube assembly reset locally at the location of fan cowl vent louvres.
- (b) A new bracket with an altered profile ensuring improved clearance between the bracket and the scupper drain tube.

- (9) Install the new 6A6142 tube, connect to 6A6000 tube and torque to 230 to 248 lbfin (26 to 28 Nm). Refer to Figure 2.
- (10) Safety the new 6A6142 tube connector with CoMat 02-126 lockwire.

- (11) Install clipping points CP2381, CP2608 and CP2607.
- (12) Torque the bolts at clipping points CP2381, CP2608 and CP2607 to 36 to 45 lbfin (4 to 5 Nm).
