POWER PLANT - CORE HARNESSSES - REVISED CLIPPING OF LOOMS E, F AND G - CATEGORY CODE 6
- MOD.ENG-71-0152

- (1) Aircraft: McDonnell Douglas MD-90
- (2) Engine: V2500-D5 Engines prior to Serial No.V20009.

V2500-ENG-71-0152

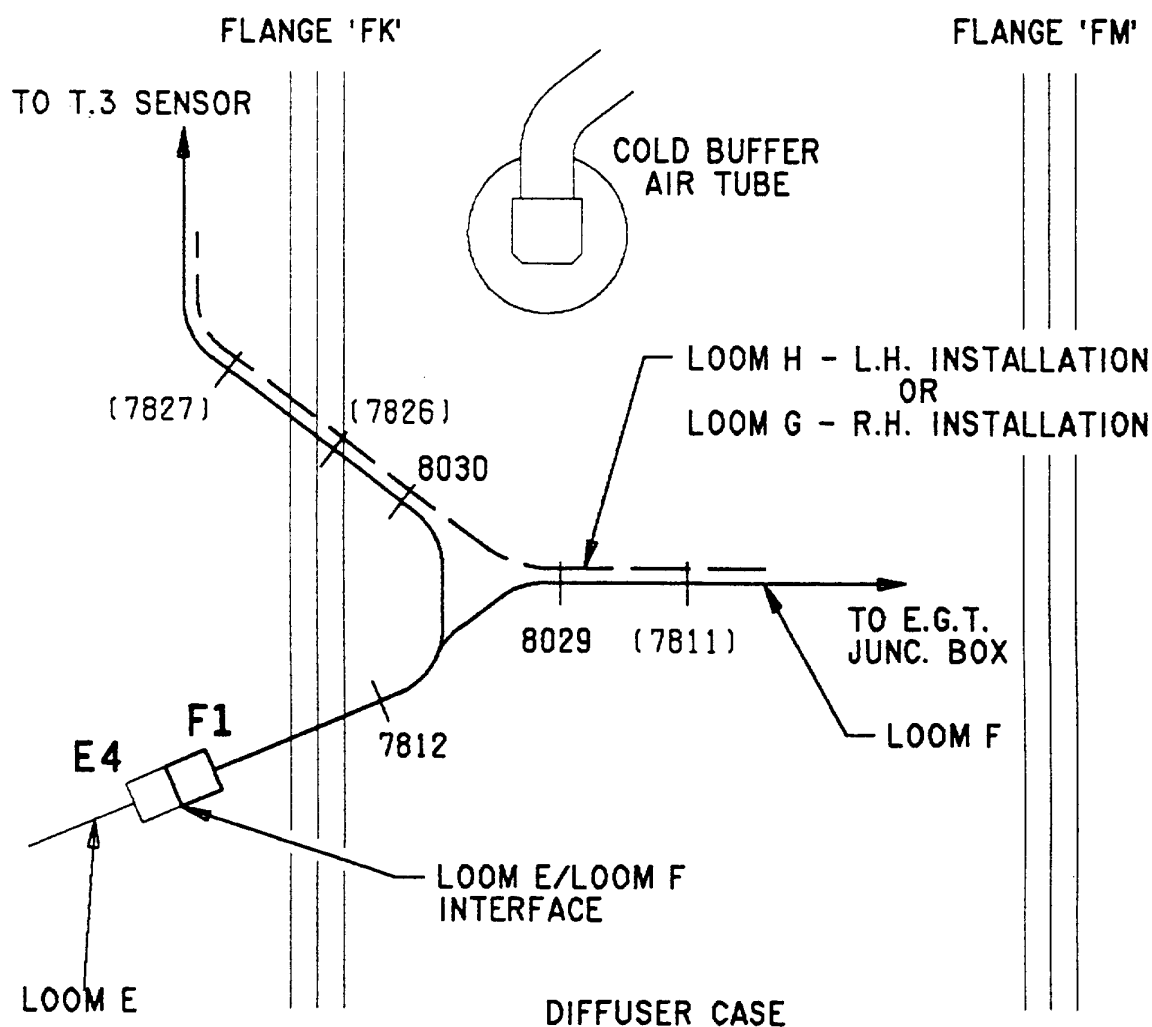
Schematic view of Loom 'F' showing clipping configuration - Before alteration
Fig.2

Insufficient clearance between the EGT harness (Loom F) and the core firerail also between the link harness/firewire (Loom H) and the Stage 10 Make Up Valve.

During assembly it was highlighted that insufficient clearance existed between the E.G.T. harness (Loom F) and the core firerail in the region of clipping points 7812 and 8029. It was also highlighted that there was insufficient clearance between Loom H and the Stage 10 Make Up Valve in the region of clipping points 7825 and 7831. In addition it was found necessary to reroute the General Services Harness (Loom E) at clipping point 7835.

- (11) Find harness loom 'F'. Refer to Figure 1 and Figure 2.
- (12) Disassemble clipping point CP8029 sufficiently to remove harness loom 'F' to E.G.T. Junc. Box from clip. Refer to Figure 2 and Figure 10.

- (13) Disassemble clipping point CP7812 sufficiently to remove harness loom 'F' from clip. Refer to Figure 2 and Figure 7.
- (14) Disassemble clipping point CP8030, clipping point is deleted. Refer to Figure 2 and Figure 11.

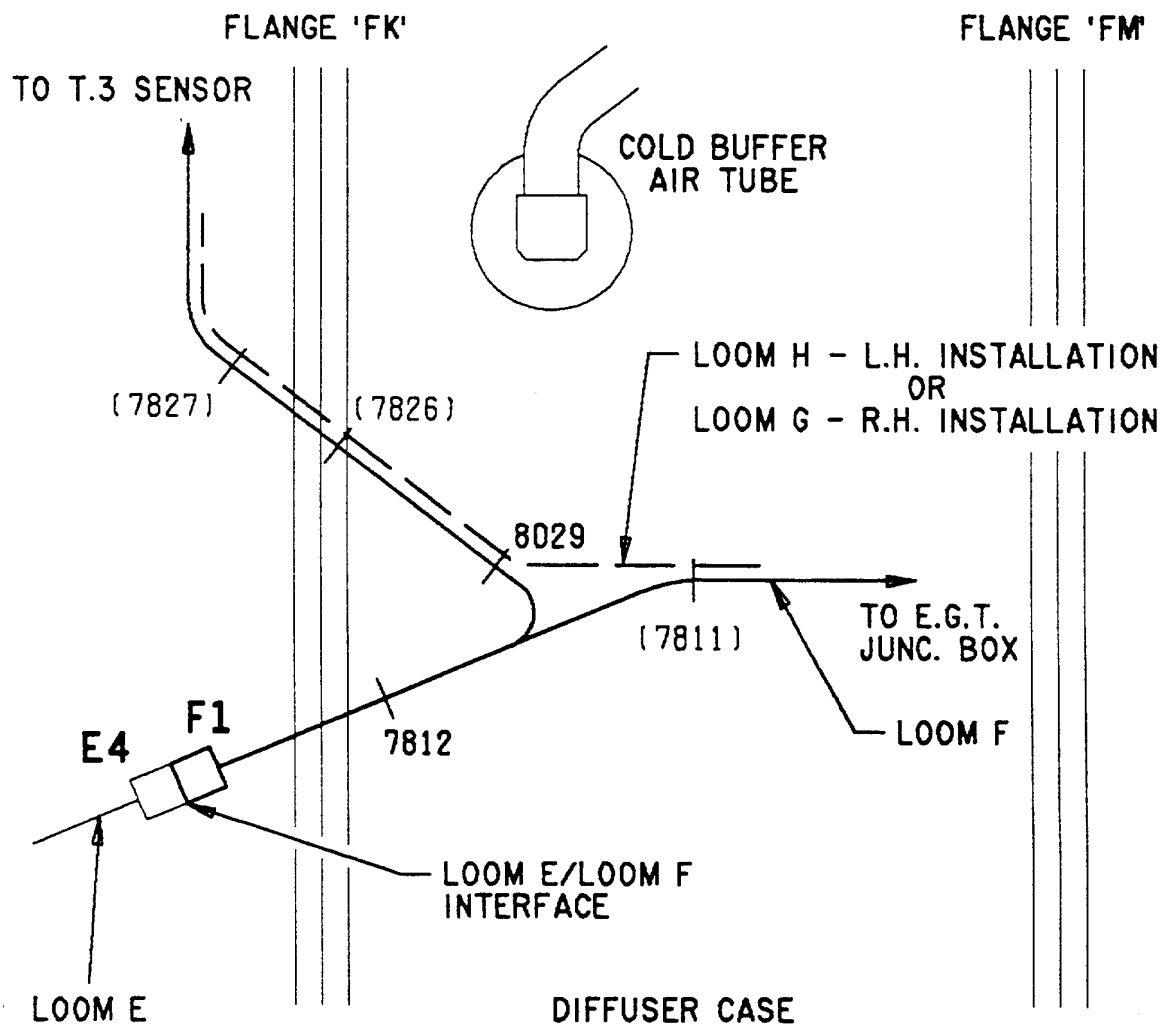
Schematic view of Loom 'F' showing clipping configuration - After alteration
Fig.3

- (1) To overcome the insufficient clearance between Loom F and the core firerail, the EGT limb of Loom F is no longer clipped at CP8029. The T.3 limb will now be clipped at CP8029 with an additional spacer. CP8030 is no longer required and is now deleted. The clip at CP7812 is rotated 180 degrees.
- (2) To overcome the insufficient clearance between Loom H and the Make Up Valve a separate clip is introduced onto existing clipping points 7825 and 7831 to clip loom H only. This opportunity has also been taken to introduce a longer Loom H.
- (3) The breakout of the 10th Stage Make Up Valve limb from the main Loom E is now repositioned between CP7835 and CP7836. The datum clipping point for Loom E is CP7837 the harness should be repositioned accordingly.

- (17) At existing clipping point CP7812 rotate the clip 180 degrees and install harness loom 'F' into clip. Assemble clipping point using existing parts. Refer to Figure 3 and Figure 7.

- (18) At existing clipping point CP8029 install harness loom 'F' to T.3 sensor into clip. Assemble revised clipping point using new 4W0112 bolt, new LK42781 spacer and existing nut. Refer to Figure 3 and Figure 10.
