POWER PLANT - DRAIN TUBE MAST - DRAINS COLLECTING BRACKET WITH INCREASED SEALING AREA  
- CATEGORY CODE 6 - MOD.ENG-71-0153

V2500-ENG-71-0153

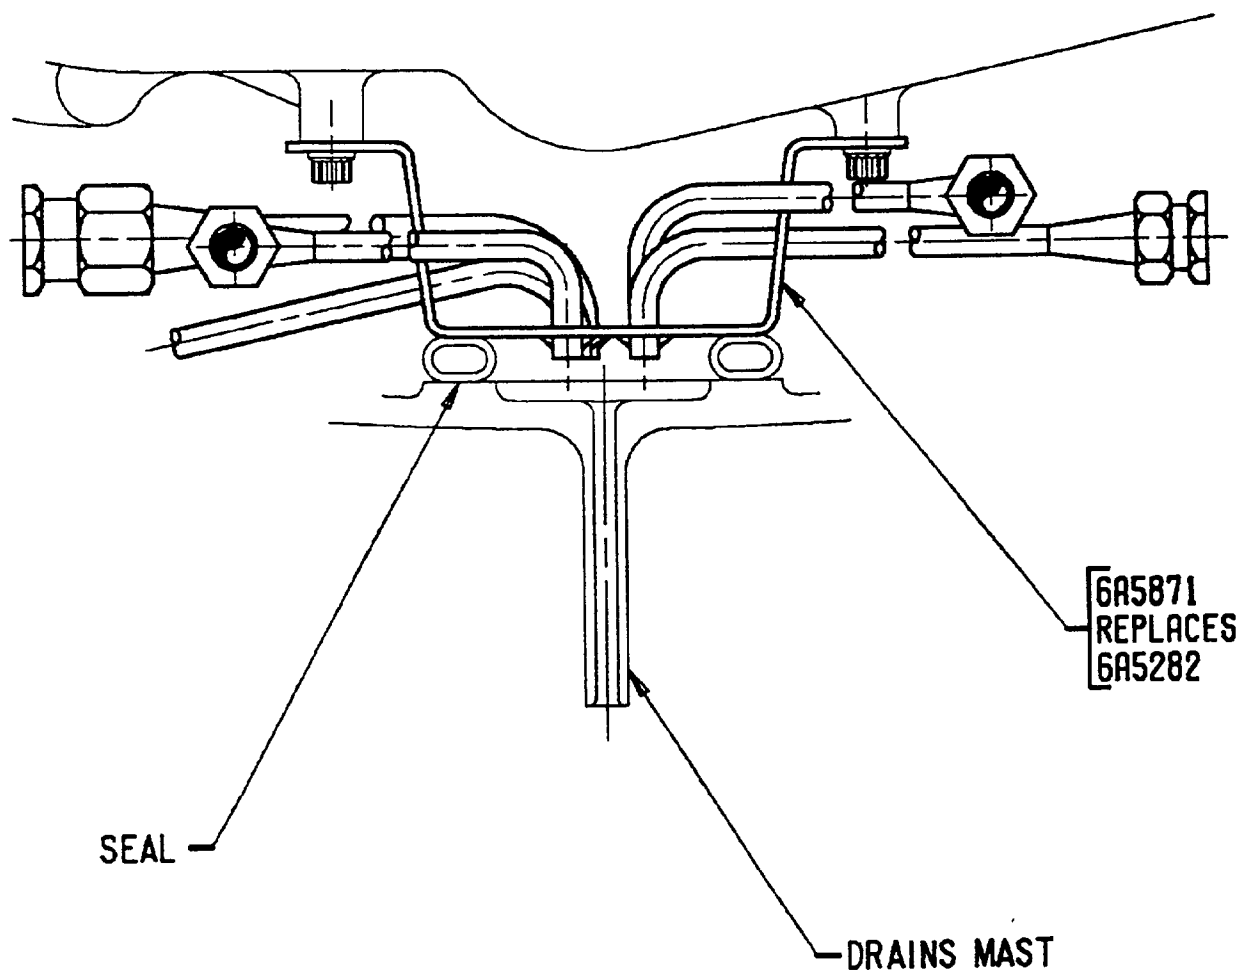
View on drains mast bracket at B.D.C. - Before and after alteration  
Fig.2

The sealing area of the drains collecting bracket is insufficient to accommodate lateral movement of the drains mast compressible seal mounted on the lower cowl door. This can permit oil leakage and damage to the compressible seal when in contact with the edge of the bracket.

This Bulletin introduces a new drains collecting bracket with an increased seal land surface. The new bracket also features a side wall opening scalloped to maintain the existing clearance with the fuel pump drains tube.

- (5) Remove 6A5282 drains mast bracket, leaving CP2607 retaining bracket.
- (6) Install new 6A5871 drains mast bracket and position CP2607 retaining bracket.
