POWER PLANT - ENGINE - FANCASE - SUPPORT BRACKETS, ATTACHING BOLTS - VARIOUS CHANGES -
CATEGORY CODE 7 - MOD.ENG-71-0155

V2500-ENG-71-0155

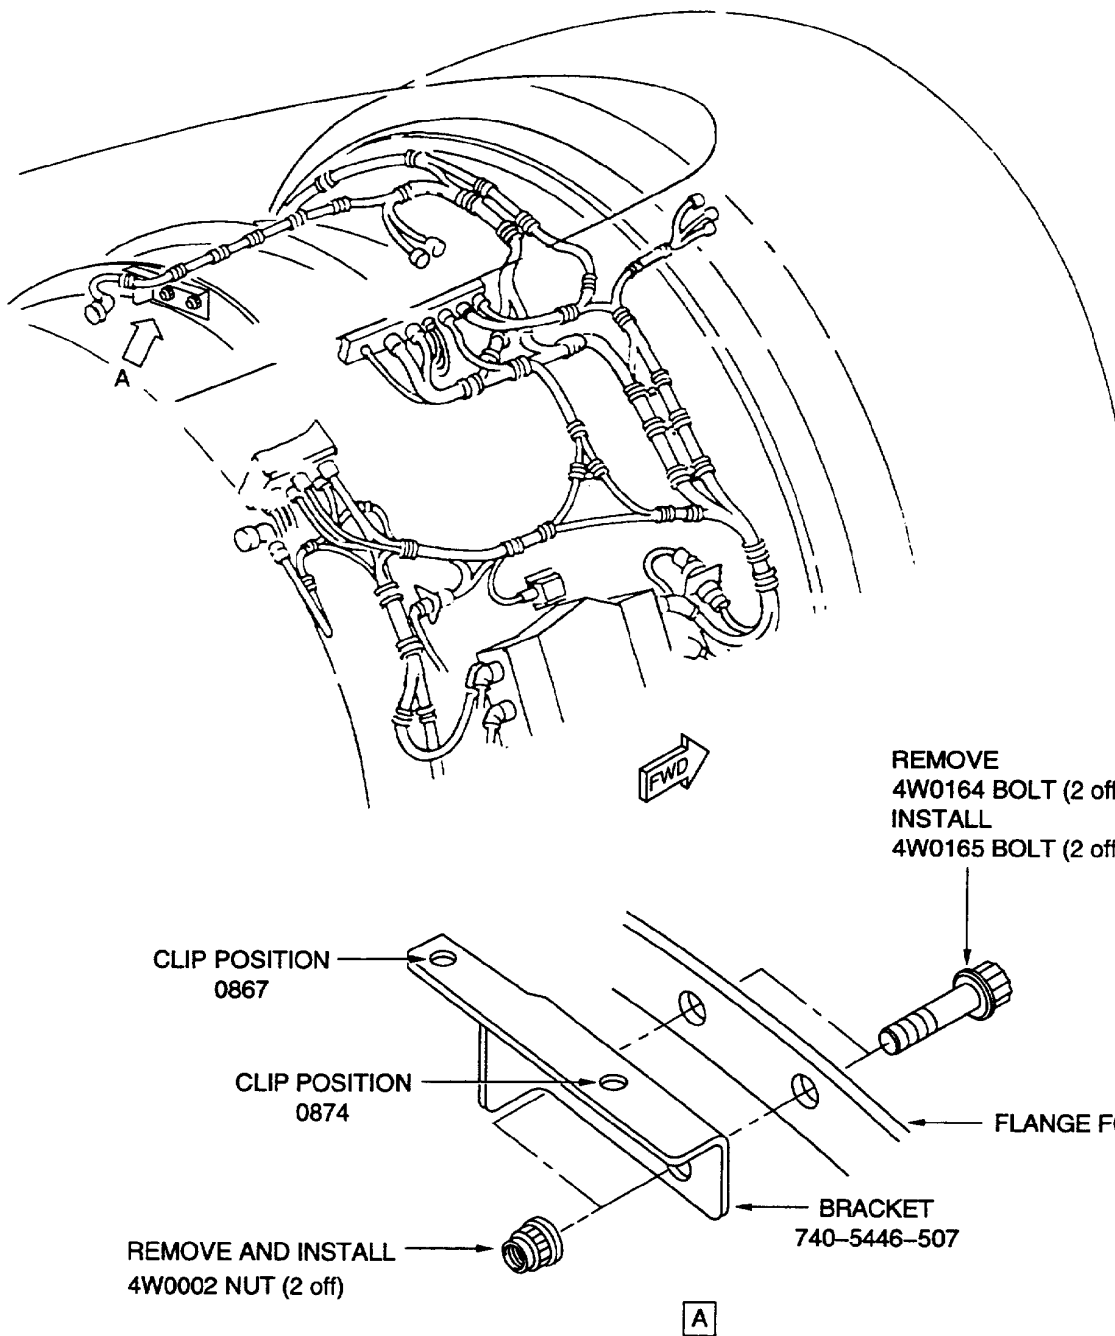
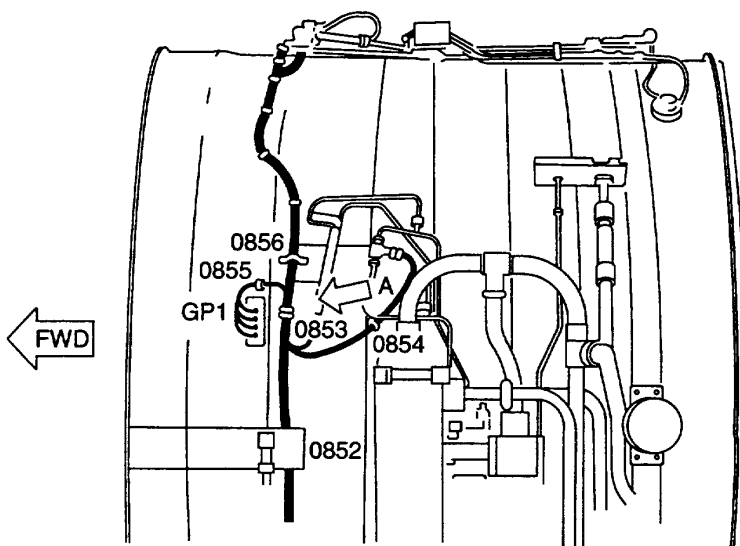
REPLACE BOLTS - CLIPPING POINT SUPPORT BRACKET
FIG.1

- (a) The existing bolts that attach the 740-5446-507 bracket are removed and replaced with longer bolts.
- (b) A new spacer is introduced at clipping point CP0853 and the existing bolt is replaced with a longer bolt.
- (c) The existing bolts that attach the 745-5425-501 bracket at clipping point CP0859 are replaced with longer bolts.
- (d) The existing bolt that attaches the 745-5425-50 bracket at clipping points CP0858 and CP1182 is replaced with a longer one.

- (1) Attach the 740-5446-507 Bracket to the Flange FC at clipping points CP0867 and CP0874 using two new 4W0165 Bolts and two 4W0002 Nuts as shown. Torque each nut to between 85 and 105 lb in (10 to 12 Nm). Refer to Figure 1.
- (2) Assemble clipping point CP0853 as shown with a new AS21425 Bolt, TA02507409 Clip, ST1698D50 Spacer, a new ST1698D47 Spacer, AS20624 Nut and SP154D Washer. Torque the bolt to between 36 and 45 lb in (4 to 5 Nm). Refer to Figure 2.
- (3) Attach the 745-5425-501 Bracket to the Flange FA1 at clipping point CP0859 using two new 4W0165 Bolts and two 4W0002 Nuts as shown. Torque each nut to between 85 and 105 lb in (10 to 12 Nm). Refer to Figure 3 Sht 1.
- (4) Install a new 4W0165 Bolt and a 4W0002 Nut at clipping points CP0858 and CP1182 as shown. Torque the nut to between 85 and 105 lb in (10 to 12 Nm). Refer to Figure 3 Sht 2.

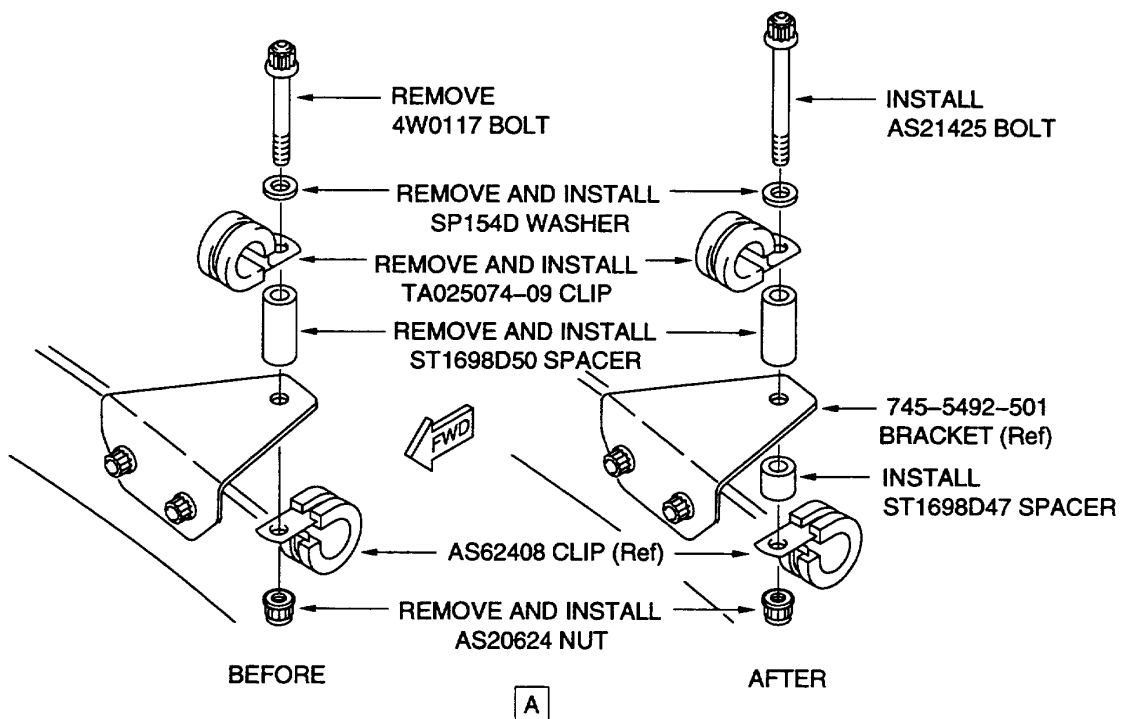
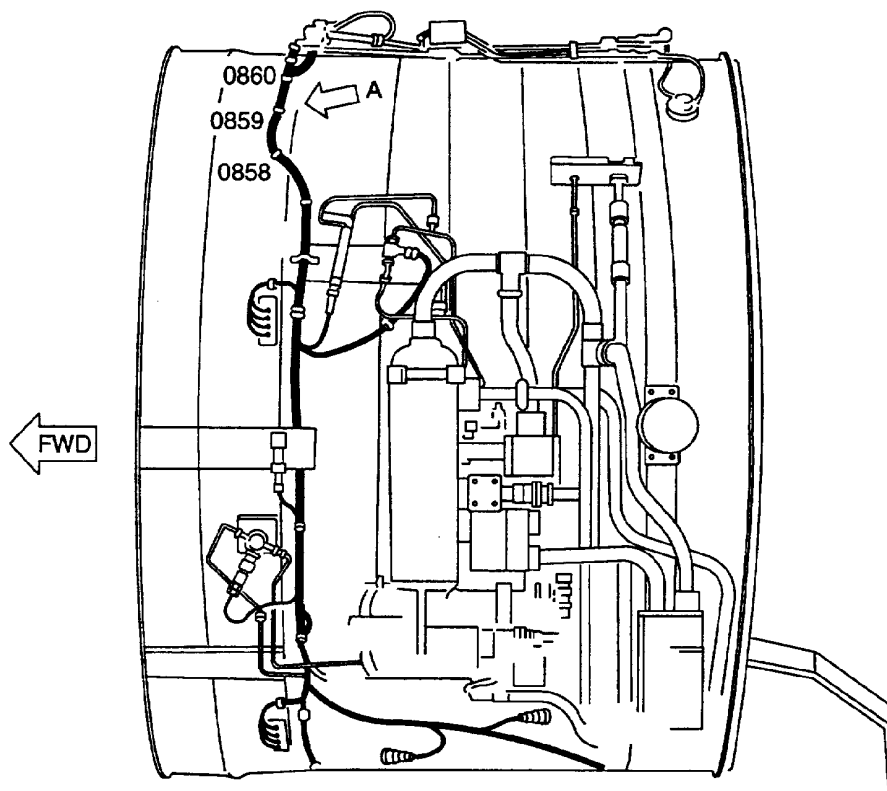
INSTALLATION OF LONGER BOLT AND SPACER AT CLIPPING POINT CP0853
FIG.2

The PMA cooling tubes are rerouted for future provision of a low nox system (ref : Service Bulletin V2500-ENG-72-0160). This necessitates the replacement of various bracket attaching bolts and the introduction of a new a spacer.
