SERVICE BULLETIN

POWER PLANT - ENGINE - EEC HARNESS FAN - REVISED CLIPPING OF LOOMS B AND D ADJACENT TO FUEL COOLED OIL COOLER - CATEGORY CODE 6 - MOD.ENG-71-0156

V2500-ENG-71-0156

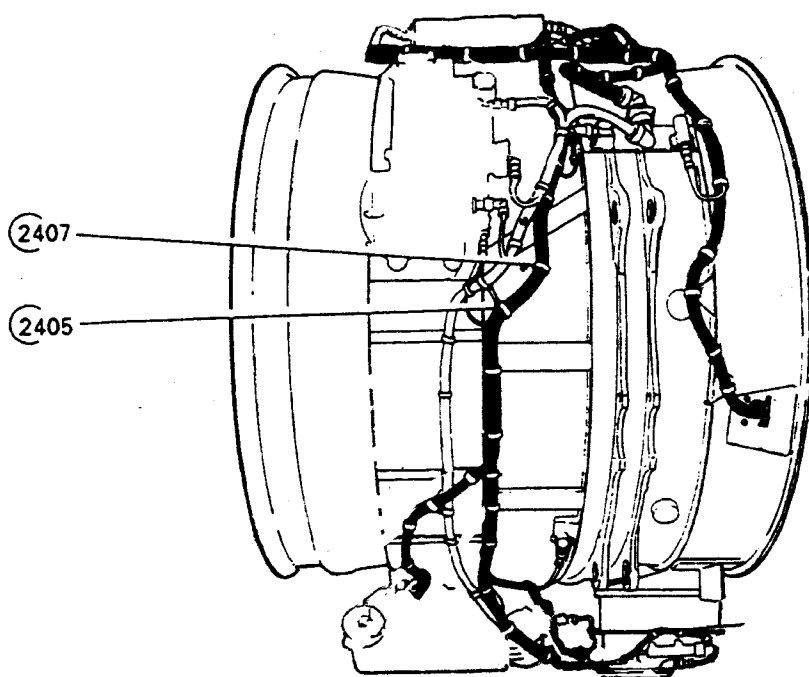
Location of clipping points 2405 and 2407
Fig.1

- (1) Find harness looms 'B' and 'D'. Refer to Figures 1 and 2.
- (2) Disassemble clipping point CP2405, remove 4W0112 bolt, 4W0043 clipnut, UP10480 spacer and AS62515 clamp. Refer to Figures 2 and 4.

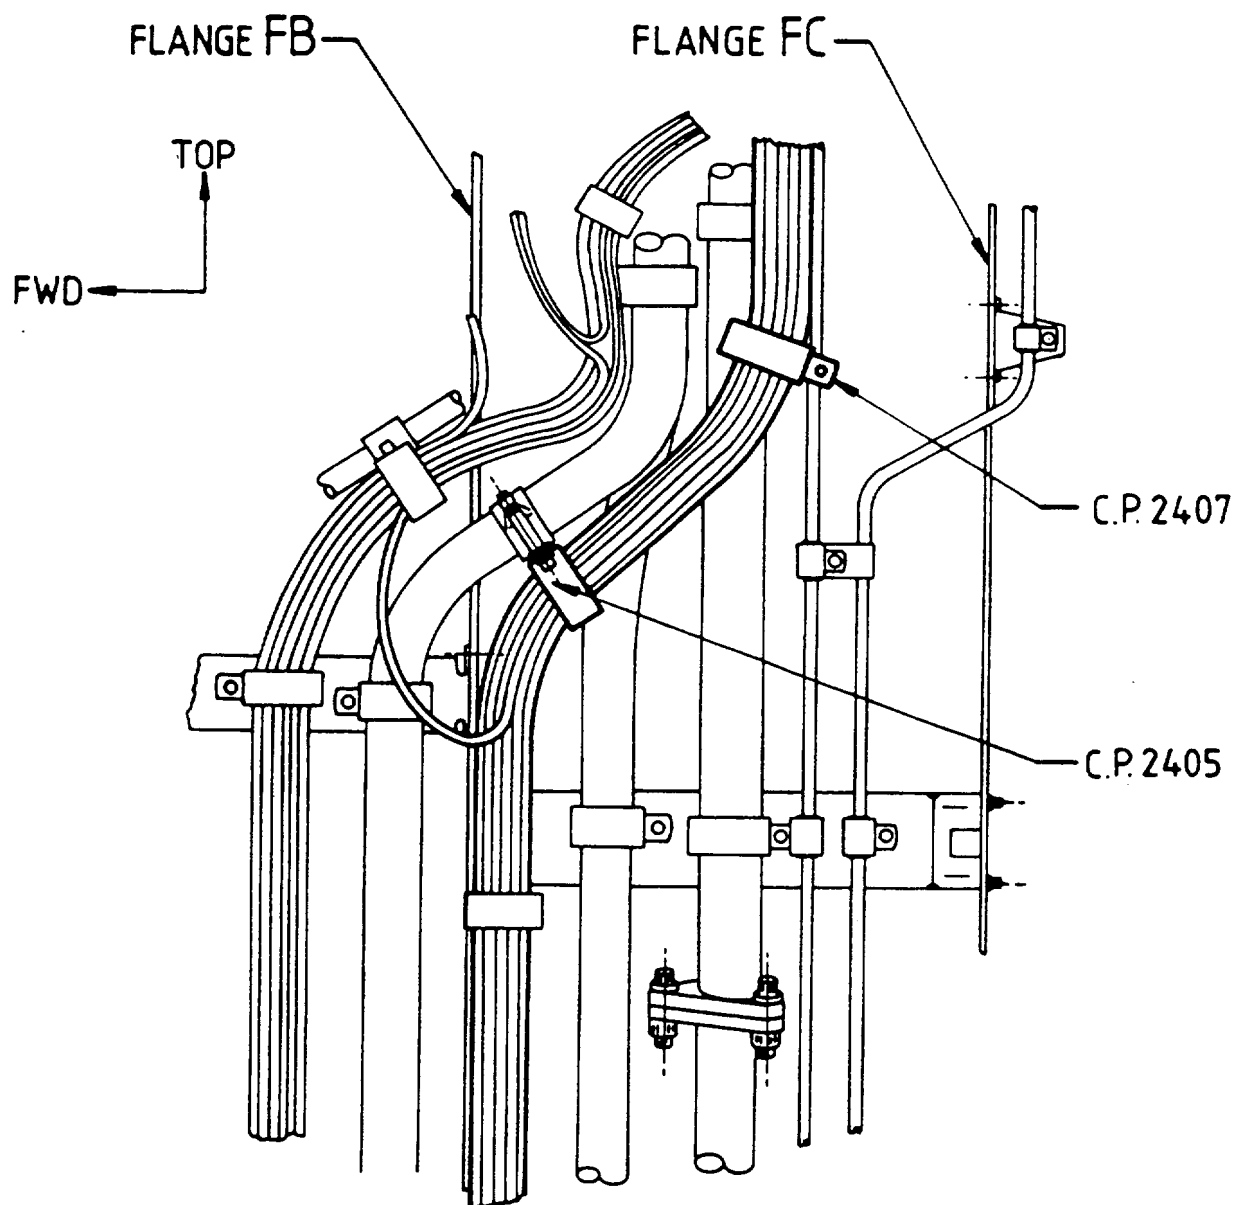
Part view on left hand side of engine - Before alteration
Fig.2

During assembly it was highlighted that limited clearance existed between the EEC harness looms B and D and the No.3 fan cowl upper door hinge.

- (3) Disassemble clipping point CP2407, remove AS20908 bolt and 4W0001 nut. Refer to Figures 2 and 5.
- (4) Remove the AS21010 bolts (2 off) and 4W0002 nuts (2 off) at hole position numbers 61 and 62 on flange face 'B'. Refer to figures 3 and 6.
