ENGINE - POWER PLANT - INTRODUCE A NEW FANCASE HARNESS WITH REVISED LENGTH LOOMS -
CATEGORY CODE 7 - MOD.ENG-71-0159

V2500-ENG-71-0159

May.3/95

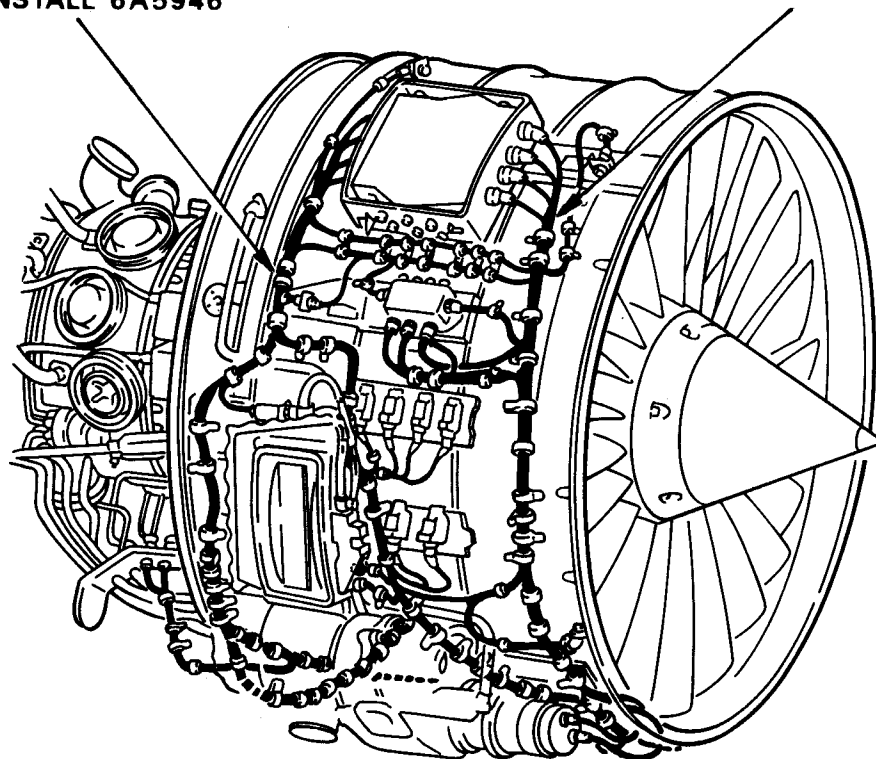
Location of fan case harnesses
Fig.1

During installation of the EEC fan harness it was highlighted that the length of harness looms A and B required adjustment.

REMOVE 6A5941 LOOM B
AND INSTALL 6A5946

REMOVE 6A5940 LOOM A
AND INSTALL 6A5945
