ENGINE - POWER PLANT - EEC HARNESS FAN - FCOC FUEL TEMPERATURE THERMOCOUPLE CONNECTOR  
WITH IMPROVED SOCKETS - CATEGORY CODE 4 - MOD.ENG-71-0160

V2500-ENG-71-0160

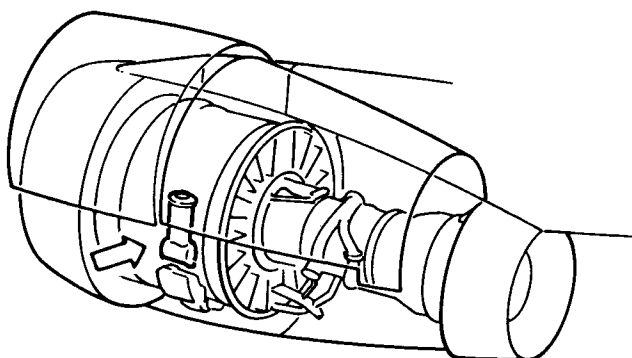
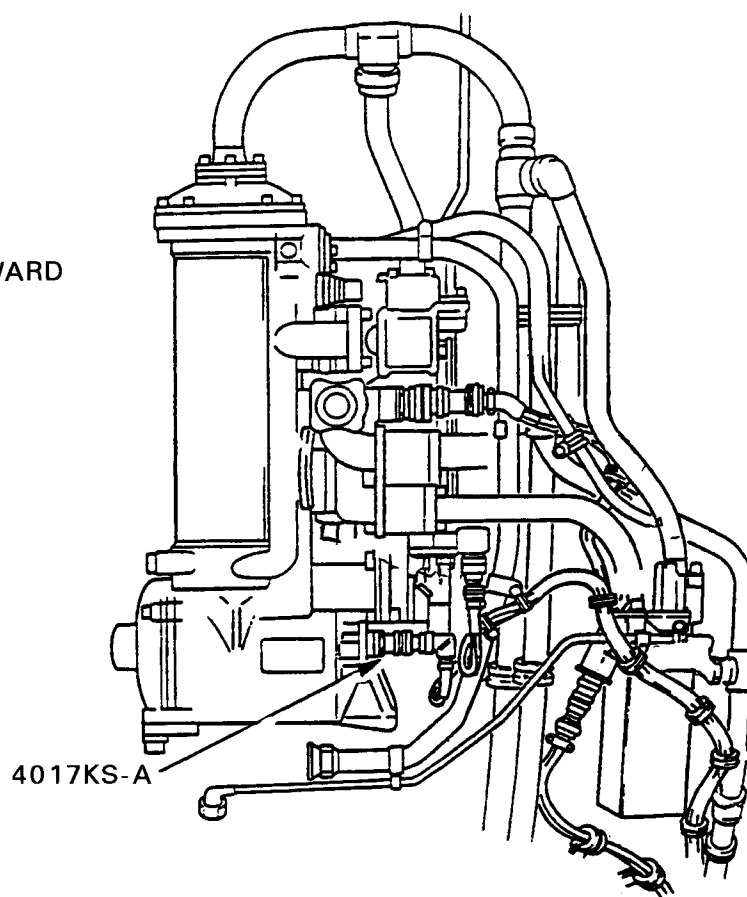
Location of 401KS-A connector  
Fig.1

- (1) Disconnect the EEC Fan harness electrical connector (4017KS-A) from the fuel temperature thermocouple on the FCOC. Refer to Figure 1.

- (1) Connect the 4017KS-A electrical connector to the fuel temperature thermocouple on the FCOC and torque to 100 to 120lbfin (11,3 to 13,6 Nm). Refer to Figure 1.
