**V2500-A1/A5 SERIES PROPULSION SYSTEMS SERVICE BULLETIN**

This document transmits Revision 1 to Service Bulletin EV2500-71-0162 and  
 Revision 1 to the Supplement

**V2500-ENG-71-0162**  
 Transmittal - Page 1 of 2

POWER PLANT – ELECTRICAL HARNESS – LIGHT DUTY – EEC LINK HARNESS CORE – REVISED  
COOLING AIR DEFLECTOR BRACKET ASSEMBLY FOR ELECTRICAL CONNECTOR AT STAGE 10 ON/OFF  
VALVE

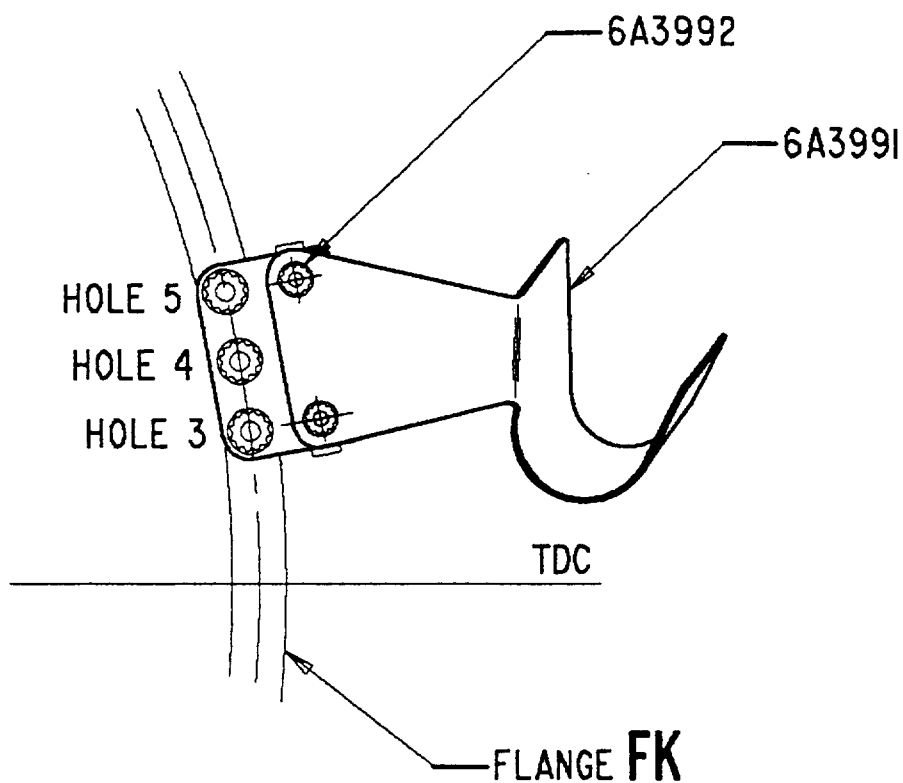
Bracket assembly - before alteration  
Figure 3

High Cycle Fatigue (HCF) cracking of the core harness cooling air deflector bracket assembly and corresponding stub bracket for the stage 10 on/off valve electrical connector may occur.

The problem is attributed to insufficient stiffness of the current standard of brackets.
