SERVICE BULLETIN

ENGINE - POWER PLANT - EEC FAN HARNESS - REWORK TO DELETE THRUST REVERSER INTERLOCK
CIRCUIT - CATEGORY CODE 4 - MOD.ENG-71-0175

V2500-ENG-71-0175

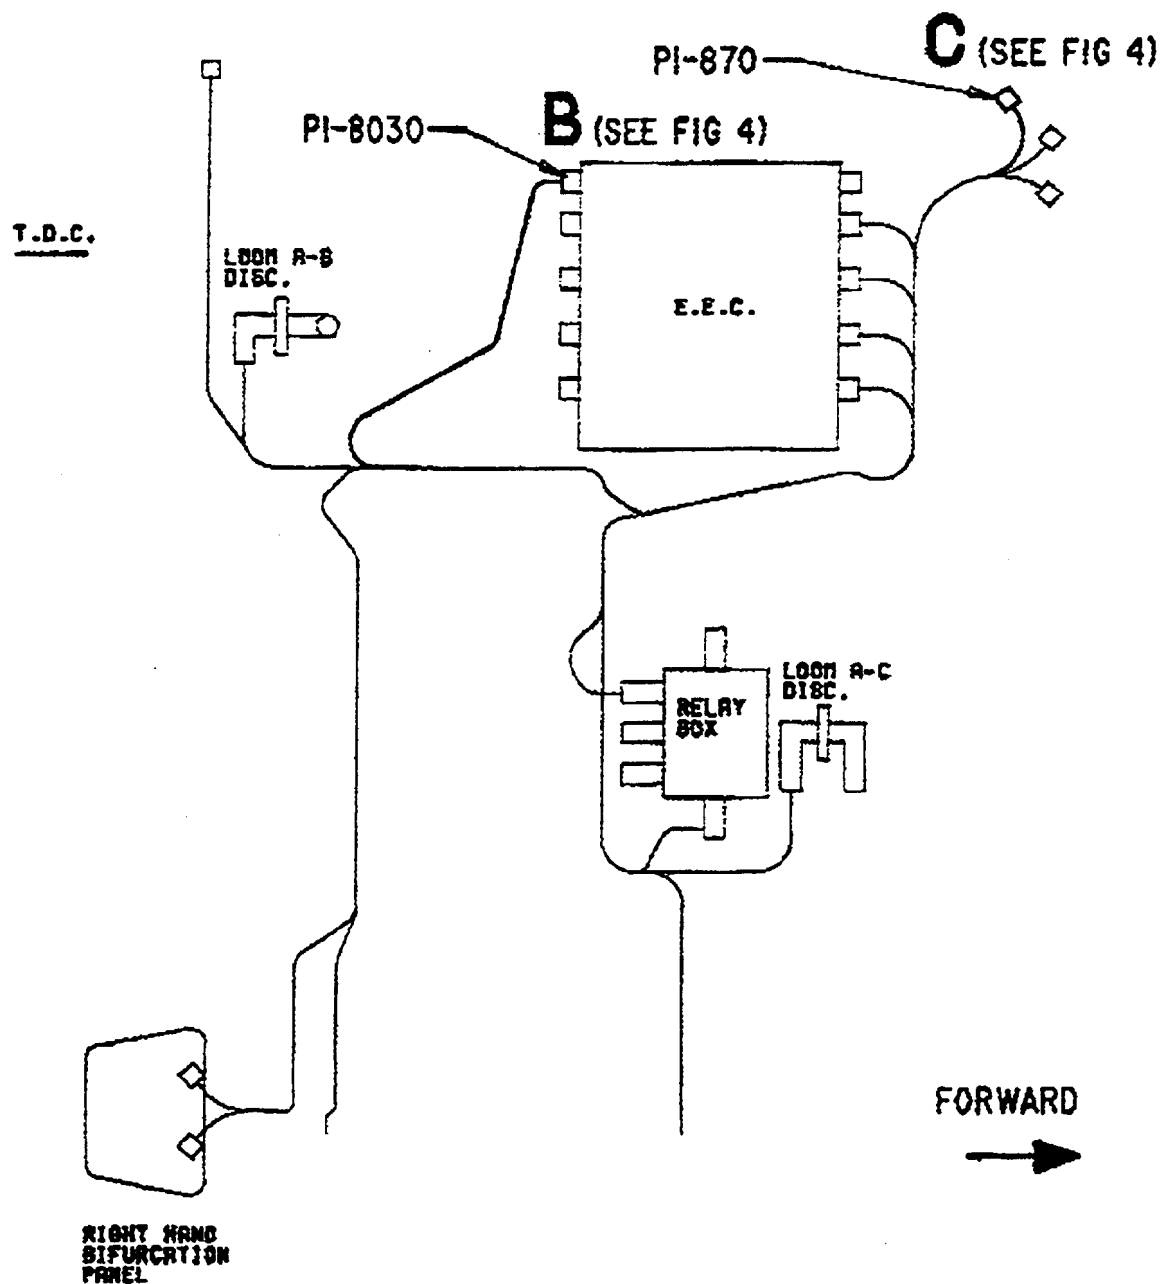
Fig.2

HARNESSES LOOM A:
6A6447 REPLACES 6A5940
6A6445 REPLACES 6A5945

Part schematic view of harness loom A showing harness limbs affected - Before and after alteration

| (a) Identify and locate the EEC Fan harness, Loom A, along with the EEC interface connector P1-8030 and pylon interface connector P1-870 | See Figure 2 |

- (g) Cancel the existing part number on the re-worked EEC Fan harness Loom A and identify with the new number
- See Figure 2
Refer to SPM TASK 70-09-00-400-501. SUBTASK 70-09-00-400-002

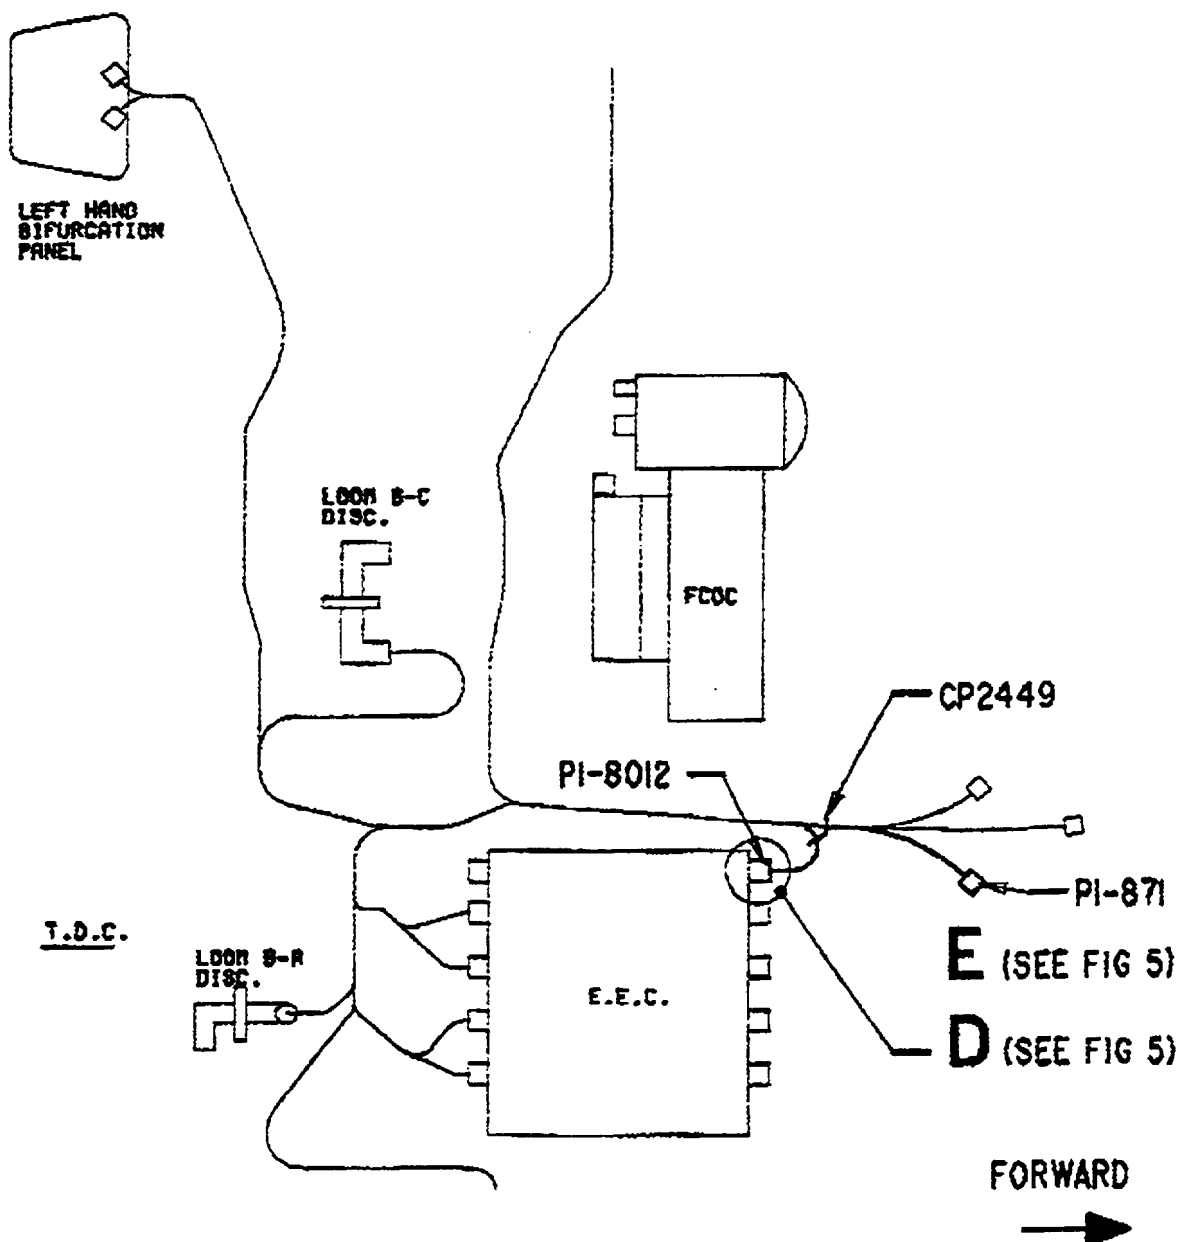
HARNESSES LOOM B:
6A6448 REPLACES 6A5941
6A6446 REPLACES 6A5946

Part schematic view of harness loom B showing harness looms affected - Before and after alteration
 Fig.3

- (a) Identify and locate the EEC Fan harness, Loom B, along with the EEC interface connector P1-8012 and pylon interface connector P1-871
- See Figure 3
- (b) Remove sockets R and h, from the connector P1-8012 and pins 10 and 2 from the connector P1-871
- Use the applicable contact extraction/insertion tool
- (c) Cut the EEC Fan harness, 2 wires, to remove the sockets/pins from each wire
- See Figure 5
Use standard workshop equipment

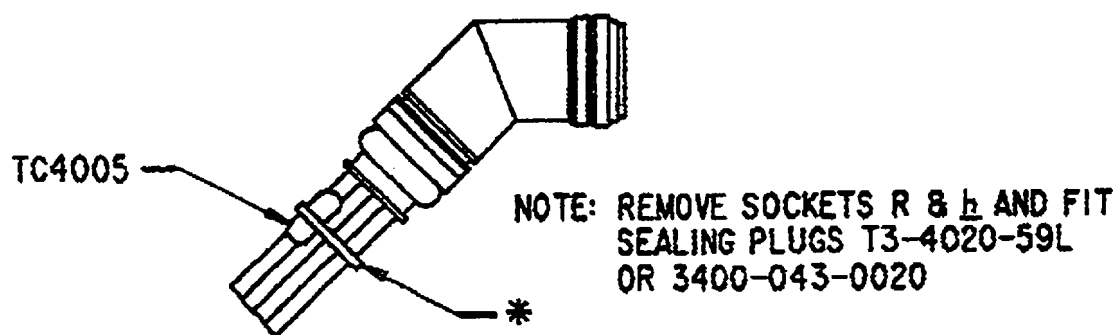
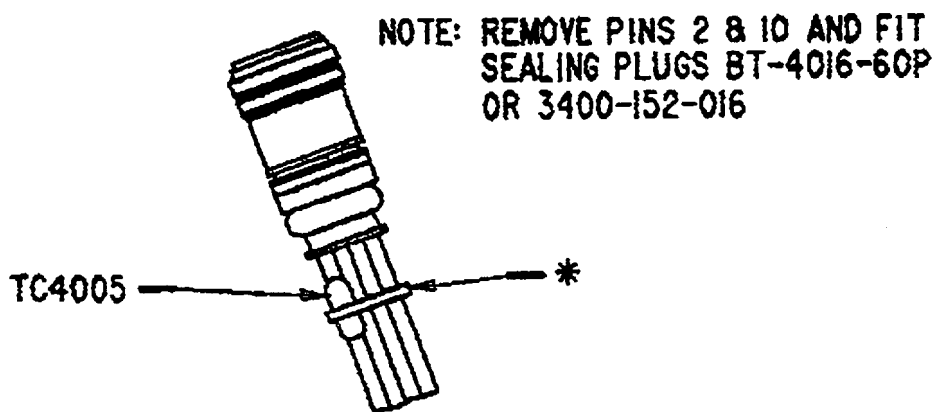
**NOTE : HARNESS LIMBS TO BE CUT 1.000 (25.4) MIN FROM
CONNECTOR BACKSHELLS AND EXPOSED ENDS TO HAVE
HEATSHRINK CAPS TC4005 FITTED**

**ENLARGED VIEW AT B (SEE FIG 2)
SHOWING REWORK OF HARNESS LOOM A
AT EEC INTERFACE PI-8030**

Enlarged view at C (see fig.2) - Showing rework of harness Loom A at pylon interface
P1-870
Fig.4

| (c) Cut the EEC Fan harness, 2 wires, to remove the sockets/pins from each wire | See Figure 4
| (d) Protect the cut ends with heat shrink caps | See Figure 4

- (f) Seal up the vacated sockets R and h in the connector P1-8030 and pin holes 10 and 2, in the connector
- See Figure 4
Use sealing plug T3-4020-59L or 3400-043-0020, 2 off and sealing plug BT-4016-60P or 3400-152-016, 2 off and sealing plug BT-4016-60P or 3400-152-016, 2 off, as necessary

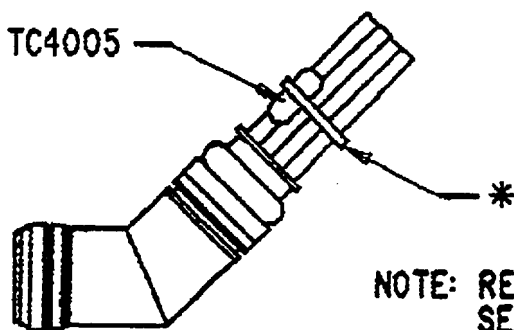
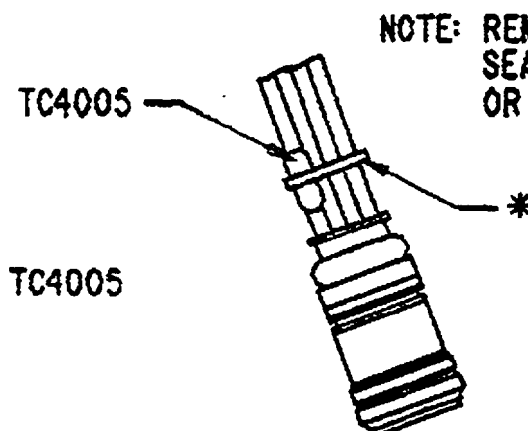
NOTE: REMOVE SOCKETS R & H AND FIT
SEALING PLUGS T3-4020-59L
OR 3400-043-0020

ENLARGED VIEW AT **D** (SEE FIG 3)
SHOWING REWORK OF HARNESS LOOM B
AT EEC INTERFACE PI-8012

NOTE: REMOVE PINS 2 & 10 AND FIT
SEALING PLUGS BT-4016-60P
OR 3400-152-016

Enlarged view at E (see fig.3) Showing rework of harness Loom B at pylon interface
P1-871
Fig.5

| (d) Protect the cut ends with heat shrink caps | See Figure 5

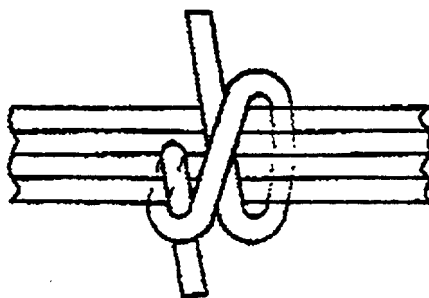
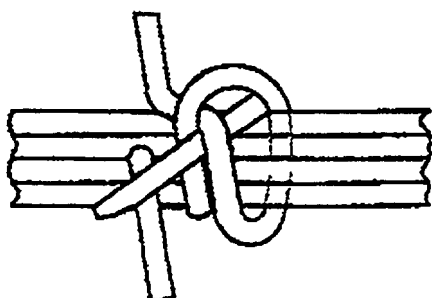
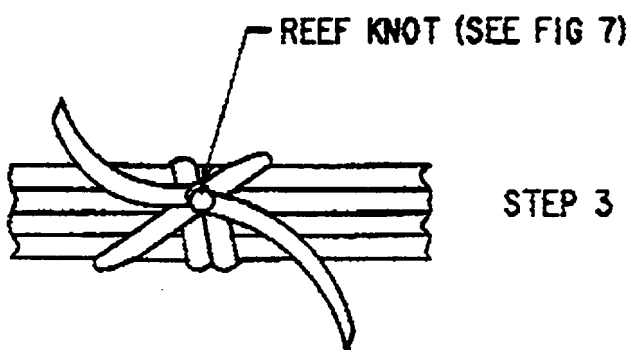
Rework of existing harnesses looms A and B – Showing procedure for fastening lacing tape
Fig.6

| (e) Tie back the cut ends onto the existing EEC Fan harness | See Figures 6 and 7

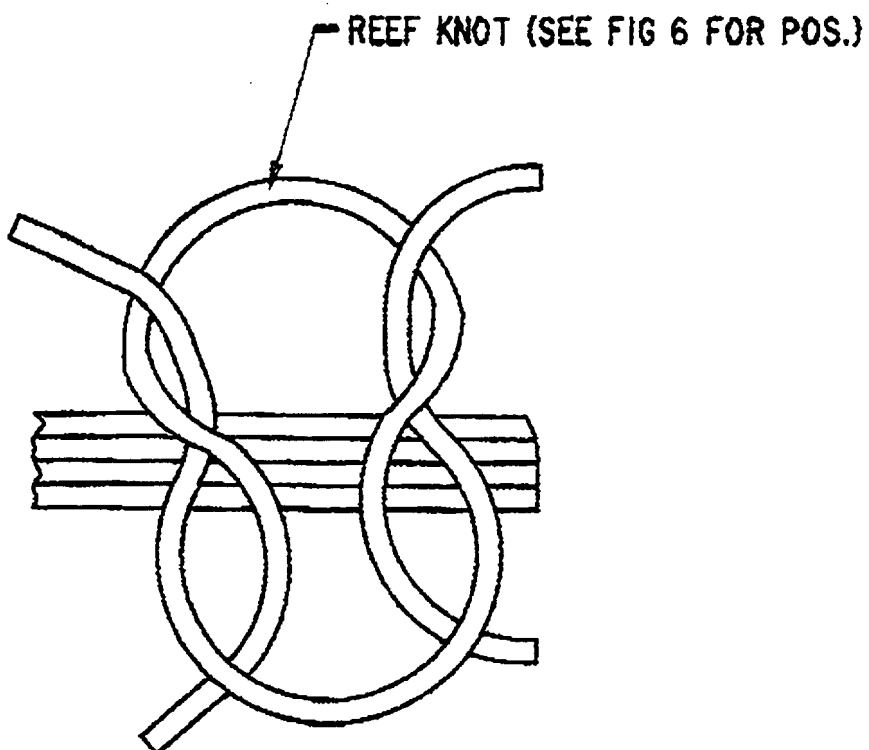
Rework of existing harnesses looms A and B - Showing procedure for fastening lacing
tape
Fig.7
