International Aero Engines
SERVICE BULLETIN

POWER PLANT - EEC CHANNEL-A AND B HARNESSSES (LOOM A AND B) - INTRODUCTION OF
REVISED ENGINE DEDICATED ALTERNATOR CONNECTORS

V2525-D5

V2500-ENG-71-0182

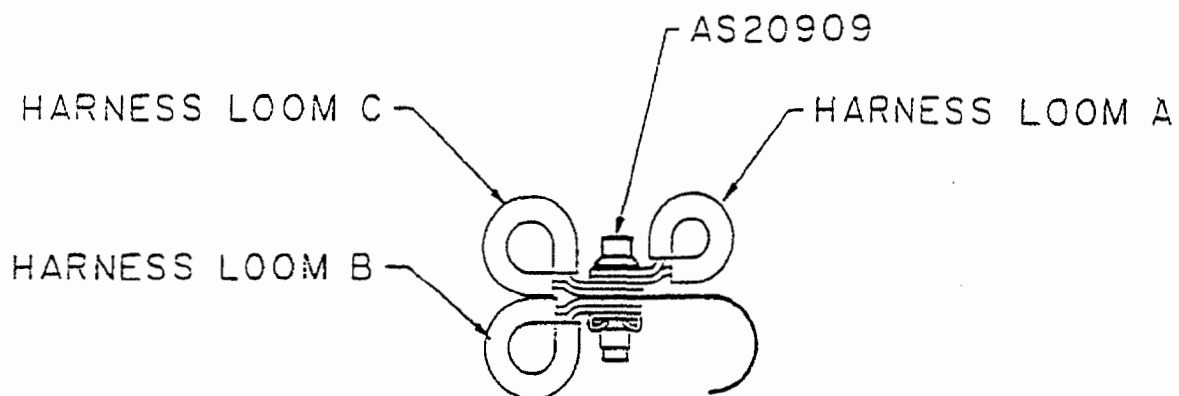
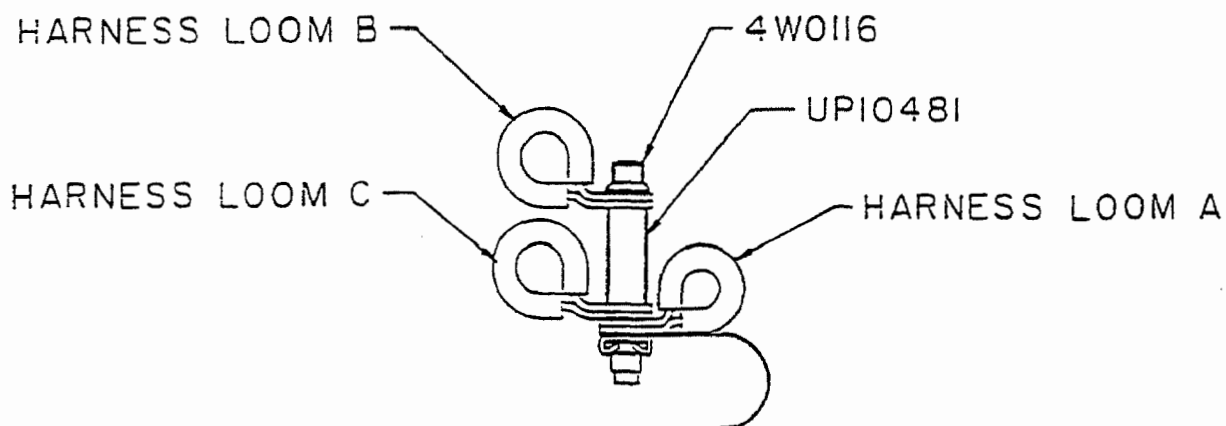
SCHEMATIC VIEW OF CLIP
POINT 2346 BEFORE CHANGE

SCHEMATIC VIEW OF CLIP
POINT 2346 AFTER CHANGE

- (g) With the clip removed at (d) and a 20,0 mm spacer, install Loom-B at CP2346.

Torque load the nuts between 36 and 45 lbf.in. (4,0 and 5,0 Nm). (Refer to Figure 10).
